PEST CONTROL SERVICE REPORT

Initial Treatment & Inspection Report

1145 Lucaya Circle, Orlando, FL 32824

Service Date: April 8, 2026 · Account #1052

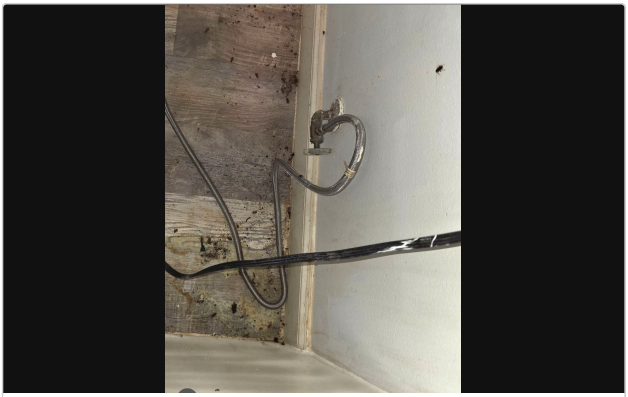
Behind Refrigerator — Primary Nesting Zone
Heavy frass covering floor and rear panel. Live roach visible on wall. Water/utility lines contaminated. Long-established harborage site.

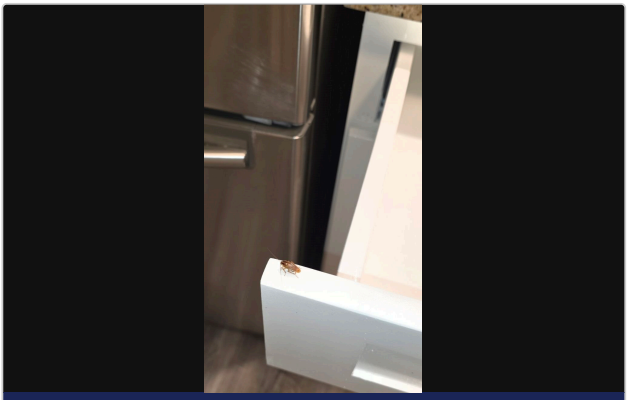
Kitchen Cabinet Drawer — Live Adult Roach
Adult German Roach perched on cabinet drawer edge directly adjacent to refrigerator — primary nesting zone. Clear specimen documentation.

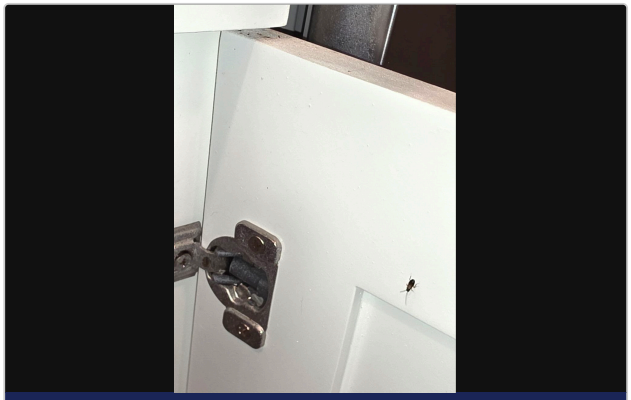
Kitchen Cabinet — Late-Stage Nymph
Late-instar nymph on cabinet door panel near hinge. Frass spotting visible on door surface. Confirms all developmental stages present in kitchen area.

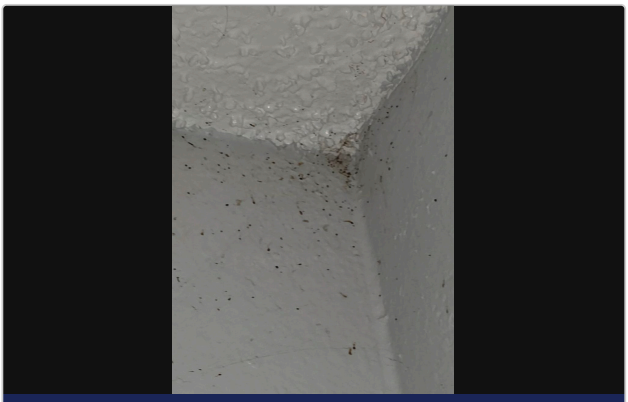
Ceiling Corner — Upper Wall Void Harborage
Dense frass spotting on ceiling and upper wall surfaces. Confirms harborage has spread into wall voids well above floor level.

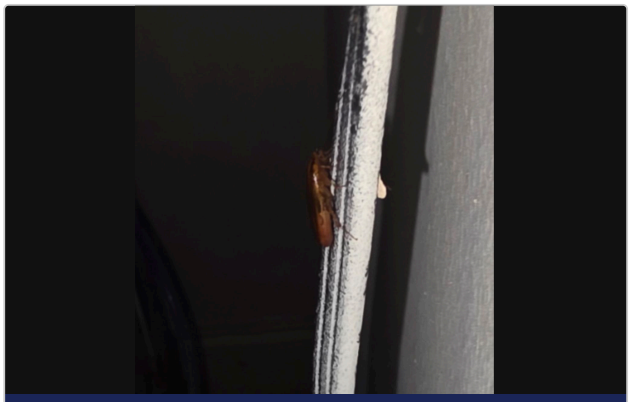
Gravid Female — Active Ootheca (Egg Case)
Pregnant female German Roach with ootheca visibly protruding from abdomen. Confirms active on-site reproduction. One ootheca = 30–40 eggs.

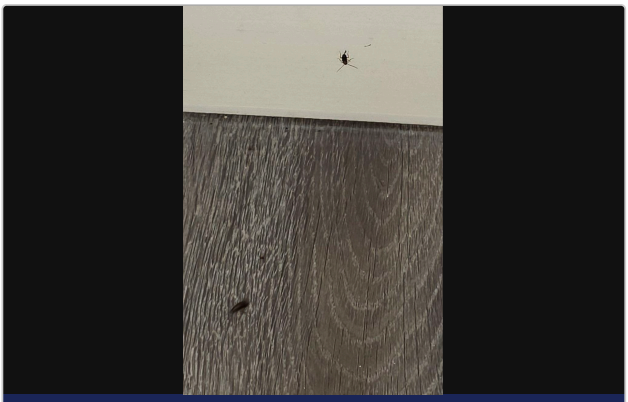
Living Room — Baseboard Activity
Live nymph on wall above baseboard. Confirms spread well into the primary common living area.

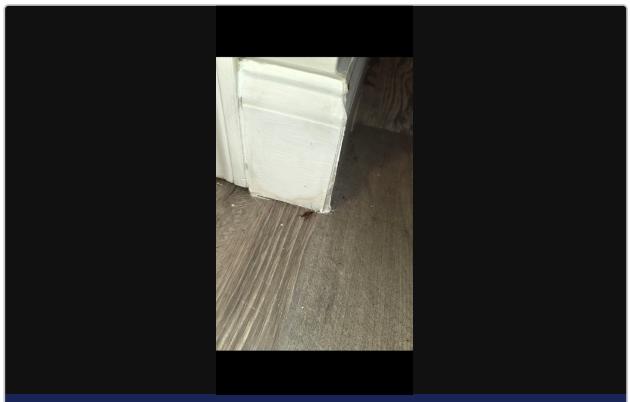
Hallway — Live Roach at Door Frame Base
Adult German Roach at base of door frame with frass debris on floor. Confirms spread through main corridor of the unit.

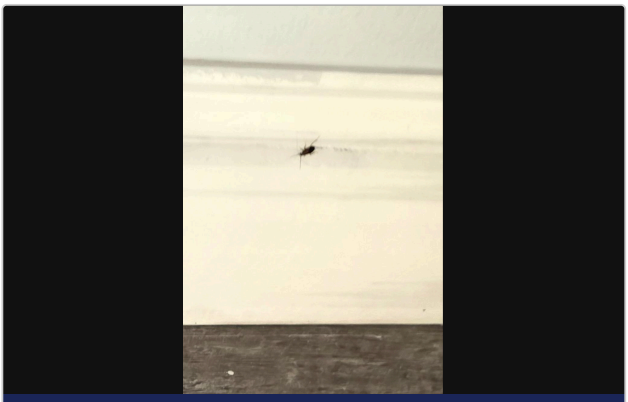
Secondary Bedroom — Live Roach on Baseboard
Live adult German Roach on wall above baseboard. Confirms activity in all sleeping areas.

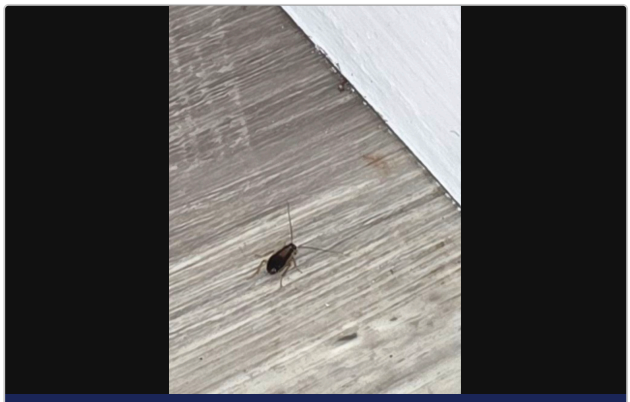
Secondary / Guest Bathroom — Live Adult Roach
Large live adult German Roach on floor at baseboard junction. Clear, well-documented specimen. Activity confirmed in both bathrooms.

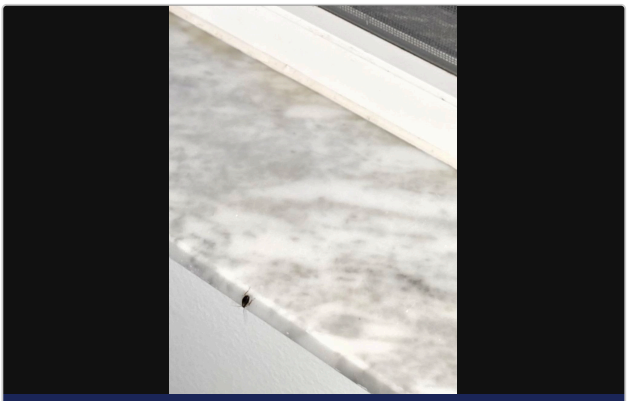
Master Bedroom — Window Sill Activity
Live nymph at front edge of window sill. Confirms spread into master bedroom and window frame areas.
