c00a170fe1

lidar tier · 2 rooms · 15.11 m² [14.11, 16.10] · 11.6 s
every value carries a nominal 90% interval · * means the sensor never saw it

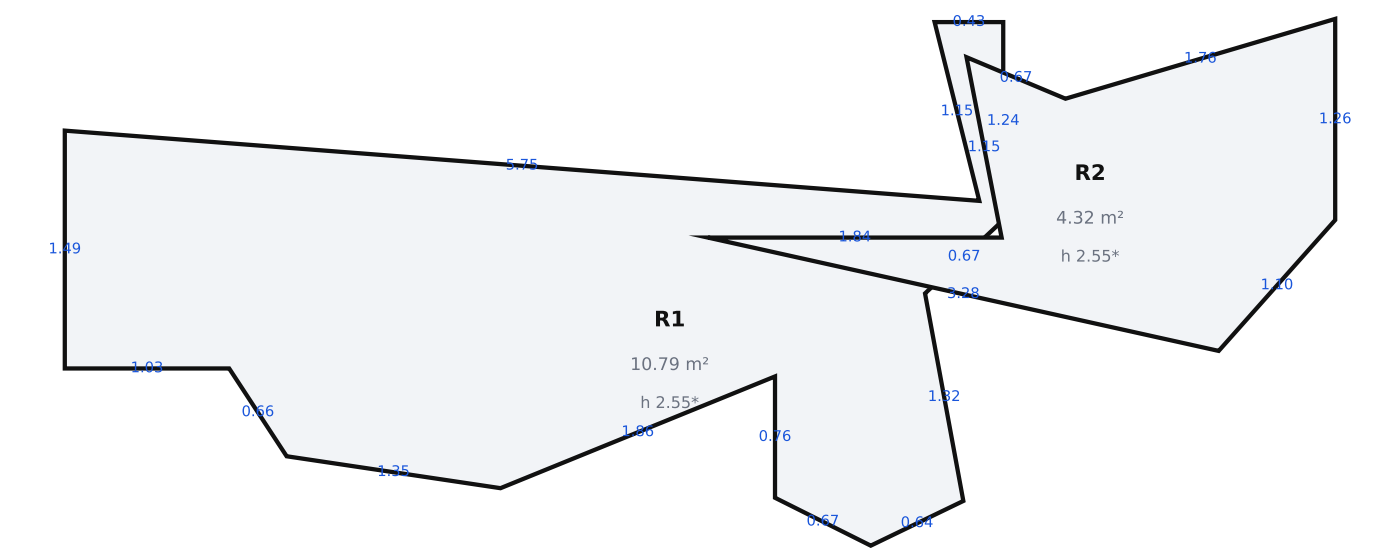
Room	Area m²	Ceiling m	Walls	Openings
R1	10.79 (10.08-11.50)	2.55 *	14	1
R2	4.32 (4.03-4.60)	2.55 *	7	1

no damage regions found
class would be shape-derived; naming a defect needs appearance

- [warning] the walk did not return to its start (3.18 m apart); drift correction has no loop to close, so accumulated error cannot be removed
- [warning] mirrors and glass are NOT detected. Two geometric tests were built and neither separates a reflection from ordinary geometry; 10.9% of points sit outside the floor envelope here, which is normal for ceilings and occluded floor. Geometry near any mirror in this capture is wrong and unflagged. The capture protocol asks the operator to approach mirrors at an angle

- [warning] floor is missing beneath 40% of the path the camera actually walked, which is the signature of a wet or glossy surface scattering the beam away. Floor area is under-reported there

- [warning] the ceiling was never seen; ceiling heights are population typicals with wide intervals, flagged observed=false
- [info] rooms are split at doorway-width necks and under-split rather than over-split; a merged pair still reports a correct combined floor area, an invented room does not
