PACKAGING

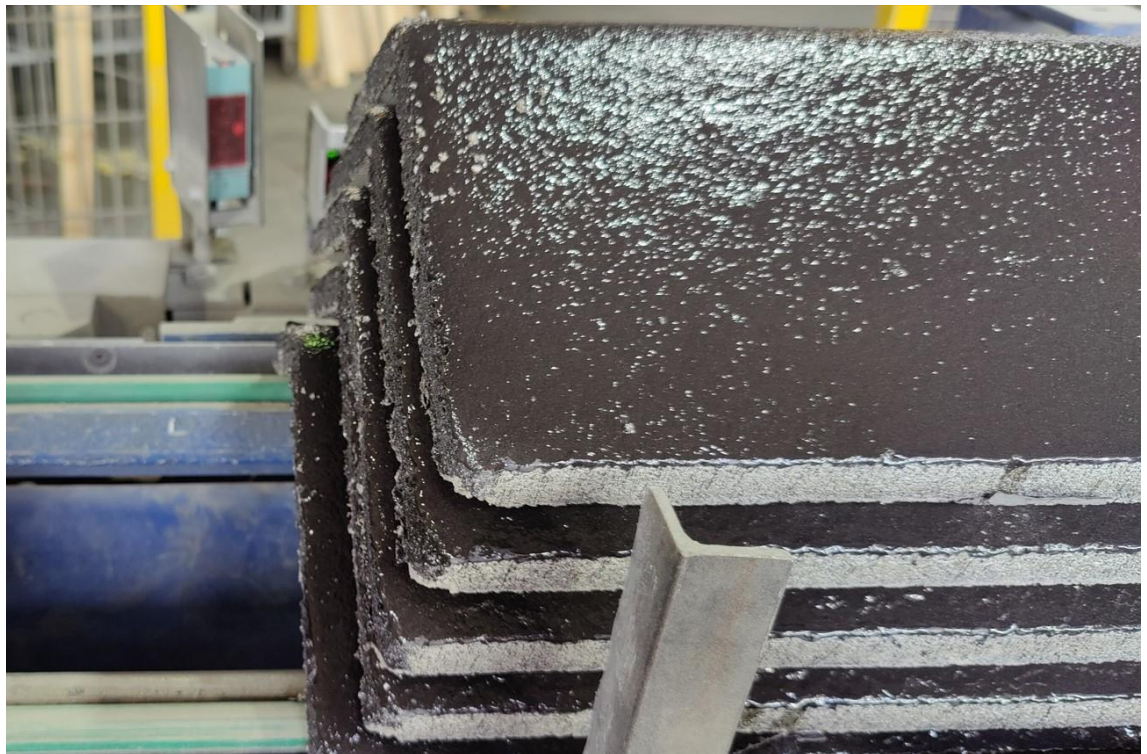
*In this installation there are 3 or 4 critical points to evaluate:

1) Forming packages of 4 tiles, the tiles are not well aligned.

(They should be aligned as the bundle is being formed or when strapping).

***See the possibility of aligning the tiles in the formation of the package.**

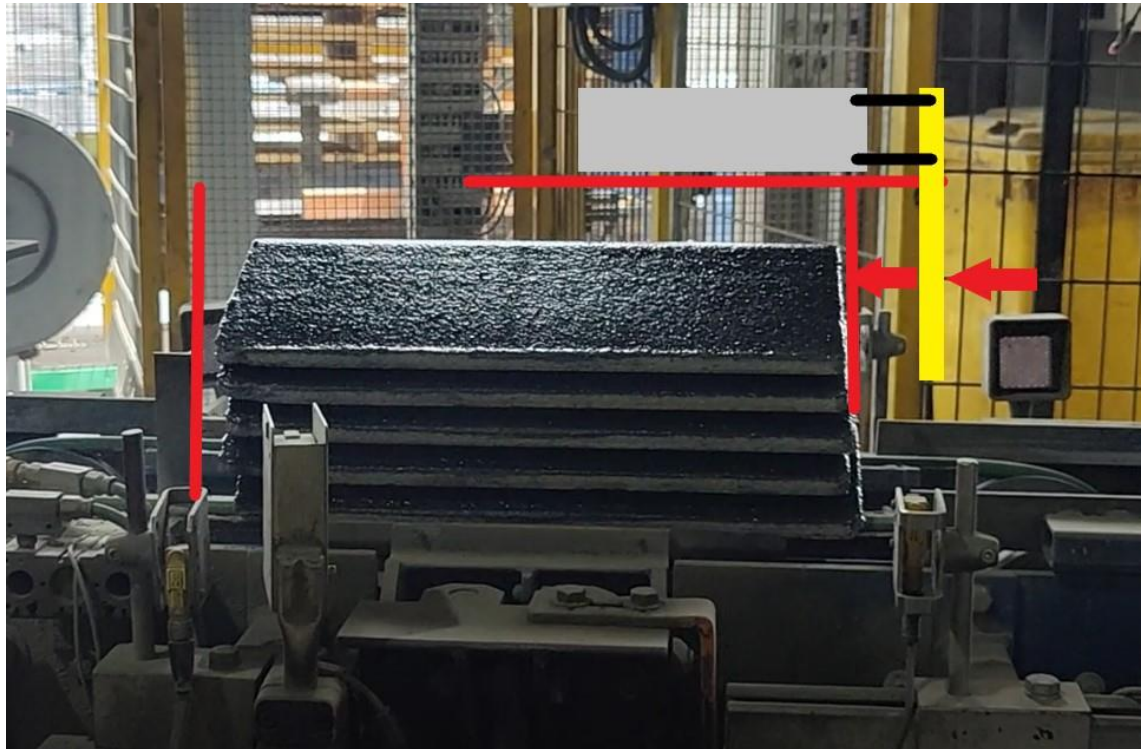
2)*When strapping the packages of 4 tiles, they do not fit well, the strap seems to me too rigid and does not fit, for the arch of the 4 tiles,

(Poorly fitted and poorly welded/not aligned).

***See the possibility of aligning the tiles in the strapping of the package.**
