Hilbert curve absorber by Matthew Petroff

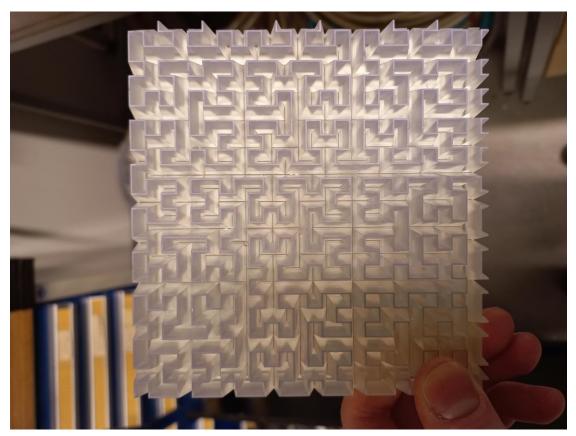
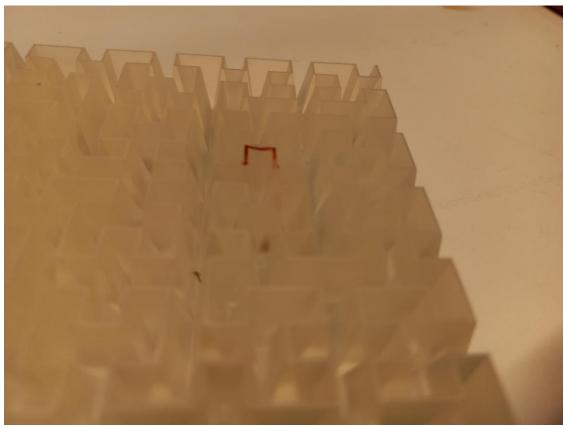
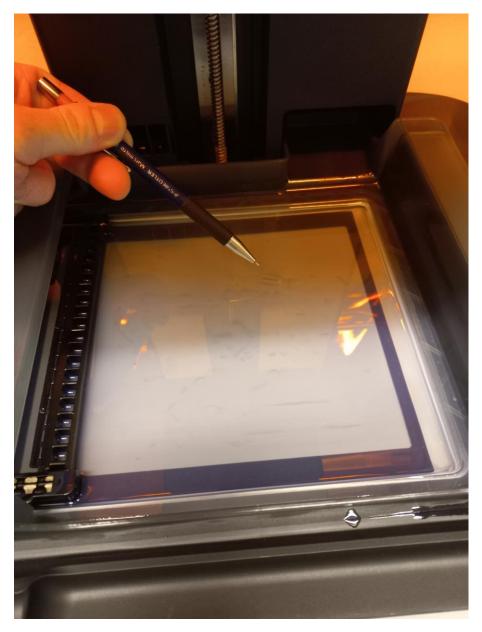
Original file made by Petroff was bigger than the maximal printing size of our Form 3 printer, therefore design vas cut to fit printer building table with size 145×145 mm. » deformations were observed on print, one on the top of aborber edges a defect in edge was observed (marked with red). Another defect was observed on the bootom, and it was concluded, that it's source is defect on formlabs printer screen, which was most likely produced by a small support part, which was squezzed betwen laser head and screen and make irreverible deformation on the screen.
