Learning from failures in cruise ship industry: The blackout of Viking Sky in Hustadvika, Norway

Michaela Ibrion ^{a,*}, Nicola Paltrinieri ^a, Amir R. Nejad ^b

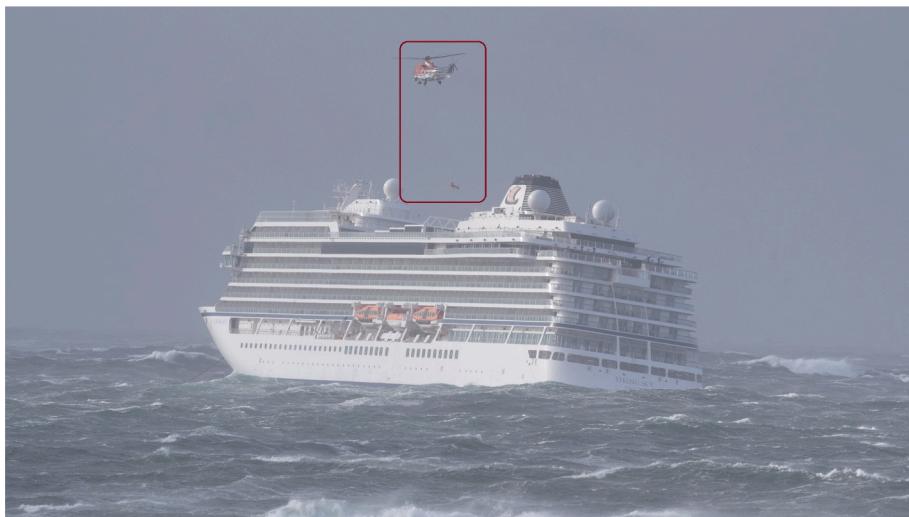
Regarding the helicopter rescue operation, the Norwegian Search and Rescue (SAR) contacted the company CHC at 14.00, immediately upon receiving the mayday from Viking Sky. Within 30 min from the call for assistance, the first CHC aircraft which was on contract with the Norwegian Ministry of Justice reached at Viking Sky area and started to hoist passengers, initially, one at a time. Very shortly, another helicopter - on contract with Equinor at Heidrun - arrived at the Viking Sky location. A rescue pattern was established in order to ensure that one helicopter was hoisting passengers all the time. The Fig. 5 shows the hoisting process of a passenger via helicopter during the blackout in Hustadvika.

Fig. 5. Evacuation of passengers from the Viking Sky cruise ship via helicopter, adapted from NRK [43] - please note the passenger hoisted by helicopter.

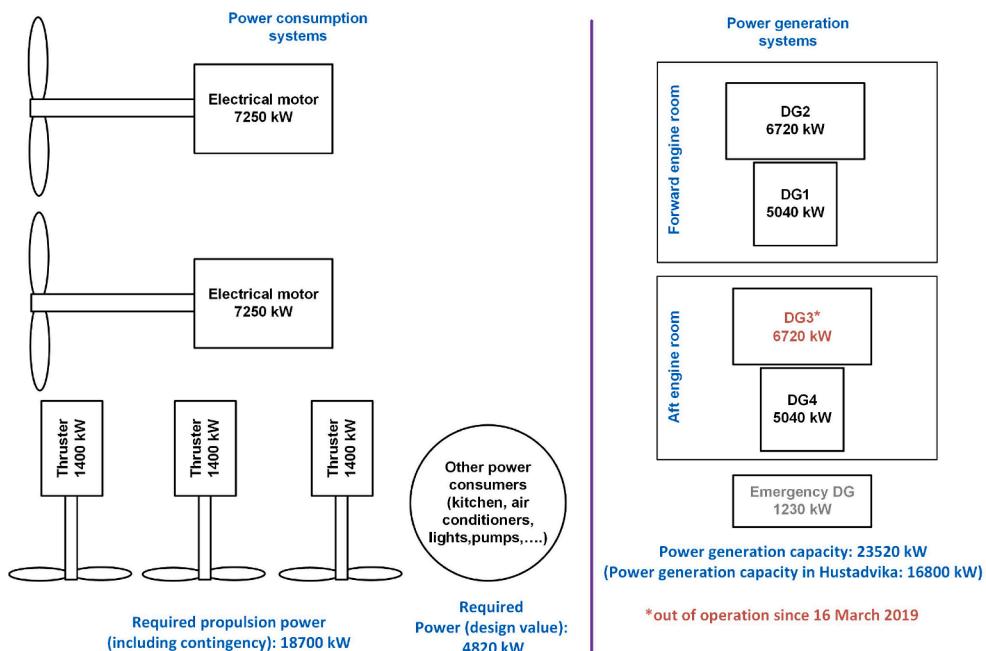
Fig. 6. Power generation and power consumption capacity for Viking Sky cruise ship.

high waves most probably caused movements in the tanks so large that the supply of oil to pumps stopped. This triggered the level alarms which indicated a low level for lubricating oil and shortly, an automatic shutdown of engines occurred. "The heavy seas in Hustadvika probably caused movements in the tanks so large that the supply to the lubricating oil pumps stopped," and the sensors had detected the shortage and shut off engines to prevent a breakdown [34,42].

A failure precursor is represented by the technical failure confronted by Viking Sky: one large DG (out of two existing large DGs) - the DG3 - was out of operation for many days - since 16 March - because of a turbocharger failure. Consequently, before the blackout in Hustadvika, there were only three operational DGs - one large and two small ones. Before the blackout, the first DG which shut down was the small DG - the DG4 - which was situated in the aft engine room, the same room where the out of operation large DG3 was located. Turbochargers are seen to be among the high-technological and critical engine components on board of a ship. A turbocharger is a piece of high-speed machinery which serves continuously in harsh conditions and under high strain. A damage to a turbocharger negatively impacts engine, brings a significant reduction in speed of a ship and can be considered as a significant safety hazard. Furthermore, a turbocharger damage is linked with very costly repairs [48].

The AIBN issued an interim report and the owners/operators of all vessels were recommended to carefully ensure the levels of lubricating oil in the tanks are strictly maintained according to instructions of engine manufacturer. In case of a stormy weather

forecast, the engine lubricating oil levels need to be topped up [20]. Furthermore, on 27 March 2019, the Norwegian Maritime Authority has issued a general safety notice - the Safety notice 04/2019 - on risk assessment of critical systems. All shipping companies were asked to ensure a continuous supply of lubricating oil to engines and other critical systems during poor weather conditions. "This should be done in cooperation with the engine supplier and, moreover, be included in the ship's risk assessments in the safety management system" [49,52].
