**CONSULTANCY SERVICES TO VERIFY AND RECORD ASSETS
UNDER THE UGIFT PROGRAMME
REF: MOFPED/UGIFT/CONS/25/26/00015
ASSET VERIFICATION REPORT**

6 October 2026

Financial reporting date 30 September 2026

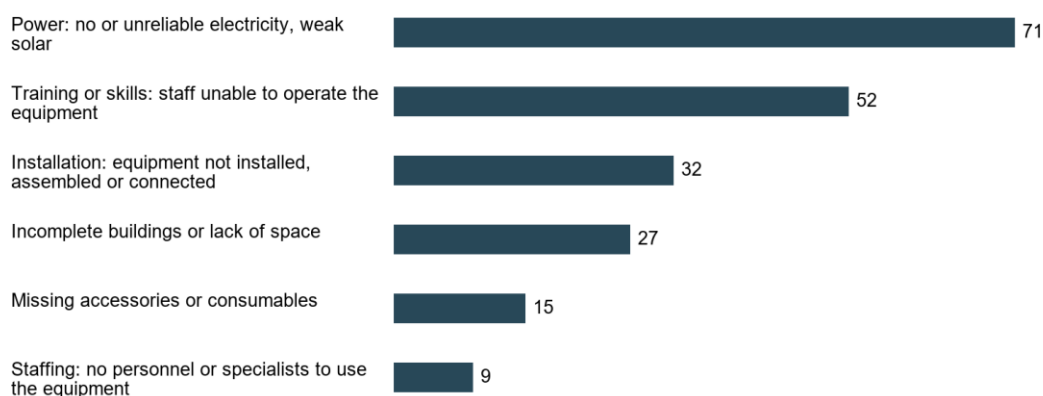
Figure 2: Reasons for equipment not in use

Verification also noted that over 7000 assets mainly in seed secondary schools and Health Centres had not been used requiring installation or the facility itself was not yet ready. Notable among the facilities include Lungulu Seed Secondary School in Nwoya District where desktop computers, a printer and UPS units were still boxed because the school was waiting for power connection. At Nansanga Seed Secondary School in Budaka, 27 of 28 desktop computers remained packed for lack of reliable power.

Figure 2 shows the reasons for non-deployment of some of the assets even when they were found to be in good condition.

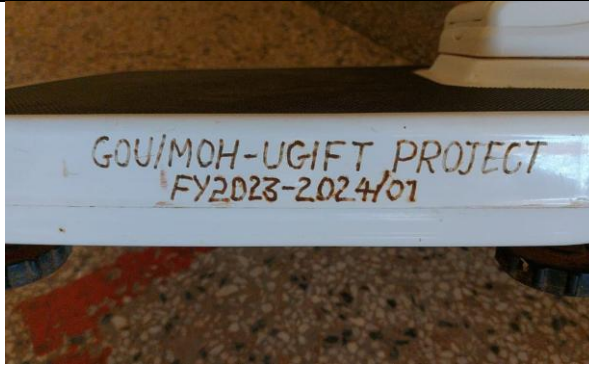
Engraving reading GOU/MOH-UGIFT PROJECT FY/2023/2024 on a desk at Namwaya Health Centre III, Tororo District	Engraving reading APESSS MOES/UGIFT/KABE/SPLRS/2023-24/001 on a desk at Aperikira Seed Secondary School, Kaberamaido District
Chair engraved UgIFT/ BUDDE SEED S.S M-PHALL CHAIR 105 with a serial number at Budde Seed Secondary School, Butambala District	Wheelchair backrest marked GOU/MOH UGIFT-PROJECT. FY2023/2024 at Kalemungole Health Centre III, Moroto District
