**CONSULTANCY SERVICES TO VERIFY AND RECORD ASSETS
UNDER THE UGIFT PROGRAMME
REF: MOFPED/UGIFT/CONS/25/26/00015
ASSET VERIFICATION REPORT**

6 October 2026
Financial reporting date 30 September 2026

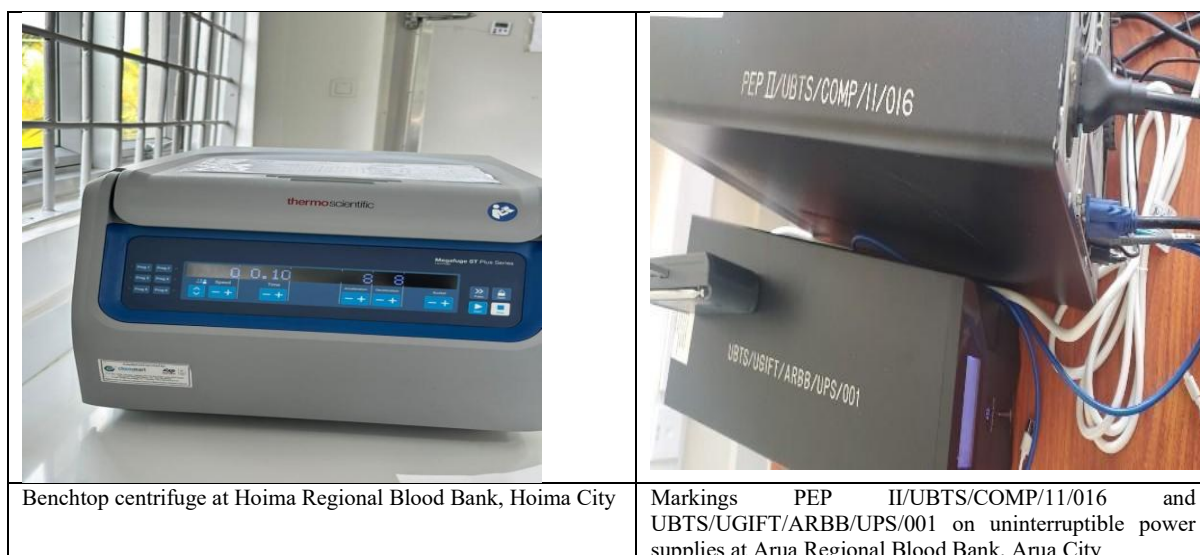
Figure 16A: Asset photographs from regional blood banks

Donor couches in the donor room at Hoima Regional Blood Bank, Hoima City

Blood-bank refrigerators and plasma snap freezer at Soroti Regional Blood Bank.

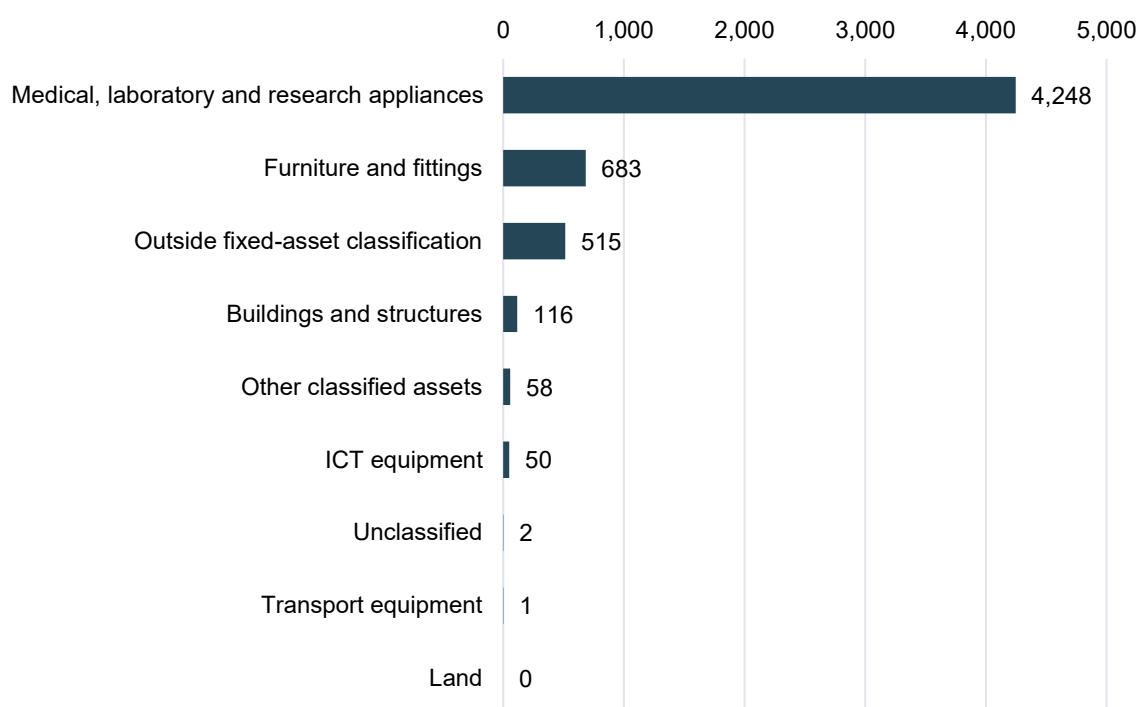
Figure 18: Faulty assets at Health Centres by category

The findings indicate that of the 63,432 health-centre assets, 57,759 (91.1%) were recorded as functional and in use and 5,673 (8.9%) were recorded as faulty and not in use. Figure 18 and Table 25 present the condition of the assets. These two register categories do not establish separate current counts of items in store, broken items and other reasons for non-use.
