**CONSULTANCY SERVICES TO VERIFY AND RECORD ASSETS
UNDER THE UGIFT PROGRAMME
REF: MOFPED/UGIFT/CONS/25/26/00015
ASSET VERIFICATION REPORT**

6 October 2026
Financial reporting date 30 September 2026

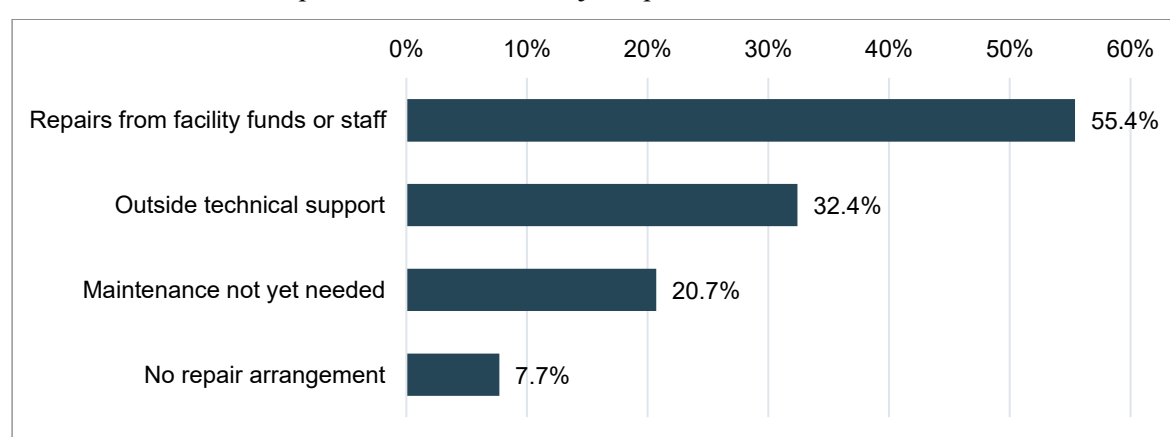
Figure 46: Most facilities met repairs from their own funds or staff

Repair arrangements. Of the 469 facilities that described their maintenance arrangements, 260 (55.4%) met repairs at facility level, from their own funds or with their own staff. Health Centres named Primary Health Care funds (94 of 278, 33.8%), while schools named the capitation or Universal Secondary Education grant, parents' contributions or the school budget (52 of 191, 27.2%). Busaale Health Centre III in Kayunga used Primary Health Care funds for repairs, and Kagumba Seed Secondary School in Kamuli had repaired broken furniture during the second term. A facility could describe more than one arrangement.

Support from outside the facility was cited by 152 facilities (32.4%): district offices, mainly the District Health Officer, 85 (18.1%); regional referral hospital workshops or national teams 52 (11.1%); hired technicians and artisans 27 (5.8%); and contractors or suppliers under defects liability, guarantee or warranty 12 (2.6%). Major medical equipment repairs depended on this support. Todora Health Centre III in Nwoya worked through the District Health Officer and the Gulu Regional Referral Hospital technical team, Avogera Health Centre III in Buliisa received support from Hoima Regional Referral Hospital, and Bundimulangya Health Centre III in Bundibugyo obtained a team through the District Health Officer.

In all, 97 facilities (20.7%), 59 of them schools, had not yet needed maintenance because the assets were new, not yet handed over or the buildings were still under construction, and 36 (7.7%) reported no repair arrangement, with broken items set aside or not repaired. Funds for maintenance and repair were reported as insufficient, particularly for major repairs, by 32 of the 505 facilities that described maintenance or challenges (6.3%). At Kyankaramata Health Centre III in Kyenjojo, Primary Health Care funds met minor repairs, but the cost of major repairs was a constraint.

Figure 46 compares these arrangements at Health Centres and seed schools. Health Centres relied more on outside technical support (41.4% of health centres against 19.4% of schools), while schools more often had not yet needed maintenance (30.9% against 13.7%).

Recommendation. Facility managers and school governing bodies should keep the local and regional repair arrangements that already work and adopt a fixed routine: a condition check at least every school term in schools and every quarter in health centres, and a full count of UgIFT assets each year. Each facility should keep a condition book or fault list naming each item requiring action, the responsible person and the agreed completion date; the 36 facilities with no repair arrangement and the 80 with no functionality or breakdown record should set these up first.

District health and education offices should review unresolved repairs each quarter and arrange technical assistance, and regional referral hospital workshops should include UgIFT equipment in their scheduled visits. Annual maintenance plans should separate minor repairs from major repairs such that the minor repairs be met from Primary Health Care funds or school grants, while major repairs can be handled through district or national funding.

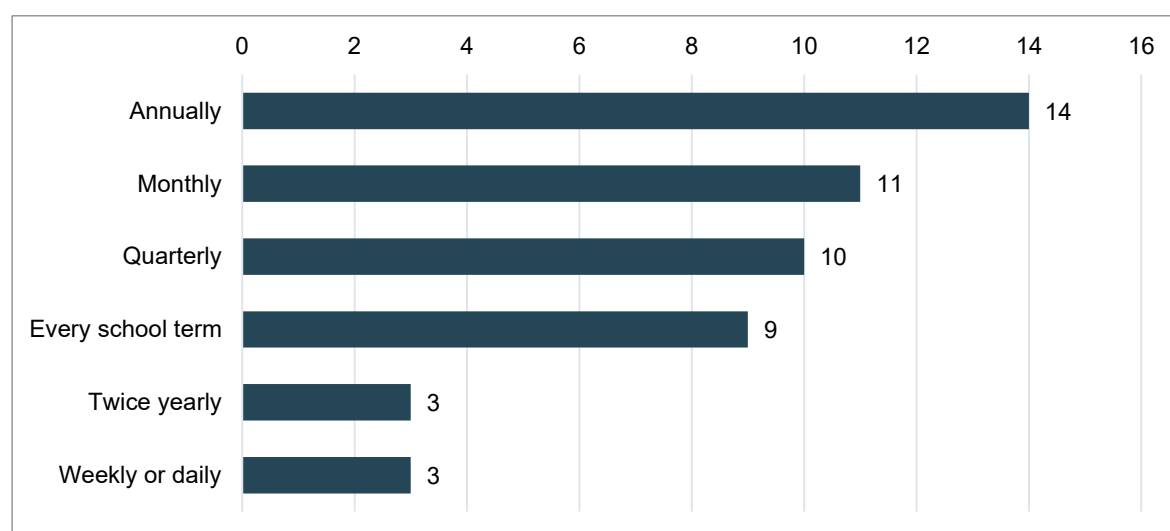
Figure 47: Annual, monthly and quarterly checks were the most common stated intervals

Frequency. Few facilities worked to a fixed maintenance interval. Of the 494 programme-list facilities that described how they maintain UgIFT assets or check their condition, 50 (10.1%) did so at a fixed interval. Of these 50, 14 (28.0%) worked annually, 11 (22.0%) monthly, 10 (20.0%) quarterly, 9 (18.0%) every school term, 3 (6.0%) twice a year and 3 (6.0%) weekly or daily, as Figure 47 shows. A further 18 facilities (3.6%) described routine or scheduled servicing without a set interval, mostly scheduled visits by regional referral hospital maintenance teams, and 61 (12.3%) repaired items as the need arose. Ngwedo Seed Secondary School in Buliisa engaged a caretaker every month and used the Directorate of Industrial Training for furniture repairs, while Busaale reviewed asset condition every quarter.
