**CONSULTANCY SERVICES TO VERIFY AND RECORD ASSETS
UNDER THE UGIFT PROGRAMME
REF: MOFPED/UGIFT/CONS/25/26/00015
ASSET VERIFICATION REPORT**

6 October 2026
Financial reporting date 30 September 2026

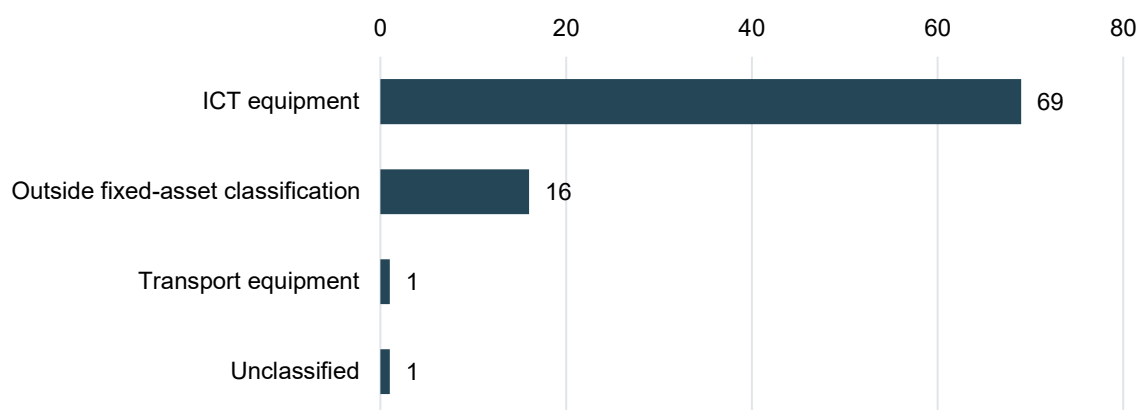
Figure 6: Assets verified at MoWT

Condition and functionality: Of the 87 assets, 71 (81.6%) were recorded as functional and in use; sixteen (18.4%) were recorded as faulty and not in use.

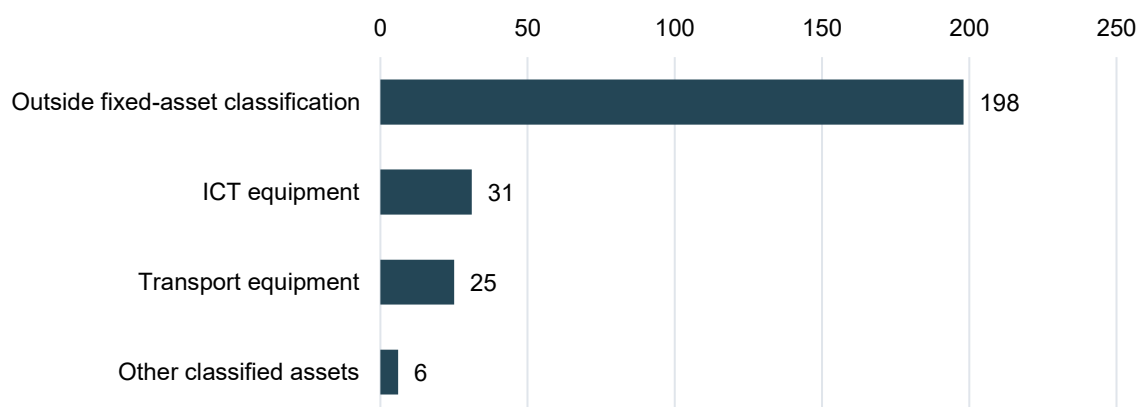
Figure 9: Assets verified at MoH

The Ministry of Health's other items include two heavy-duty binding machines, two CC20240 paper shredders and 12 entries described as Accessories (12-Helmets). All 12 helmet entries share asset number UGIFT-217204, so the identity and quantity of the helmets require confirmation. The reported total of six power items remains unreconciled. Three have been traced to Kyamwinula Health Centre III under Tororo Municipal Council: one power bank and two regulators (UGIFT-118553–UGIFT-118555). These are already included in the health-centre total. These items are also associated with TASO or RHITES E, so their attribution to UgIFT requires confirmation. The other three power items have not been identified.

Condition and functionality: The assets recorded as functional and in use were 259 (99.6%). Only one asset, a double-cabin pickup, was recorded as faulty and not in use.

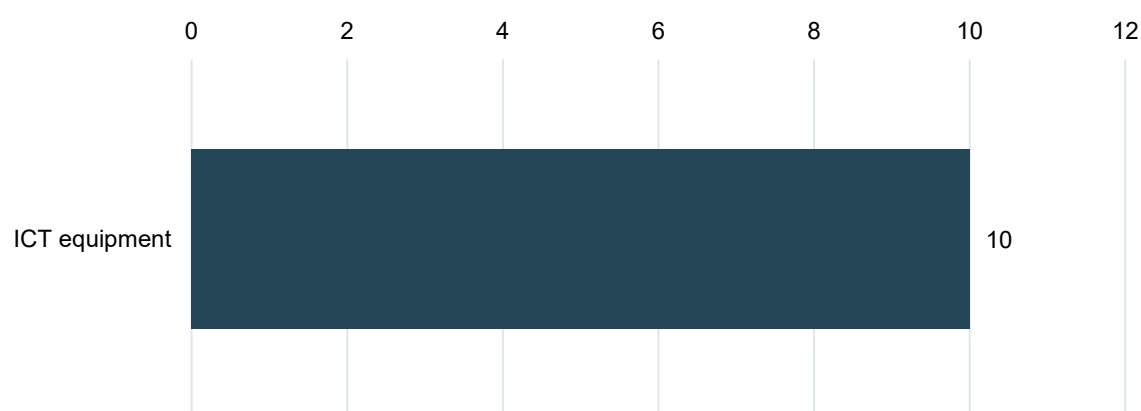
Figure 10: Assets verified: OPM

Condition and functionality: Seven assets (70.0%) were recorded as functional and in use. Three (30.0%) were recorded as faulty and out of use.

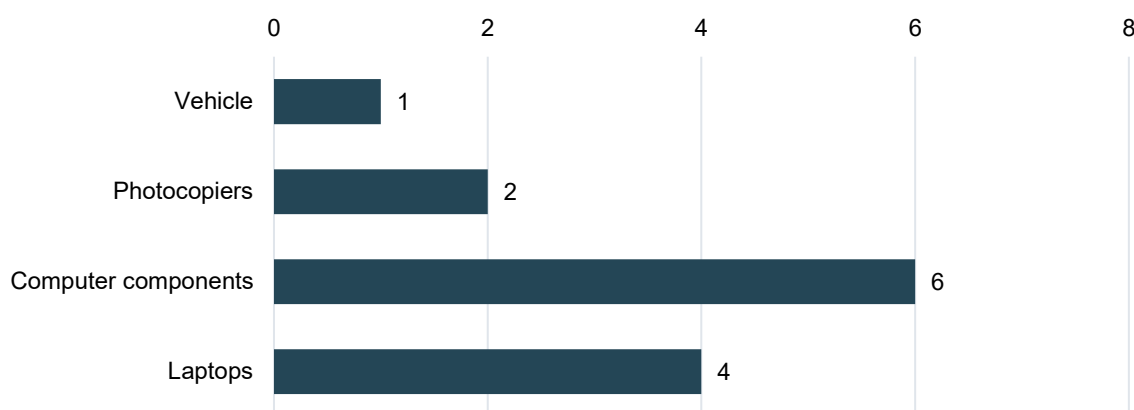
Figure 15: Assets verified at MoLG

The two photocopier entries share the identifier UGIFT-MOLG/PHC/23-01. Their identity requires reconciliation to establish whether they are two separate items. Computer components are counted separately in Figure 15.

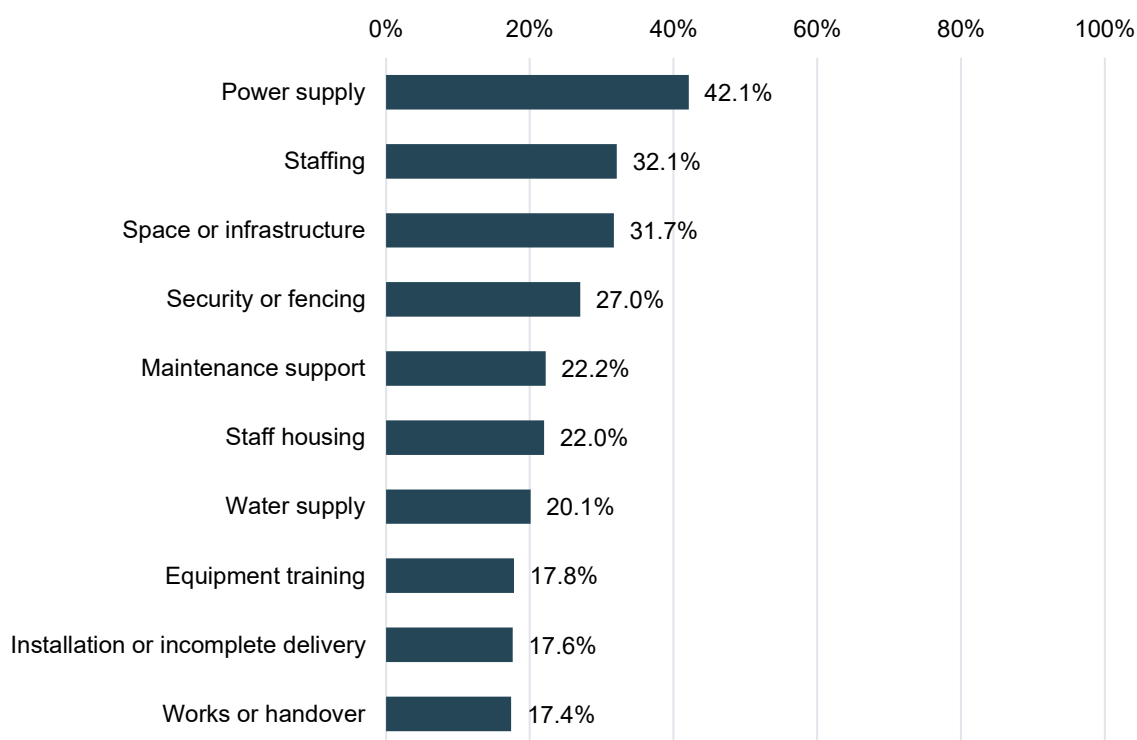
Figure 45: Service gaps and challenges

- i. Insufficient Power supply which was reported by 201 facilities (42.1%), including 44.4% of Health Centre respondents and 38.9% of school respondents;
- ii. Inadequate Staffing which was reported by 32.1% of the facilities (153 of 477).
- iii. Inadequate space or infrastructure reported by 31.7% of the facilities (151 of 477).
- iv. Insecurity or absence of fencing reported by 27.0% of the facilities (129 of 477).
- v. Limited maintenance support was raised by 22.2% of the facilities (106 of 477).
- vi. Inadequate staff houses reported by 22.0% of the facilities (105 of 477).
- vii. Poor water supply reported by 20.1% of the facilities (96 of 477).

- viii. inadequate training of staff to operate the equipment reported by 28.9% of the health centres (82 of 284), and 1.6% of schools (three of 193).
- ix. Incomplete or delayed works, handover or commissioning reported by 28.0% of Seed Secondary School respondents (54 of 193) and 10.2% of Health Centre respondents (29 of 284).
- x. Equipment not installed, not assembled or delivered incomplete was raised by 17.6% of the facilities (84 of 477).
