**CONSULTANCY SERVICES TO VERIFY AND RECORD ASSETS
UNDER THE UGIFT PROGRAMME
REF: MOFPED/UGIFT/CONS/25/26/00015
ASSET VERIFICATION REPORT**

6 October 2026
Financial reporting date 30 September 2026

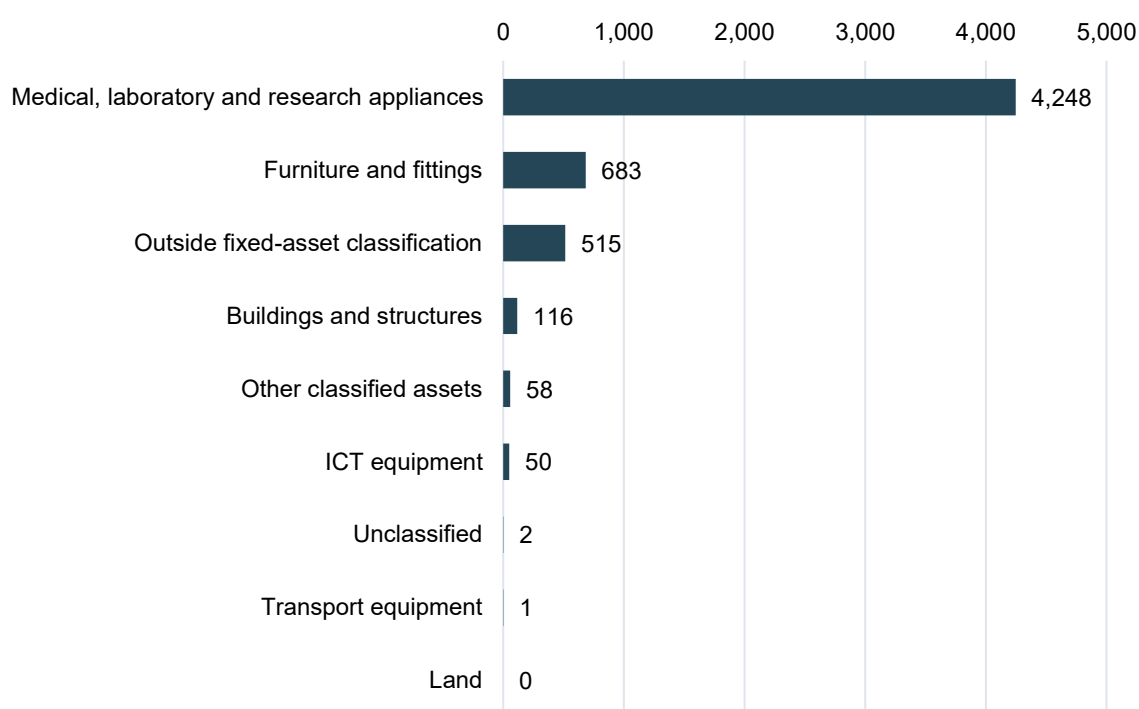
Figure 18: Faulty assets at Health Centres by category

The findings indicate that of the 63,432 health-centre assets, 57,759 (91.1%) were recorded as functional and in use and 5,673 (8.9%) were recorded as faulty and not in use. Figure 18 and Table 25 present the condition of the assets. These two register categories do not establish separate current counts of items in store, broken items and other reasons for non-use.
