**CONSULTANCY SERVICES TO VERIFY AND RECORD ASSETS
UNDER THE UGIFT PROGRAMME
REF: MOFPED/UGIFT/CONS/25/26/00015
ASSET VERIFICATION REPORT**

SK&CO **Sejjaaka, Kaawaase & Co.**
AUDIT • ADVISORY • FORENSICS **Certified Public Accountants**

6 October 2026
Financial reporting date 30 September 2026

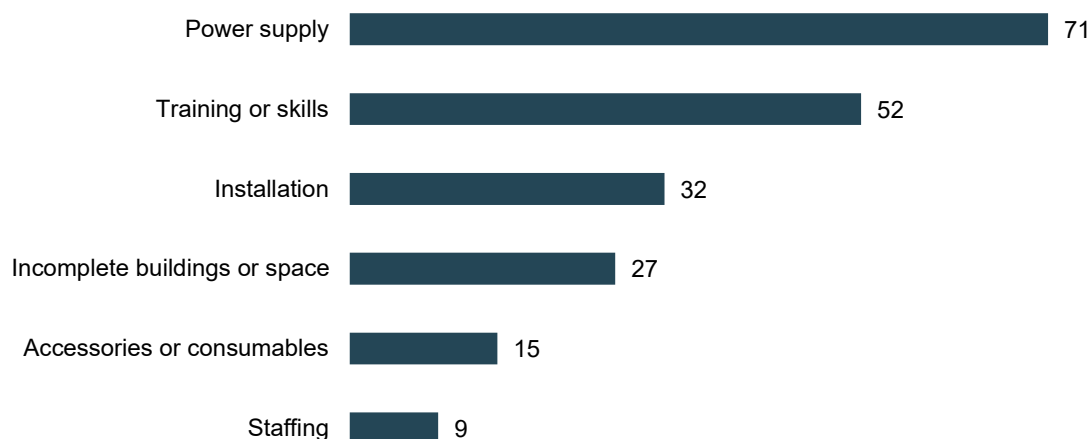
Figure 2: Reasons for equipment not in use reported by facilities (156 respondents; multiple responses)

Verification also noted that 13,520 assets, mainly in seed secondary schools and Health Centres, were classified as faulty and out of use. Some were awaiting installation or the facility itself was not yet ready. Notable among the facilities include Lungulu Seed Secondary School in Nwoya District where desktop computers, a printer and UPS units were still boxed because the school was waiting for power connection. At Nansanga Seed Secondary School in Budaka, 27 of 28 desktop computers remained packed for lack of reliable power.

Figure 2 shows the reasons for non-deployment of some of the assets even when they were found to be in good condition.

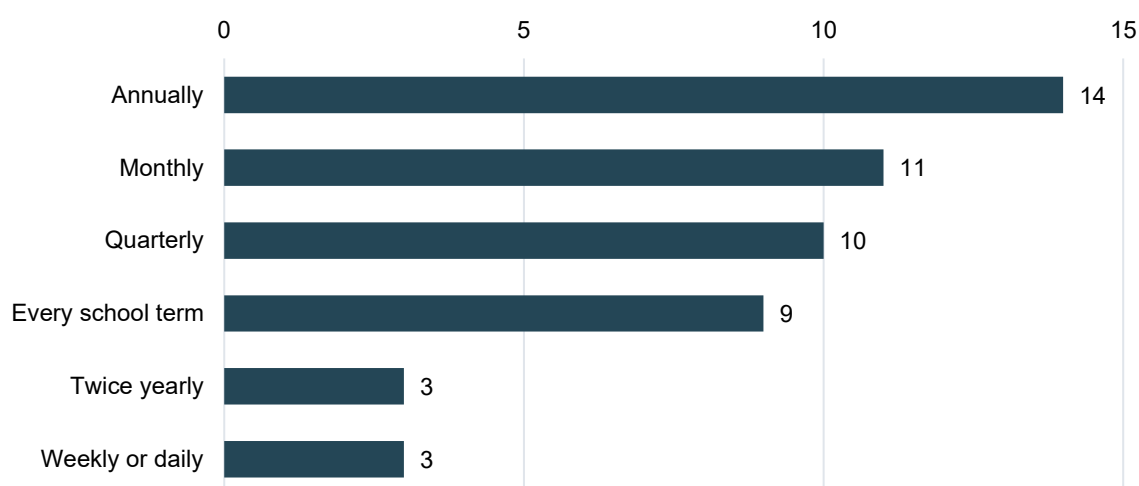
Figure 47: Annual, monthly and quarterly checks were the most common stated intervals

Frequency. Few facilities worked to a fixed maintenance interval. Of the 494 programme-list facilities that described how they maintain UgIFT assets or check their condition, 50 (10.1%) did so at a fixed interval. Of these 50, 14 (28.0%) worked annually, 11 (22.0%) monthly, 10 (20.0%) quarterly, 9 (18.0%) every school term, 3 (6.0%) twice a year and 3 (6.0%) weekly or daily, as Figure 47 shows. A further 18 facilities (3.6%) described routine or scheduled servicing without a set interval, mostly scheduled visits by regional referral hospital maintenance teams, and 61 (12.3%) repaired items as the need arose. Ngwedo Seed Secondary School in Buliisa engaged a caretaker every month and used the Directorate of Industrial Training for furniture repairs, while Busaale reviewed asset condition every quarter.

Recommendation. Facility managers and school governing bodies should keep the local and regional repair arrangements that already work and adopt a fixed routine: a condition check at least every school term in schools and every quarter in health centres, and a full count of UgIFT assets each year. Each facility should keep a condition book or fault list naming each item requiring action, the responsible person and the agreed completion date; the 36 facilities with no repair arrangement and the 80 with no functionality or breakdown record should set these up first.
