VisionAI Industrial Inspection Report

Id: 8376e300aca8445b939588820a2b2dcf

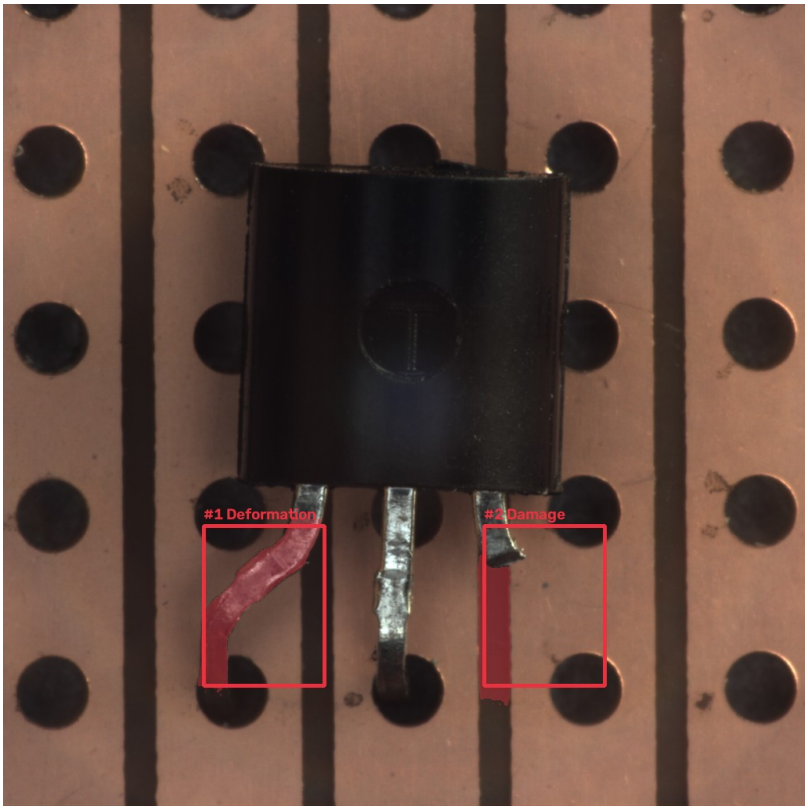
Status: FAIL

Summary: The left pin is improperly bent, and the right pin is damaged and deformed.

#	Type	Area (px)	Area (mm2)
1	Deformation	10415	Not calibrated
2	Damage	6997	Not calibrated
