Quality Assurance Report

CUSTOMER(고객명)	DESCRIPTION(품명)	LOT NO(로트번호)	ISSUED DATE(발행일자)
(주)씨스파인	0.1*20	20250520 -01	2025-05-20
규격(재질)		LOT SIZE(수량)	
0.1*20 304 1/2H	Ni 0.7μm~	21 Kg

품명 : 0.1X20 LOT NO : 250520-01 DATE : 25.05.20.

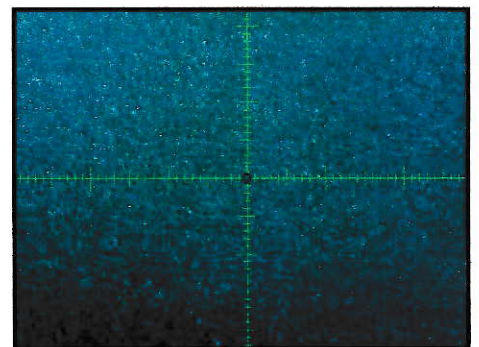
No	μm Ni	Ni tolerance
1	1.216	1.144 1.180 1.216
2	1.188	
3	1.165	
4	1.170	
5	1.186	
6	1.155	
Mean	1.180	
S.Dev	0.022

도금원소 : Ni//SS
측정값 개수 6
최대값 1.216
최소값 1.155
범위 0.061
평균값 1.180
표준편차 0.022
변동계수 1.836
