FUTURE CLOTHING LTD.

DURGAPUR, MONDOLBARI, ZIRABO, ASHULIA, SAVAR, DHAKA
(23.903727, 90.303310)
18 July 2022

RSC RMG SUSTAINABILITY COUNCIL

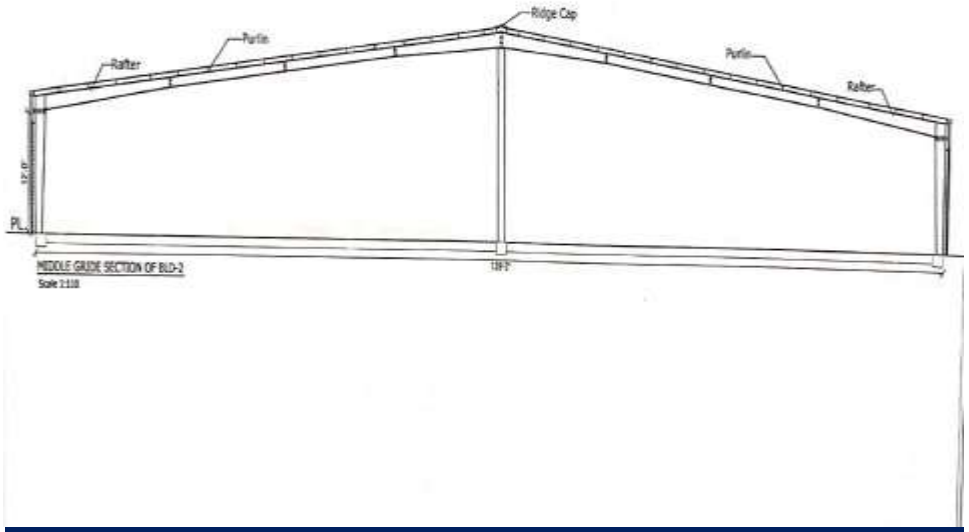
Shed-1 (Sewing)

Absence of design documents

As per BNBC, every building or structure designed shall have its design documents prepared in accordance with the provision of Section 1.9.1. The design document shall include a design report, and a set of structural drawings, which shall be prepared in compliance with section 1.9.1.1 and section 1.9.1.2 as per BNBC. At the time of inspection design report was not available. Factory engineer is required to prepare the design report in compliance with section 1.9.1.1 (part-6, BNBC).

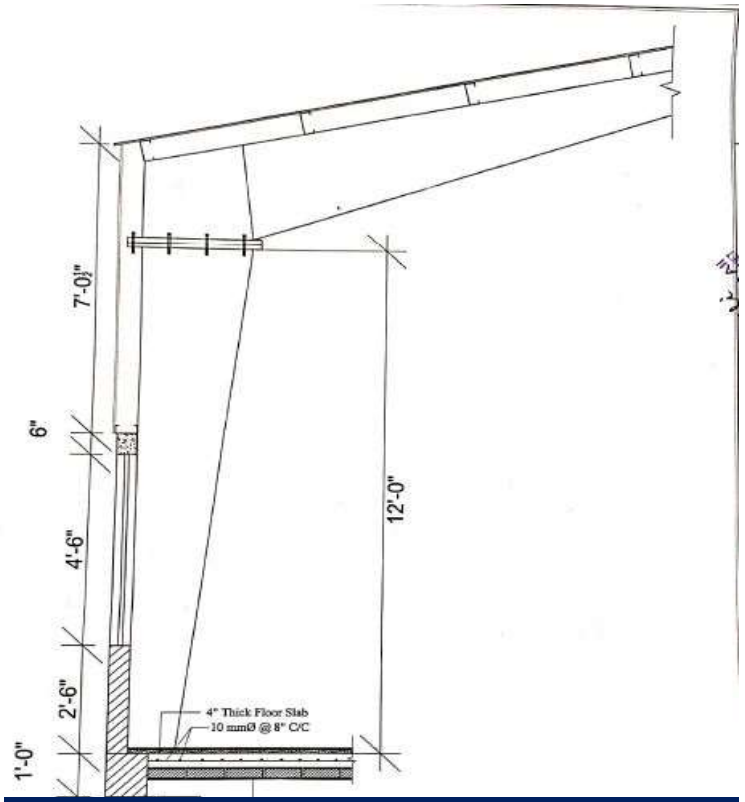
Section provided with no dimension of members

Steel section was shown in as-built drawing, but no dimension of steel members was mentioned. Also, no bracing layout included in as-built drawing. Factory engineer is required to prepare the full set of as-built drawing in compliance with section 1.9.1.2 (part-6, BNBC).

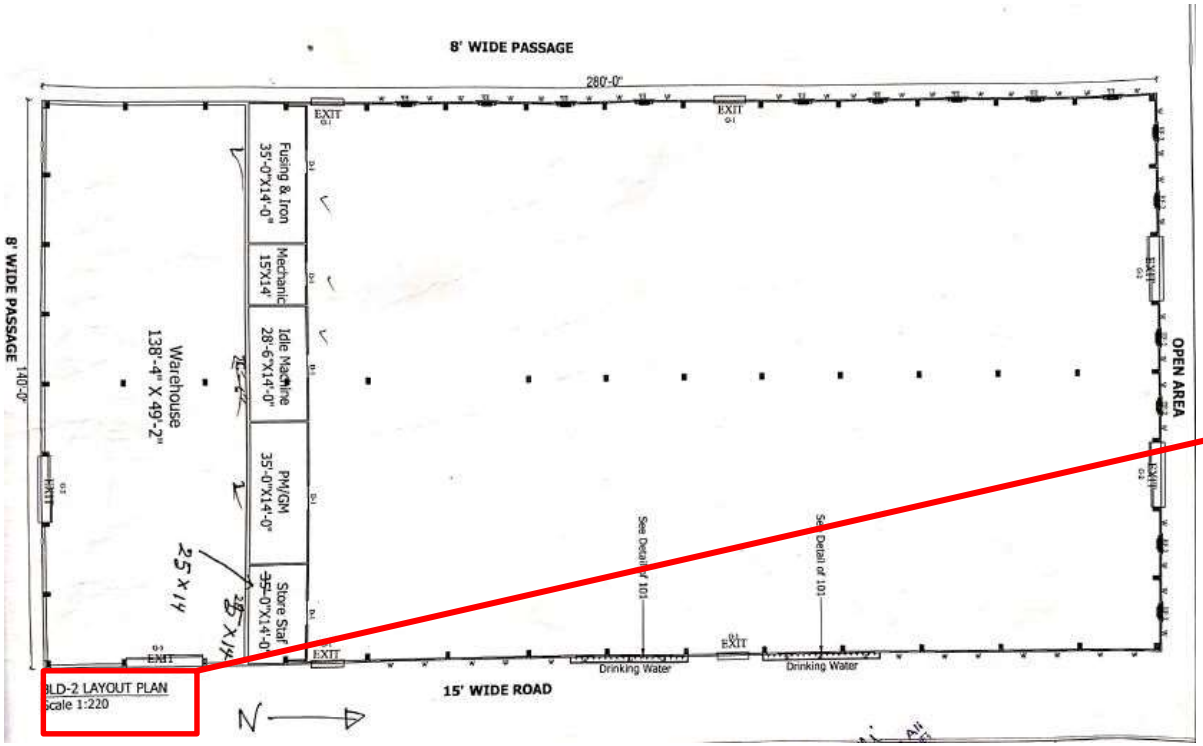
No canopy shown in as-built drawing

A structurally connected canopy observed

A structurally connected canopy observed at marked location which was not shown in as-built drawing. Factory engineer is required to survey the whole structure and prepare accurate as-built drawing.

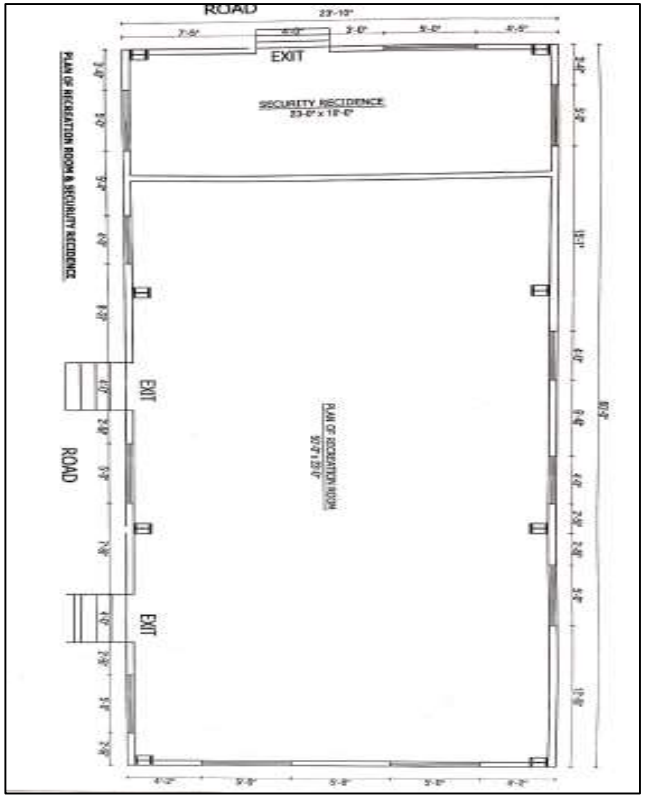
Shed 04 (Wash Sent)

Absence of design documents

As per BNBC, every building or structure designed shall have its design documents prepared in accordance with the provision of Section 1.9.1. The design document shall include a design report, and a set of structural drawings, which shall be prepared in compliance with section 1.9.1.1 and section 1.9.1.2 as per BNBC. At the time of inspection design report was not available and only a floor layout was available which are required to be prepared in compliance with section 1.9.1.1 and section 1.9.1.2 (part-6, BNBC).

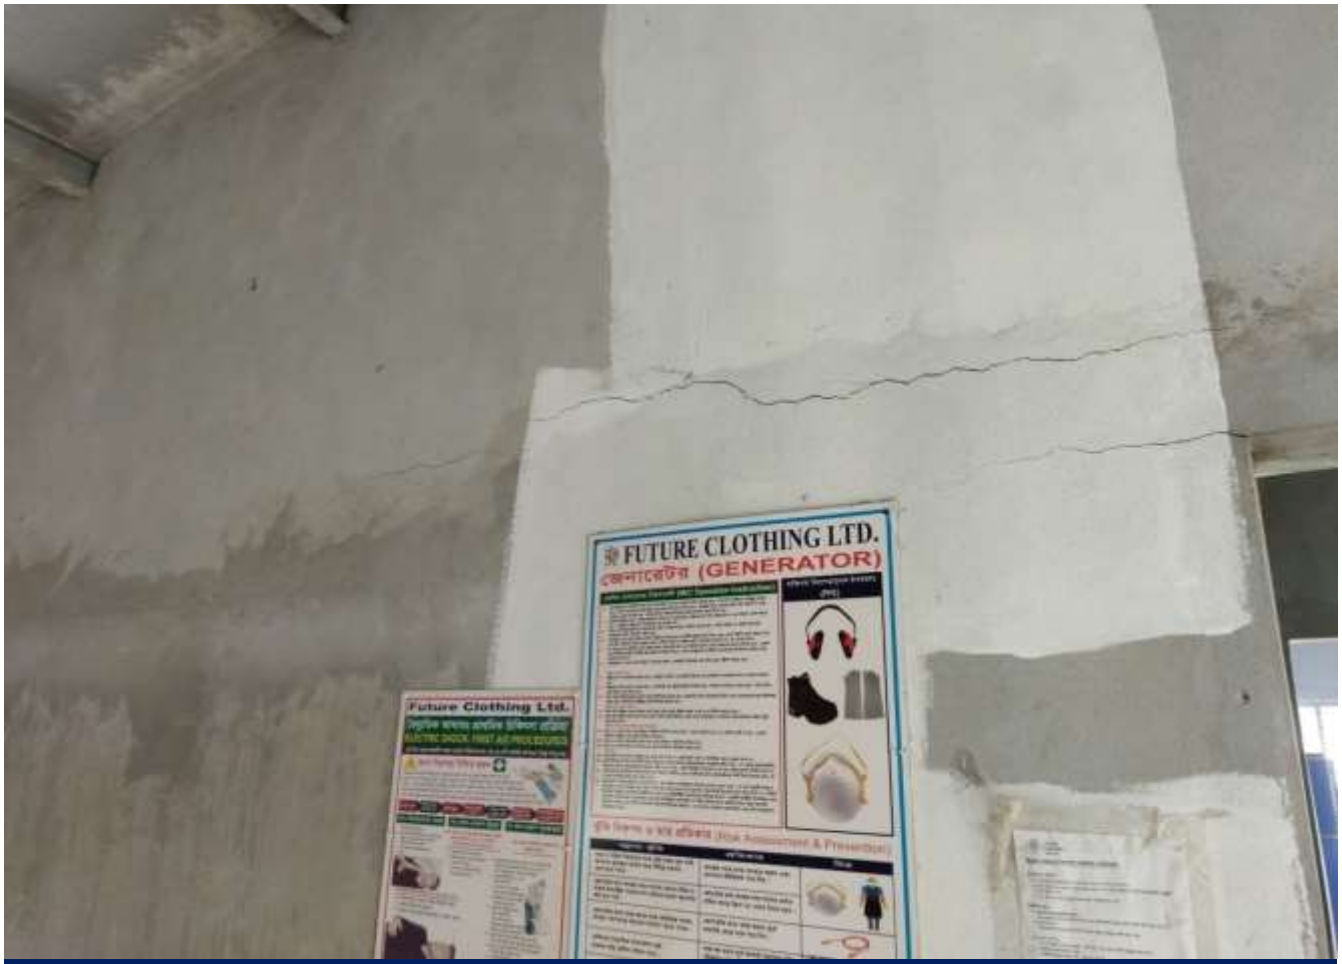
Shed-6 (Utility)

Absence of design documents

As per BNBC, every building or structure designed shall have its design documents prepared in accordance with the provision of Section 1.9.1. The design document shall include a design report, and a set of structural drawings, which shall be prepared in compliance with section 1.9.1.1 and section 1.9.1.2 as per BNBC. At the time of inspection design report was not available which is required to be prepared in compliance with section 1.9.1.1 (part-6, BNBC).

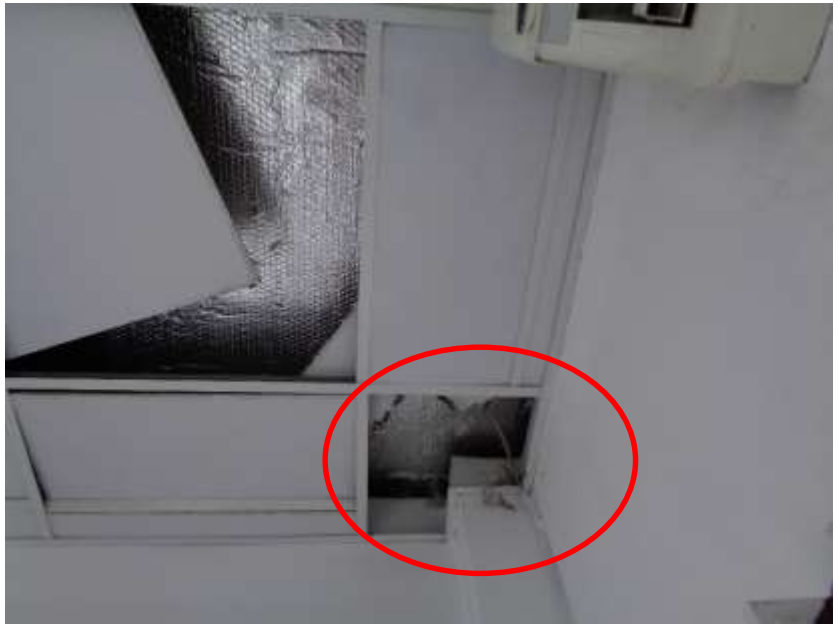
Shed 07 (Compressor Room)

Absence of as-built drawings and Apparently inadequate connection

As-built drawing of this structure was not available at the time of inspection. Factory engineer is required to prepare full set of as-built drawing as per 1.9.1.2 (BNBC)

Steel members (both purlin and truss) are welded with rebars of columns without any joint plate which is appeared to be inadequate. Factory engineer is required to check the connection adequacy for uplift forces as a part of EA and implement remediation work where required.
