Gardenia Wears Ltd.

310/668, Shitpara, Bormi, Sreepur, Gazipur - 1743
(24.230718N, 90.505587E)
10th September 2018

ACCORD
on Fire and Building Safety in Bangladesh

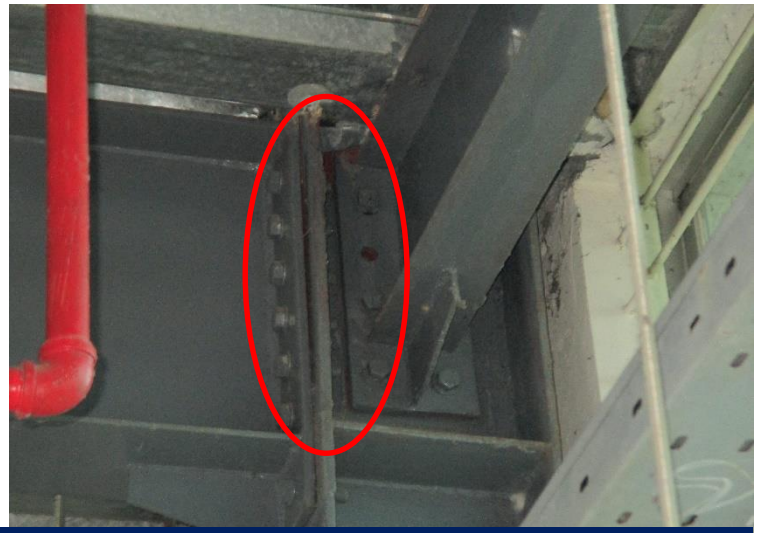
Bolt missing and existence of gap in joints

Bolts were found missing in several locations. Factory engineer to check the connections and install missing bolts. Existence of gap was observed in beam-column and column-bracing connections at several locations. Factory engineer to identify the gaps and implement the appropriate remediation.

Item No.	Observation	Recommended Action Plan	Recommended Timeline
1	(Factory Building) Bolt missing and existence of gap in joints	Factory Engineer to survey the whole structure to identify locations of all missing bolts and install them.	**6-weeks**
2	(Factory Building) Bolt missing and existence of gap in joints	Factory Engineer to survey the whole structure to locate the gap in joints and take suitable measures.	**6-weeks**
3	(Factory Building) Corrosion in Steel member	Apply suitable method to protect the steel members from corrosion.	**6-weeks**
4	(Facility Building) Mismatch in rafter size	Engage an Engineer to produce an “as constructed” drawings which reflect the actual site dimensions with complete structural information.	**6-weeks**

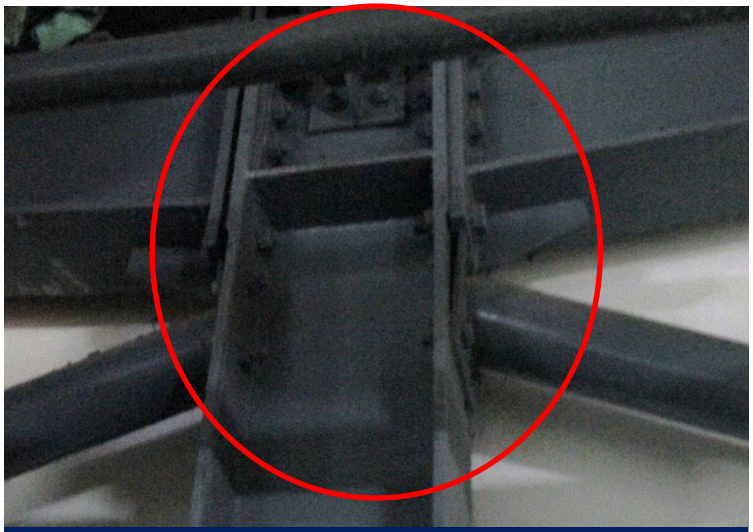
Missing bolts & gap between beam-column connection

Gap on bracing connection

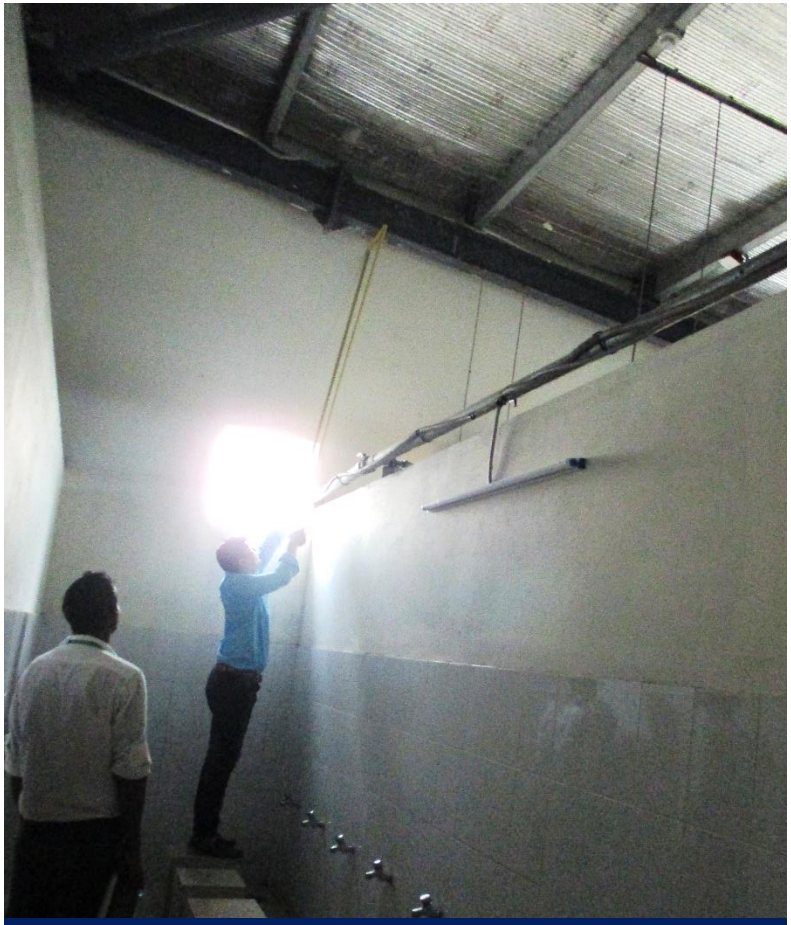
Corrosion in Steel member

Corrosion was found on column base plate and sub-beam under toilet zone. Factory is required to find out all the deteriorated areas and apply suitable method to protect the steel members from corrosion.

Corrosion at column base plate

Corrosion at sub-beam under toilet zone

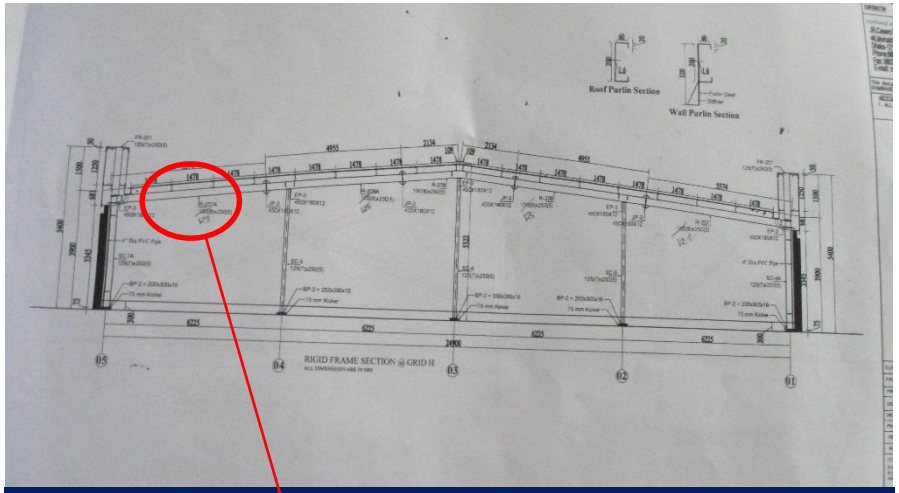
Rafter measuring

Mismatch in rafter size

Size of rafter at end bay was found 125 mm x 250 mm instead of 150 mm x 250 mm. Factory engineer is required to update the drawing reflecting actual site condition.

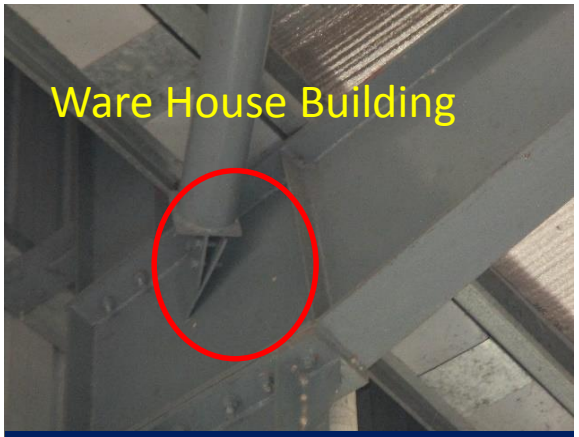
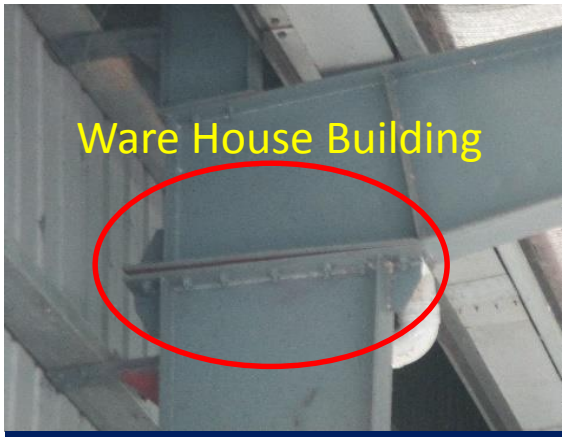
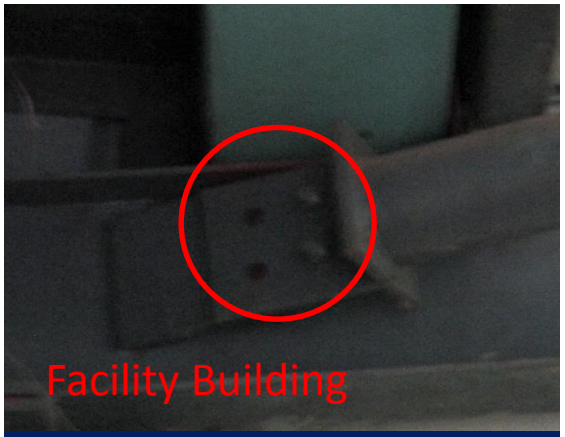
Missing bolt, gap between rafter-column joint, improper bracing connection and lack of connection details on drawings

Bolts were found missing in several locations of both structures. Factory engineer to check the connections and install missing bolts. Significant gap was observed in beam-column and column-bracing connections. Factory engineer to identify the gap and implement the proper remediation. Moreover, improper bracing connections were found and connection details of bracings were not available on provided drawings.

Missing bolt

Improper connection

Gap at rafter-column joint

Item No.	Observation	Recommended Action Plan	Recommended Timeline
5	(Facility Building & Ware House Building) Missing bolts, gap between rafter-column joints, improper bracing connections and lack of bracing details	Factory Engineer to survey the whole structure to identify locations of all missing bolts and install them	**6-weeks**
6	(Facility Building & Ware House Building) Missing bolts, gap between rafter-column joints, improper bracing connections and lack of bracing details	Factory Engineer to survey the whole structure to locate the gap in joints and take suitable measures.	**6-weeks**
7	(Facility Building & Ware House Building) Missing bolts, gap between rafter-column joints, improper bracing connections and lack of bracing details	Factory engineer to check the adequacy of bracing connections and update as-built drawings including bracing details.	**6-weeks**
8	(Facility Building & Ware House Building) Missing bolts, gap between rafter-column joints, improper bracing connections and lack of bracing details	Factory Engineer to take remedial actions where required.	**6-months**
