HANDZ CLOTHING BD LTD.

10 December 2025

RSC RMG SUSTAINABILITY COUNCIL

1. Executive Summary

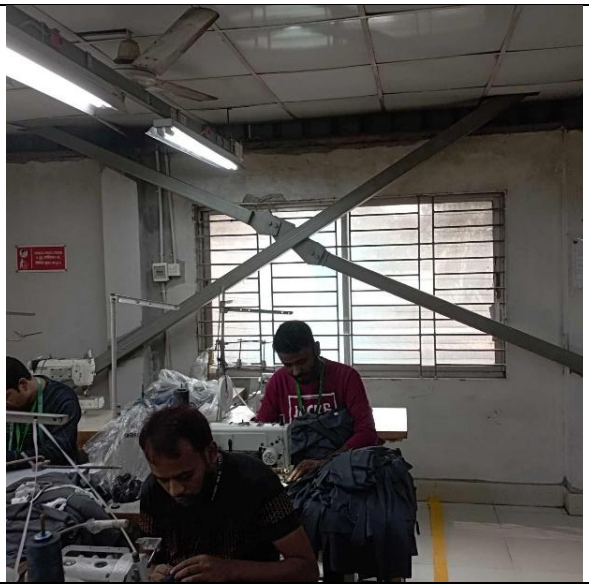
Observation 3: Faulty connection in vertical bracing (Main Production Shed).

Description: Faulty connection in vertical bracing. As the bracing is not straight, the lateral load is not transferred properly. The building engineer is required to check the load path and connection adequacy and propose a remediation plan.

5.		Based on geotechnical data, check the foundation adequacy as part of DEA.	within 6 weeks
6.	Faulty connection in vertical bracing (Main Production Shed).	The building engineer is required to check the load path and connection adequacy and propose a remediation plan.	within 6 weeks

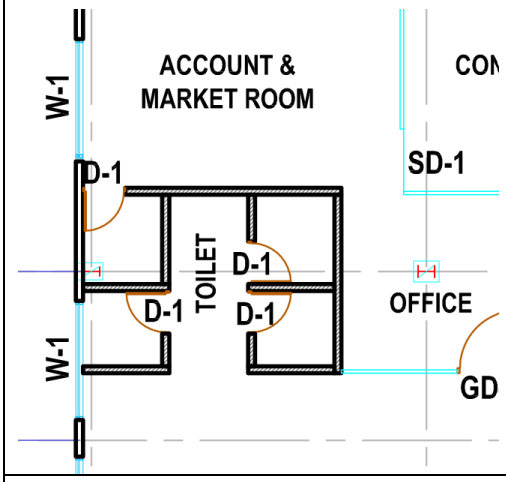
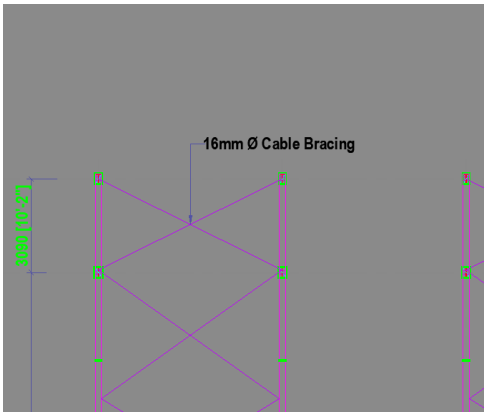
Observation 4: Possibility of construction of a new mezzanine floor (Main Production Shed).

Description: The factory has a plan to construct a new mezzanine floor inside the shed at the marked portion, which is not shown in the permit drawing. If the mezzanine floor is constructed, the total mezzanine area will exceed one-third of the ground floor area and eventually will be counted as a separate floor. Any addition to the new existing structure not shown in the permit drawing, the building engineer is required to take a fresh permit from the local authority and carry out a Detailed Engineering Assessment (DEA) in compliance with BNBC 2020.

7.	Possibility of construction of a new mezzanine floor (Main Production Shed).	Any addition to the new existing structure not shown in the permit drawing, the building engineer is required to take a fresh permit from the local authority and carry out a Detailed Engineering Assessment (DEA) in compliance with BNBC 2020.	within 6 months

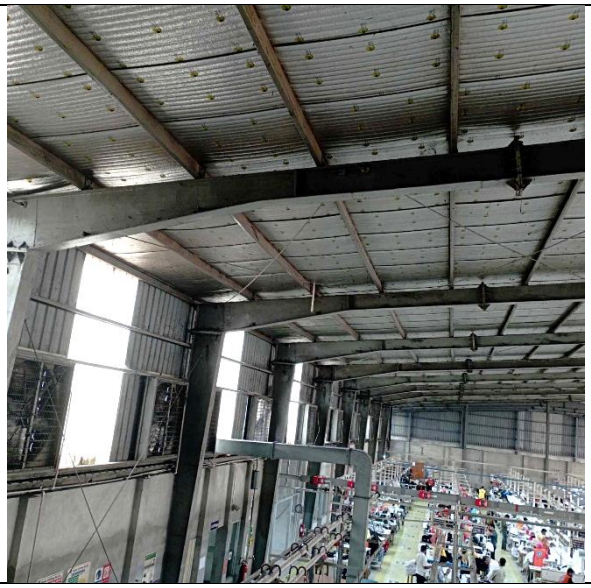
Observation 6: Corrosion on steel members (Main Production Shed).

Description: Corrosion was observed on steel members at several locations. The building engineer is required to remove the corrosion and provide rust-proof paint on steel members.

9.	Corrosion on steel members (Main Production Shed).	The building engineer is required to remove the corrosion and provide rust-proof paint on steel members.	within 6 weeks

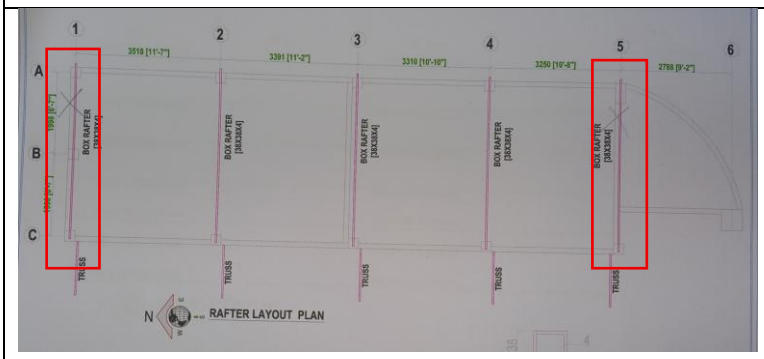
Observation 13: Apparently non-engineered connection/Shed. (Medical & Childcare Shed)

Description: Steel rafter (box section) rested on the brick wall. The building engineer is required to check the adequacy of the connection of the lightweight roof against the uplift pressure of the wind as part of the engineering assessment. Also, three brick columns are shared by the Generator & Substation Building and the Medical & Childcare Shed. The building engineer is required to separate the connection and provide a new column for the structure. Otherwise, analyze these buildings as a single structure.

18.	Apparently non-engineered connection/Shed. (Medical & Childcare Shed)	The building engineer is required to check the connection of the steel roof for the uplift pressure of wind as part of the Engineering Assessment (EA).	within 6 weeks

19.		The building engineer is required to separate the connection and provide new columns for structures. Otherwise, analyze these buildings as a single structure.	within 6 months
