Nassa Spinners and Garments Ltd.

Plot No.- 197-200, Comilla EPZ, Comilla.
Co-ordinates: 23.449240N, 91.185205E
25th July 2019

ACCORD
on Fire and Building Safety in Bangladesh

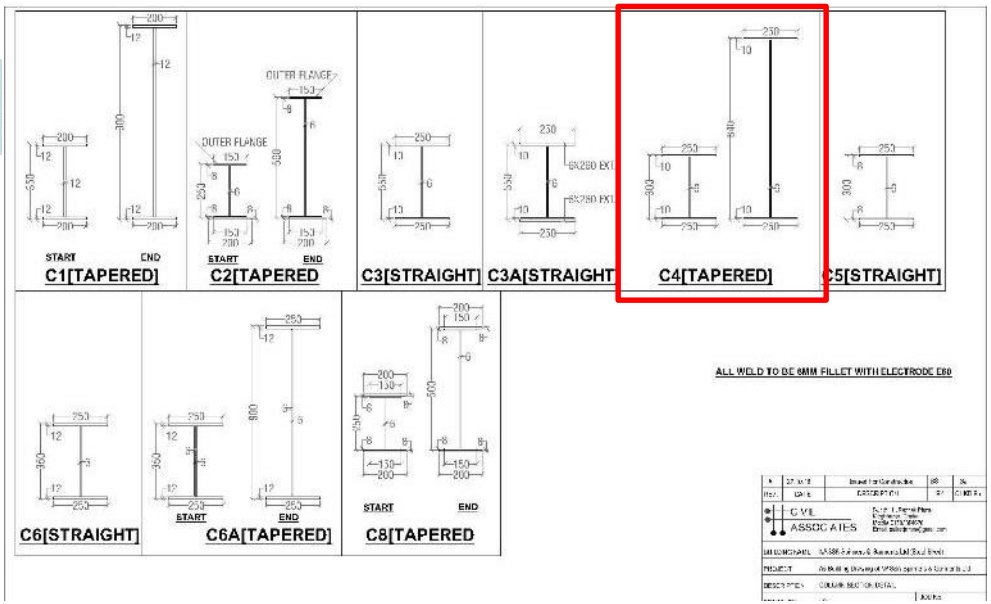
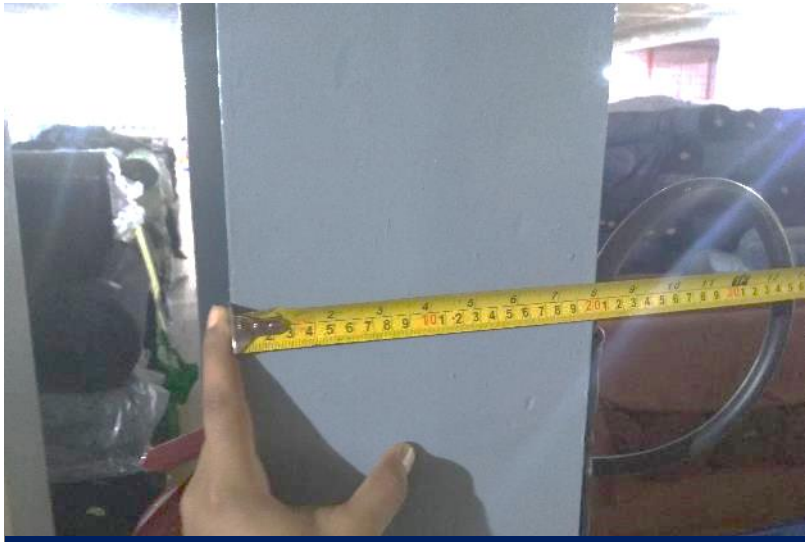
Steel column layout plan

Discrepancies in drawings

Orientation of this columns not matched.
