Nassa Spinners and Garments Ltd. (Extension)

Plot# 200 (part)- 208 (part), Cumilla EPZ, Cumilla-3500

9 November 2023

RMG SUSTAINABILITY COUNCIL

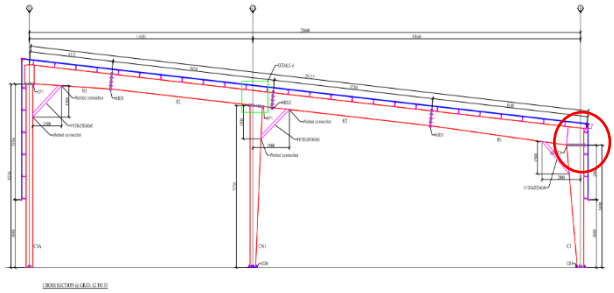
Connection adequacy shown in table of content.

Description: Connection adequacy shown in table of content but not provided in main report. The building engineer is required to update the Assessment Report including all checks as per 1.9.1 of BNBC.
