FIRE SAFETY INSPECTION REPORT

TARATEX FASHION LTD.

ACCORD
on Fire and Building Safety in Bangladesh

August 6, 2014

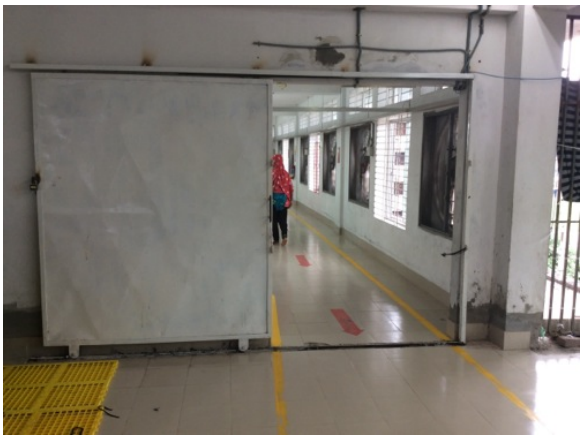
F-7	Egress	Egress doors and gates with locking features are provided at building exits, exit stairs, along egress routes and at exit discharge. All gates and doors were open and unlocked during the inspection.	Remove locking features from all egress doors and gates. If locks are required for security reasons, utilize special door locking features complying with NFPA 101.	Immediate
