Taratex Fashion Ltd. (10071)

17.AUGUST.2014

ACCORD on Fire and Building Safety in Bangladesh

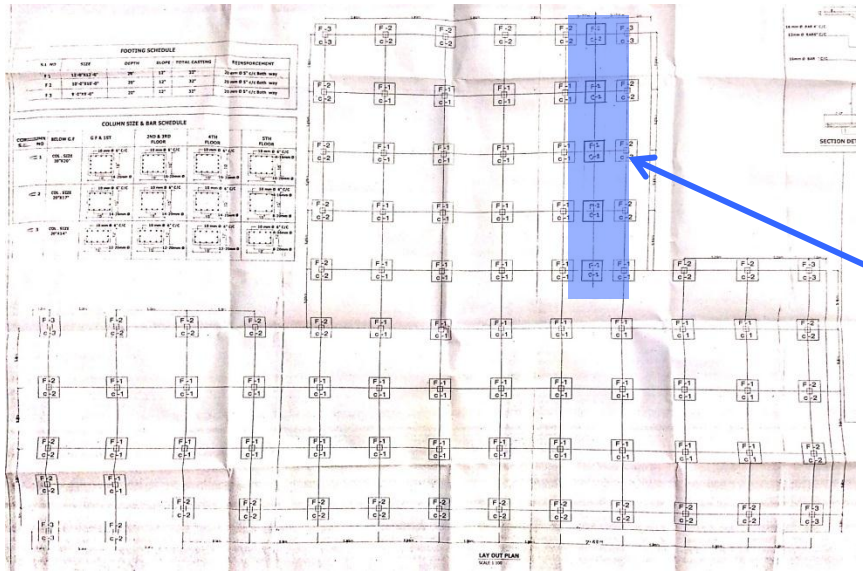
1st Priority 2 Concern

The columns in area shown on the structural drawings were not found.

There are also some 25” x 21” columns noted. These columns are not specified in the structural drawings.

Column layout plan and column schedule need to be revised.

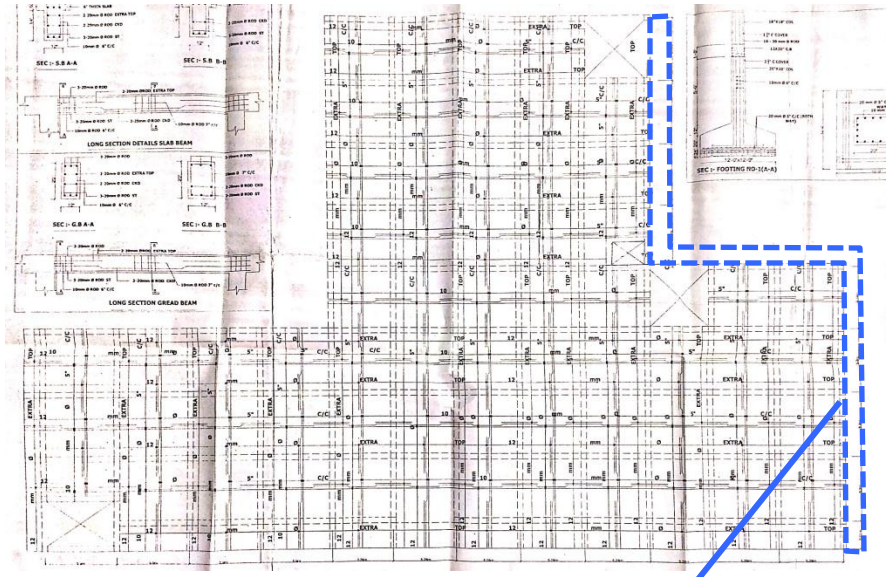
1st Priority 2 Concern

Beam layout plan and some beam details are missing in the structural drawings.

Beam layout plan is required and beam details need to be revised.
