FIRE SAFETY INSPECTION REPORT

UNITED COSTUME (PVT) LTD.

ACCORD
on Fire and Building Safety in Bangladesh

May 31, 2014

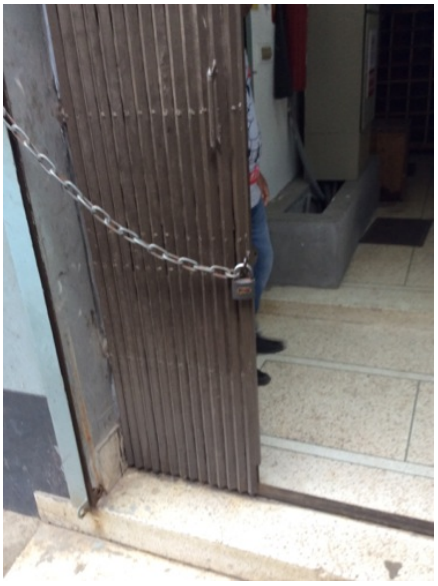
F-6	Egress	Egress doors / gates with locking features are provided at building exits, exit stairs, along egress routes, exit discharge. Location: On all floors and at exit discharges. All gates/doors were open and unlocked during the inspection.	Remove locking features from all egress doors / gates. If locks are required for security reasons, utilize special door locking features complying with NFPA 101.	Immediate

F-7	Egress	Storage was located in all the exit stairs.	Remove all storage from exit stairs and egress paths.	Immediate
