Issue	**1**
Factory ID	**26310**
Date of Issue	**19-May-2026**

A A Garments

Fire Safety Inspection Report

Pakistan Accord Initial Safety Inspection Report

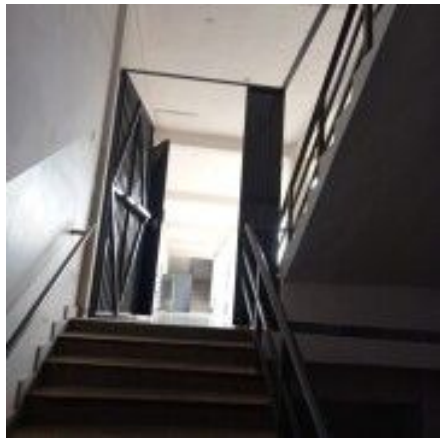
The following deficiencies have been observed on site, including (list not exhaustive):
- Basement is not fire separated from the rest of the building at Main Building.

Figure 2.16 - Basement is not fire separated from the rest of the building at Main Building.

Timeline	Remediation Plan
Medium Term CAP-0076072	Prepare a plan and drawings showing the proposed separation details. These shall be submitted to Pakistan Accord for review and approval prior to the rectification works. The drawings should cover: - Different occupancy types in the building - Proposed fire separation details (including fire rating of walls and doors)
Longer Term CAP-0076073	Provide fire rated separation between occupancies as per proposal reviewed by Pakistan Accord
