Issue	**1**
Factory ID	**26310**
Date of Issue	**22-Apr-2026**

A A Garments

Structural Safety Inspection Report

Pakistan Accord Initial Safety Inspection Report

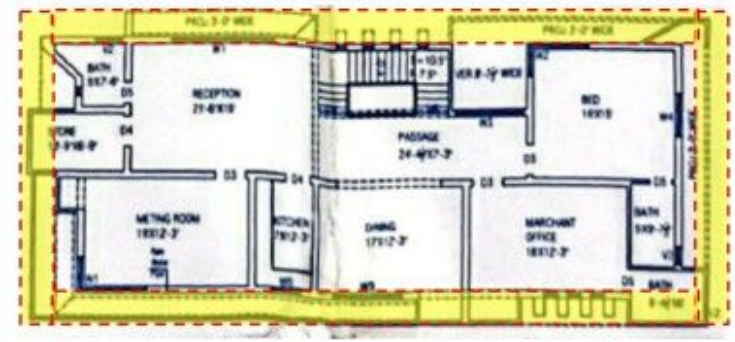
Figure 2.1 - Office building: Plan showing location of the area at roof

It concerns with inadequate edge protection which present a risk of potential injury resulting from slip, trip or fall from roof of office building where height of parapet wall is insufficient – Health & Safety concern F-202604-064563

Timeline	Remediation Plan
Immediate CAP-0076211	Provide adequate edge protection at roof, and on any other part of the factory with the same issue.
