Issue	**2**
Factory ID	**920016**
Date of Issue	**01-Apr-2026**

Agility Textile (Pvt.) Ltd.

Electrical Safety Inspection Report

Pakistan Accord Initial Safety Inspection Report

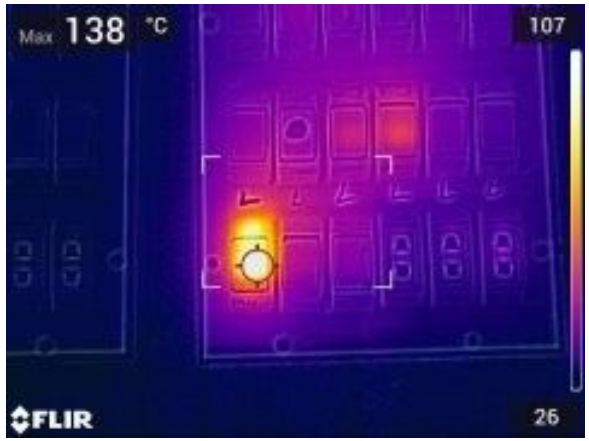
The categories of identified hot spots have been evaluated as per the ANSI NETA MTS 2019 standard, Table 100.18. Hot spots were observed, particularly at the following locations:
i. 164°C at the circuit breaker cable connection in the stitching distribution board on the first floor near the cargo lift.
ii. 138°C at the switchboard on the first floor of the main building.
iii. 58°C at the power socket in the basement hall of the main building.

Circuit breakers are typically designed to operate safely within an ambient temperature range of -20°C to 40°C. Commonly used PVC insulated cables typically have a maximum operating temperature of 70°C. Prolonged exposure to temperatures above these can degrade the insulation of the breaker as well as the cable and result in reduced performance.

Figure 2.6 - Hot spot found on the circuit breaker cable connection in the stitching distribution board on the first floor

Timeline	Remediation Plan
Immediate CAP-0074739	Any circuits identified on site with temperatures exceeding 40°C above the ambient temperature, operating above 90°C or exhibiting visual signs of burning must be immediately isolated and taken out of service. These circuits should remain de-energized until a thorough review has been conducted and appropriate remedial actions have been implemented to resolve the underlying issues.
Medium Term CAP-0074740	During the inspection, several circuits were identified where the temperature was exceeding 20°C above ambient temperature. It is recommended that the factory conducts comprehensive thermographic surveys of all electrical panels to detect similar issues. Identified hot spots should be thoroughly reviewed to determine their underlying causes. Corrective actions must be taken to address and resolve these issues, ensuring safe and reliable operation of the electrical systems.

Longer Term CAP-0074741	Regular thermographic inspections should be incorporated into the maintenance schedule to proactively manage and mitigate the risks associated with overheating.

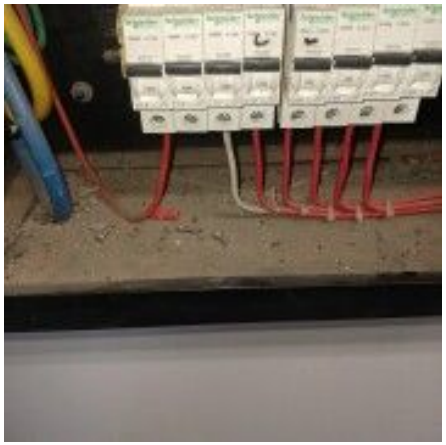
The presence of lint and dust inside distribution boards poses several hazards. Accumulated lint and dust can act as fuel for fires if exposed to electrical currents or sparks, significantly increasing the risk of electrical fires. The cooling capacity of electrical components can also be impaired by the presence of dust and lint, leading to overheating.

Figure 2.31 - Lint and dust observed in the mess area distribution board

Timeline	Remediation Plan
Medium Term CAP-0074737	All electrical panels and trunking runs shall be inspected and cleaned of any dust or lint in accordance with Section 522.4.2 of BS7671 18th Edition + A2 (2022).
Longer Term CAP-0074738	A regular maintenance procedure shall be established to ensure routine inspection and cleaning of all electrical panels and trunking runs. This will prevent the accumulation of lint and dust, thereby maintaining the safety and efficiency of the electrical systems.

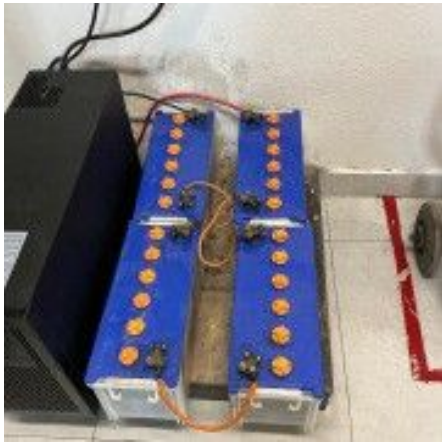
Figure 2.50 - Exposed terminals observed on the standby generator batteries
