Agility Textile (Pvt.) Ltd.

Latitude: [31.393564], longitude: [74.323596]
Date of inspection: 26-Feb-2026

Fire Safety Inspection Report

Pakistan Accord Initial Safety Inspection Report

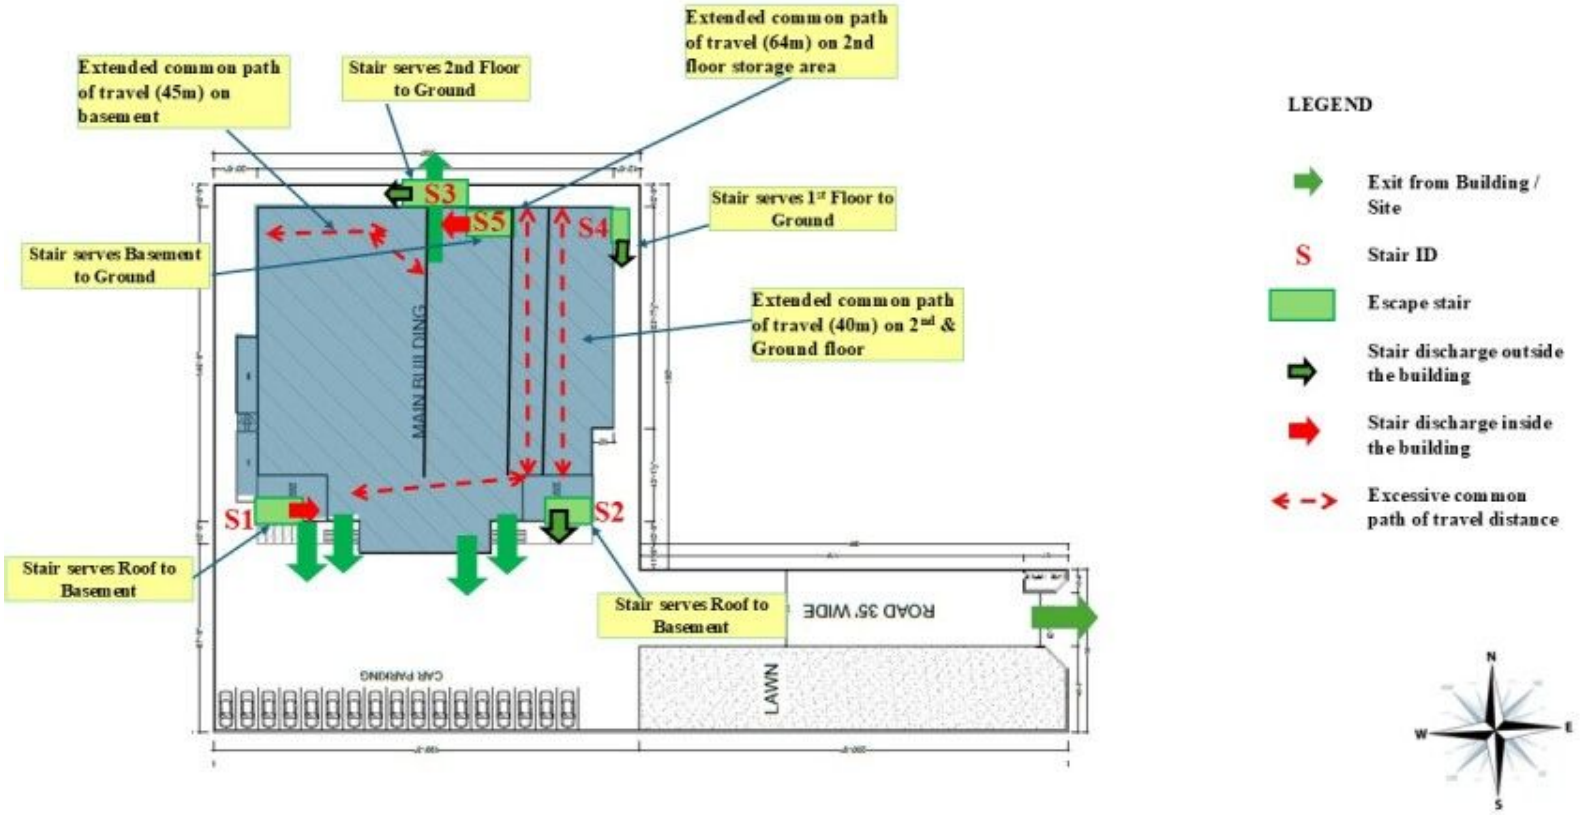
Figure 1.4. Egress layout plan of Main building

There is sufficient exit capacity in building & travel distance Common path exceed permitted limits. e.g. Extended Common path of travel in Main building in different locations like 45m on basement ,40m on ground floor & second floor studio office & 64m on storage area 2nd floor. Single exit issue observed at the mess area on the second floor.
