Ali Trading Company (Pvt.) Ltd.

Pakistan ACCORD for Health and Safety in the Garment and Textile Industry

Latitude: [32.45229], longitude: [74.49852]
Date of inspection: 12-Mar-2026

Structural Safety Inspection Report

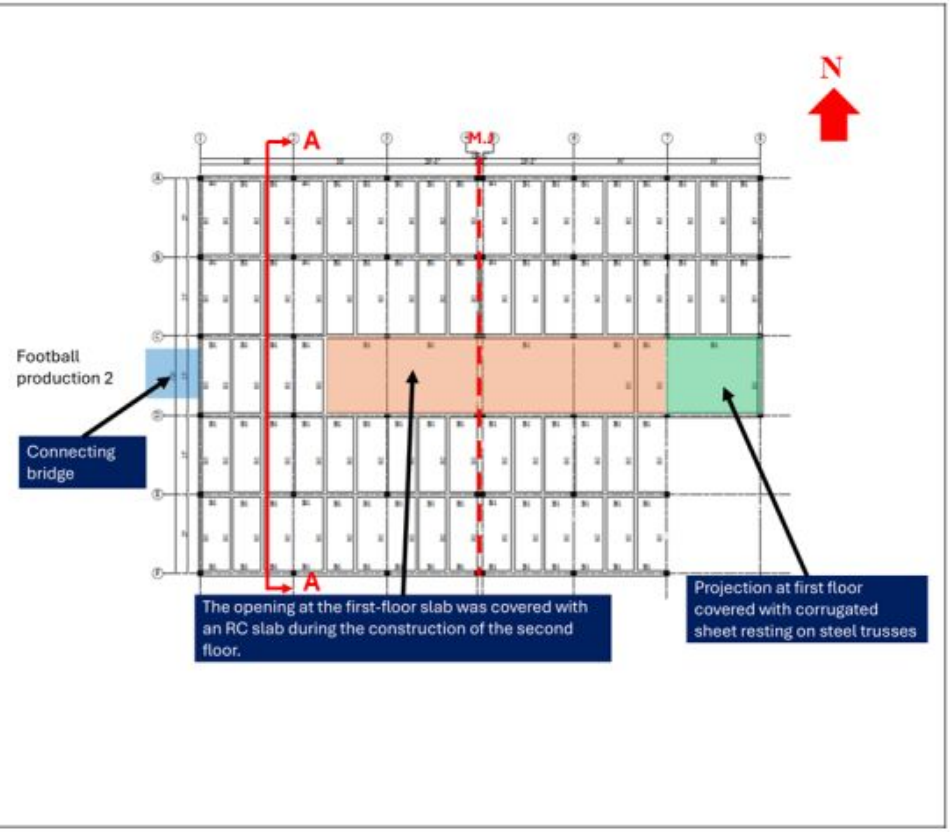
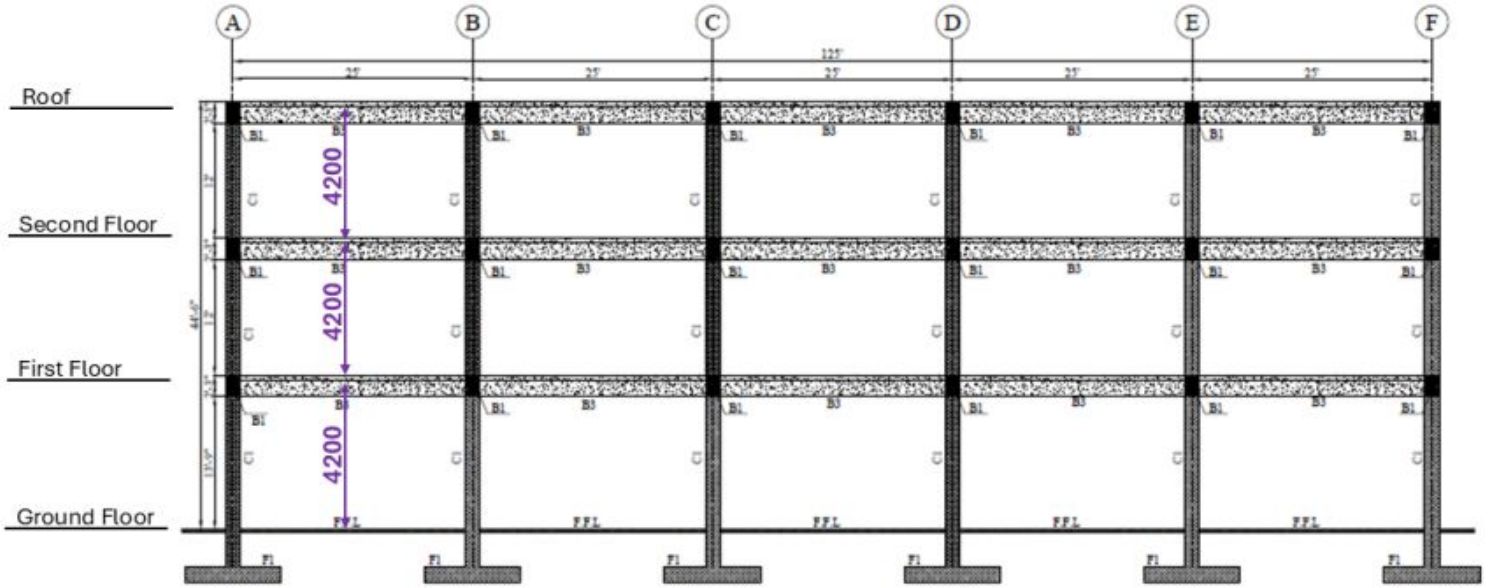
Figure 1.46. Typical floor framing plan detail of football production 1

The internal ground floor columns of Football Production 1 were observed to be highly stressed, potentially due to the relatively large structural grid spacing (9 m × 7.6 m), addition of second floor, and absence of verified concrete strength data. These conditions make the structure vulnerable to potential structural distress and reduce the overall reliability of the load-carrying system. F-202604-065239

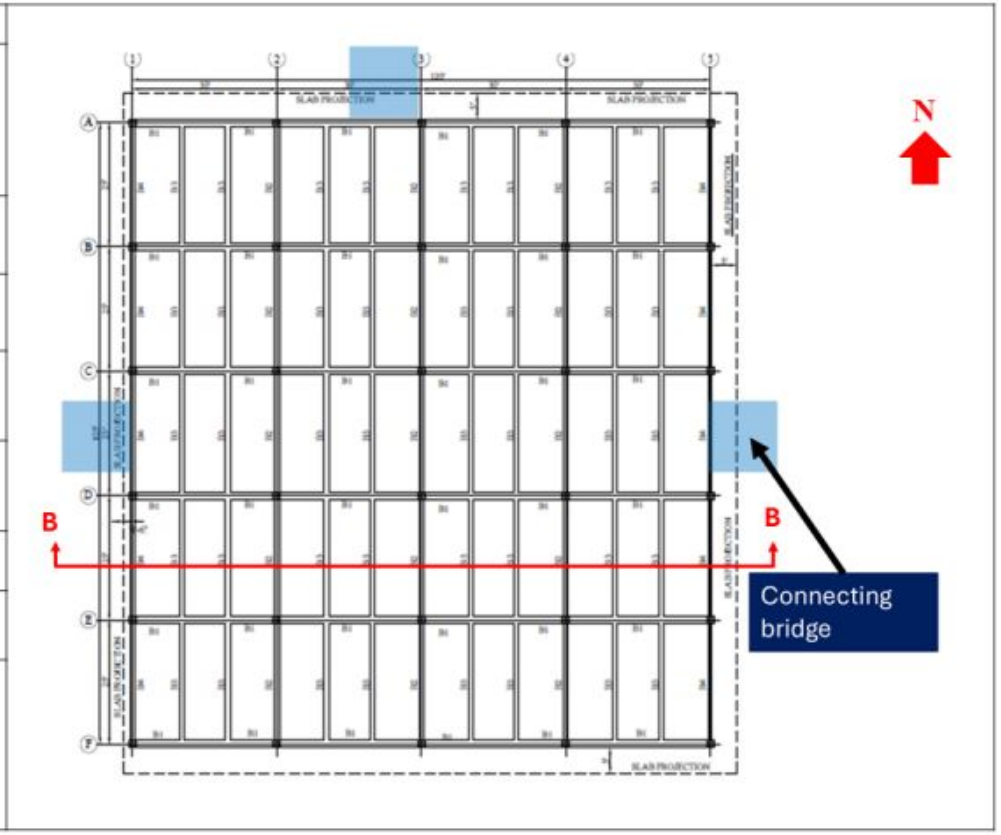
Figure 1.48. Typical floor framing plan detail of football production 2

The internal ground floor columns of Football Production 2 were observed to be highly stressed, potentially due to the relatively large structural grid size (9.18 m × 7.68 m), addition of second floor, and absence of verified concrete strength data. These conditions make the structure vulnerable to potential structural distress and reduce the overall reliability of the load-carrying system. F-202604-065240

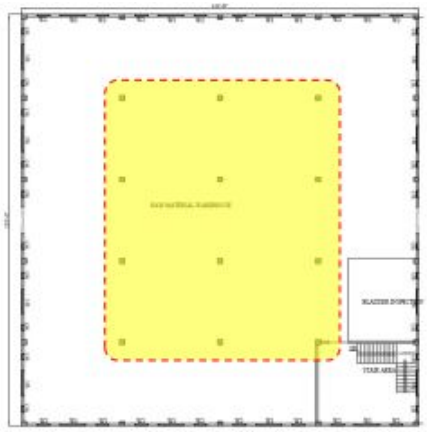
Figure 2.2 - Location of Highly Stressed Internal Ground Columns of Football Production 2

Timeline	Remediation Plan
Medium Term CAP-0077211	Verify in-situ reinforcement by removing cover and confirming no. and diameter of bars and submit results to Pakistan Accord for review.
Medium Term CAP-0077212	Verify strength of reinforcement through laboratory tensile strength testing and submit results to Pakistan Accord for review.
Medium Term CAP-0077213	Verify in-situ concrete strength for the identified columns either by 100mm dia. cores from at least 4 columns or existing cylinder strength data and submit results to Pakistan Accord.
Medium Term CAP-0077215	Factory Engineer to review design, loads and columns stresses in area identified and submit to Pakistan Accord for review.
Longer Term CAP-0077221	Produce and actively manage a loading plan for all floor plates within the factory giving consideration to floor capacity and column capacity

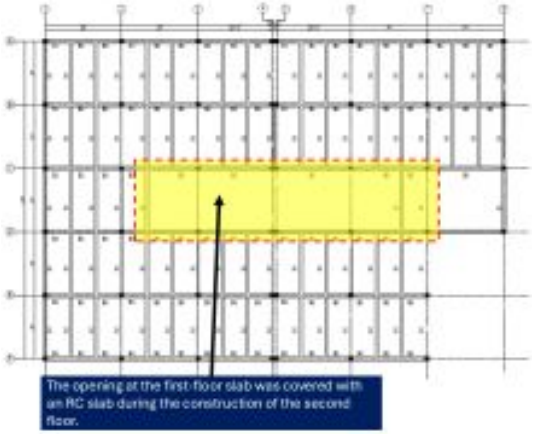
This issue refers to the first-floor slab of Football Production 1. The original opening in the slab was covered with a reinforced concrete (RC) slab during the construction of the second floor. The newly cast slab appears to be unsupported by any internal beams. This condition raises structural concerns regarding its capacity to safely resist vertical loads, control deflection, and perform adequately under lateral loading. F-202604-065682

Figure 2.3 - Covered Opening within the First Floor Slab of Football Production 1 Building

Figure 2.4 - Covered Opening within the First Floor Slab of Football Production 1 Building

Timeline	Remediation Plan
Medium Term CAP-0077978	Building Engineer to review the design of structure and propose any strengthening measures as required and submit it to Pakistan Accord for review.
Longer Term CAP-0077979	Implement the Remediation as required.

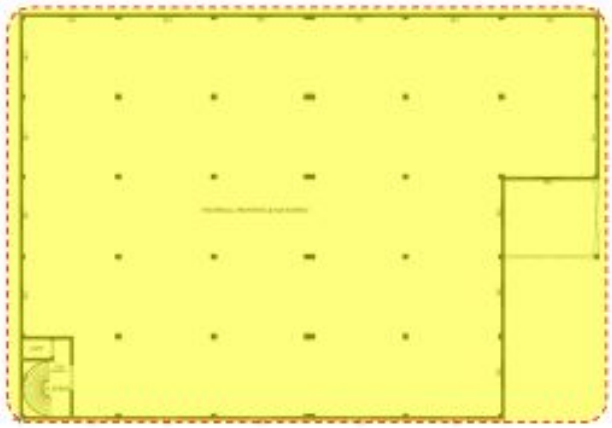
The dowel reinforcement of the column at the roof level of the Football Production 1 has been significantly affected by atmospheric corrosion. This condition may compromise the structural integrity over time. F-202604-065223

Figure 2.5 - Location of Exposed Corroded Dowel Reinforcement at the Roof of Football Production 1

Figure 2.6 - Exposed Corroded Dowel Reinforcement at the Roof of Football Production 1

Timeline	Remediation Plan
Medium Term CAP-0077173	Propose the remedial measure to protect the dowel reinforcement from future atmospheric corrosion and submit to Pakistan Accord for review.
Longer Term CAP-0077174	Implement the required remedial work.

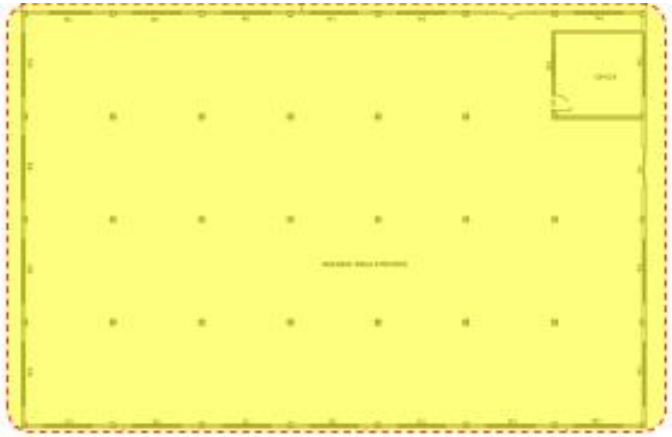
The dowel reinforcement of the column at the roof level of the Football Production 3 has been significantly affected by atmospheric corrosion. This condition may compromise the structural integrity over time. F-202604-065224

Figure 2.7 - Location of Exposed Corroded Dowel Reinforcement at the Roof of Football Production 3

Figure 2.8 - Location of Exposed Corroded Dowel Reinforcement at the Roof of Football Production 3

Timeline	Remediation Plan
Medium Term CAP-0077175	Propose the remedial measure to protect the dowel reinforcement from future atmospheric corrosion and submit to Pakistan Accord for review.
Longer Term CAP-0077176	Implement the required remedial work.

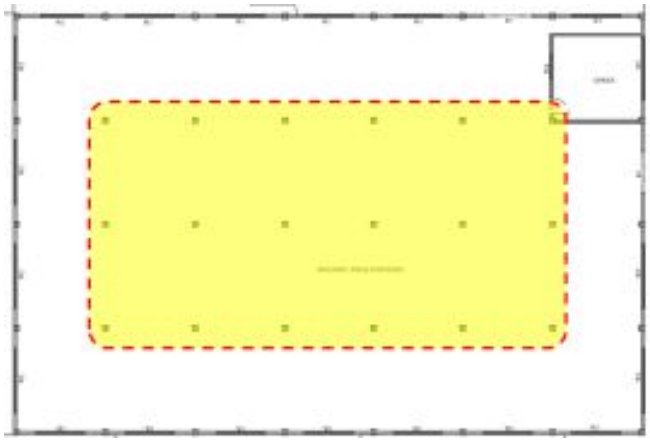
This issue refers to the ground and first floor of Football Production 3.
Damaged RC columns were observed at the ground and first floor which appears to be due to impact, possibly from movement of machines or a loaded trolley.F-202604-065230

Figure 2.11 - Location of Damaged RC Columns at the Ground and First Floor of Football Production 3

Figure 2.12 - Damaged RC Columns at the Ground Floor of Football Production Building 3

Figure 2.13 - Damaged RC Columns at the First Floor of Football Production 3 Building

Timeline	Remediation Plan
Medium Term CAP-0077179	Propose suitable protection around all RC columns in areas with vehicle or loaded trolley movement to prevent damage and collapse of columns from potential impacts and submit it to Pakistan Accord for review.
Longer Term CAP-0078696	Implement the required remedial works.

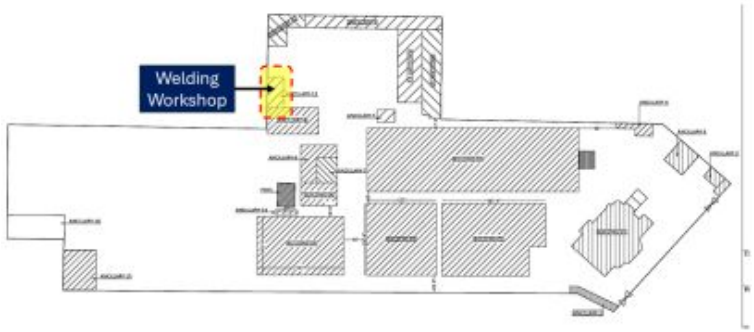
Excessive deflection was observed in the steel trusses, purlins, and roofing sheets of the welding workshop. Furthermore, misalignment of steel columns was noted. These deficiencies indicate compromised structural performance and pose a potential risk of structural instability and collapse. F-202604-065235

Figure 2.14 - Location of the Welder Shop

Figure 2.16 - Deflected Roof Trusses and Misaligned Column of the Welder Shop

Timeline	Remediation Plan
Immediate CAP-0077195	The area shall be evacuated .
Medium Term CAP-0077196	Building structural engineer to review the as-built design for code compliance (vertical and lateral loads) and confirm if it is adequate.
Medium Term CAP-0077197	Propose strengthening works as required and submit to Pakistan Accord for review.
Longer Term CAP-0077198	Implement strengthening works as required.

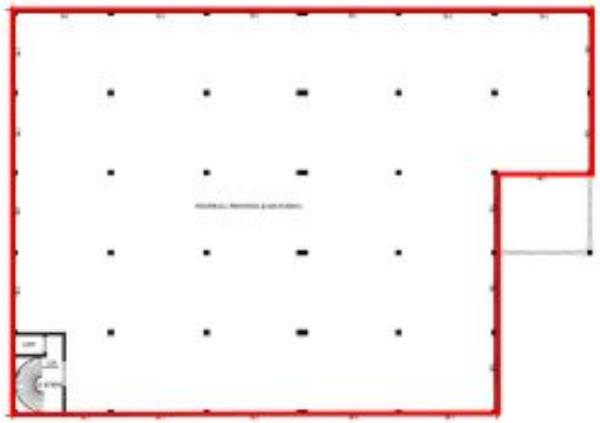
It concerns with lack of edge protection at the roof of the Football Production 1 which present a risk of potential injury resulting from slip, trip or fall from roof during the access and maintenance of services – Health & Safety concern. F-202604-065226

Figure 2.17 - Red Line Indicated Missing Edge Protection at the Roof of Football Production 1

Figure 2.18 - Missing Edge Protection at the Roof of Football Production 1

Timeline	Remediation Plan
Immediate CAP-0077181	Provide adequate edge protection on the roof, and on any other part of the factory with the same issue.

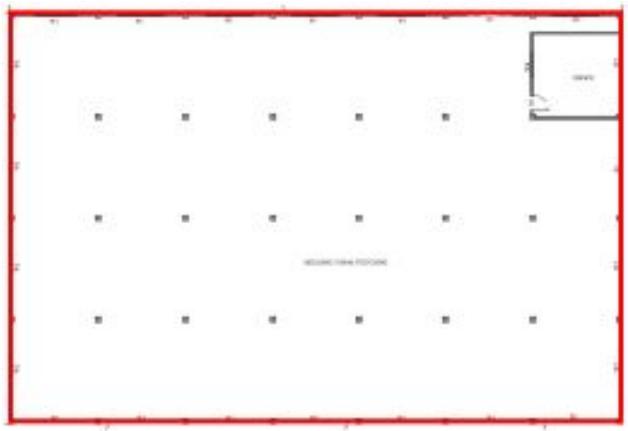
It concerns with lack of edge protection at the roof of the Football Production 3 which present a risk of potential injury resulting from slip, trip or fall from roof during the access and maintenance of services – Health & Safety concern. F-202604-065227

Figure 2.19 - Red Line Indicated Missing Edge Protection at the Roof of Football Production 3

Figure 2.20 - Missing Edge Protection at the Roof of Football Production 3

Timeline	Remediation Plan
Immediate CAP-0077183	Provide adequate edge protection on the roof, and on any other part of the factory with the same issue.

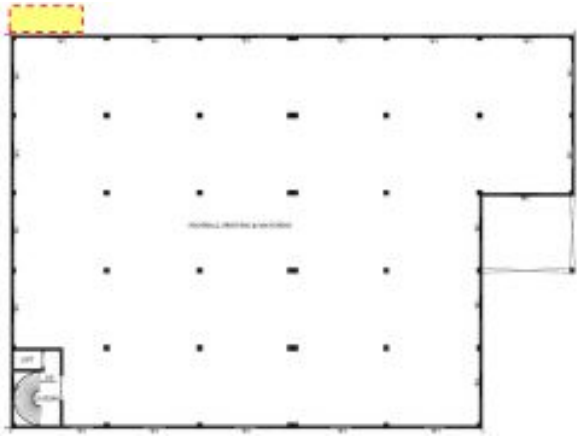
This issue refers to the steel stairs in the Football Production 1 Building. The stairs might have undersized structural elements and lack proper bracing, making them highly vulnerable. F-202604-065232

Figure 2.23 - Location of Steel Staircase in the Football Production 1 Building

Figure 2.24 - Structural Stability and Strength Issue in the Steel Staircase of Football Production 1

Timeline	Remediation Plan
Medium Term CAP-0077189	Building structural engineer to review the as-built design for code compliance (vertical and lateral loads) and confirm if it is adequate.
Medium Term CAP-0077190	Propose strengthening works as required and submit to Pakistan Accord for review.
Longer Term CAP-0077191	Implement strengthening works as required.

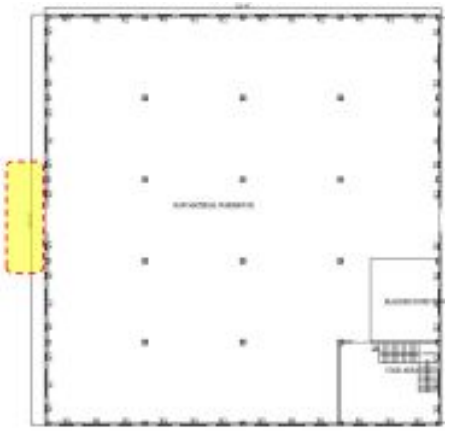
This issue refers to the steel stairs in the Football Production 2 Building. The stairs might have undersized structural elements and lack proper bracing, making them highly vulnerable. F-202604-065234

Figure 2.25 - Location of Steel Staircase in the Football Production 2 Building

Figure 2.26 - Structural Stability and Strength Issue in the Steel Staircase of Football Production 2

Timeline	Remediation Plan
Medium Term CAP-0077192	Building structural engineer to review the as-built design for code compliance (vertical and lateral loads) and confirm if it is adequate.
Medium Term CAP-0077193	Propose strengthening works as required and submit to Pakistan Accord for review.
Longer Term CAP-0077194	Implement strengthening works as required.
