Amtex Ltd.

Latitude: [31.45965], longitude: [73.0738]
Date of inspection: 13-Apr-2026

Structural Safety Inspection Report

Pakistan Accord Initial Safety Inspection Report

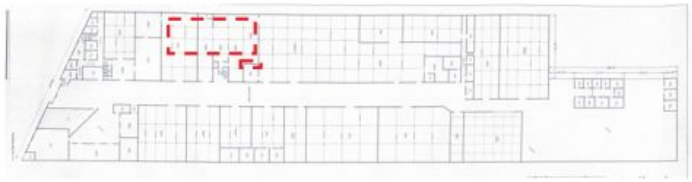
Figure 2.4 - Corrosion of Dowel reinforcement at roof of Building 01(Area 01)

This observation is related to roof of building 01(Area 01) where the column rebars are exposed and inadequately protected against corrosion at roof floor. This presents a high risk of reinforcement corrosion, which may compromise the structural integrity overtime. F-202604-065746

Timeline	Remediation Plan
Longer Term CAP-0078154	Propose measures to prevent further water ingress and inspect damage to the columns dowels and propose appropriate repairs to structure
Longer Term CAP-0078155	Implement approved remedial measures

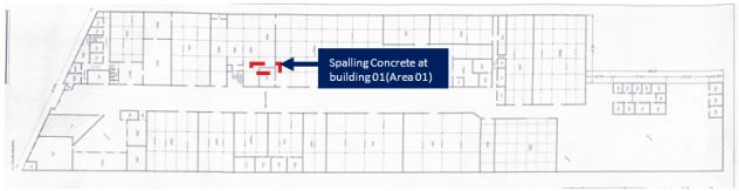
Figure 2.6 - Spalling Concrete at Roof of Building 01(Area 01)

This issue refers to building 01 (Area 01) where spalling concrete in beam was observed. The cause of spalling is corrosion of reinforcement. The potential cause of corrosion of reinforcement is due to lack of waterproofing and exposed atmospheric weather condition. F-202605-066340

Timeline	Remediation Plan
Medium Term CAP-0079200	Inspect damage to the beam and propose repair to the structure. Submit report capturing above to Pakistan Accord for approval.
Longer Term CAP-0079201	Implement remedial works
Longer Term CAP-0079245	Continue to monitor for future signs of damage.

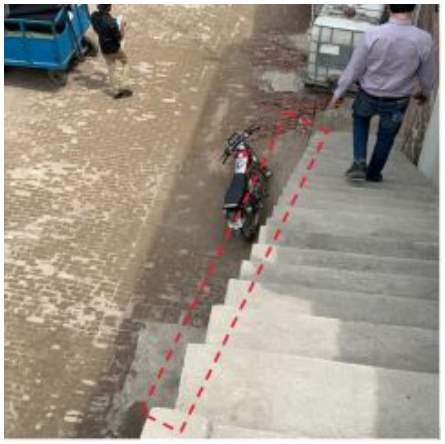
Figure 2.11 - Lack of edge protection at building 02

This issue is related to roof and staircase of building 02 where there is no edge protection leaving open edges without proper guardrails or barriers. This creates a serious fall hazard for anyone working or walking near the roof edge. F-202604-065735

Timeline	Remediation Plan
Immediate CAP-0078129	Provide adequate edge protection on the roof, staircase and on any other part of the factory with the same issue.
