Arshad Corporation (Pvt.) Ltd. (Apparel Division)

Latitude: [31.471655], longitude: [73.309928]
Date of inspection: 21-Apr-2026

Fire Safety Inspection Report

Pakistan Accord Initial Safety Inspection Report

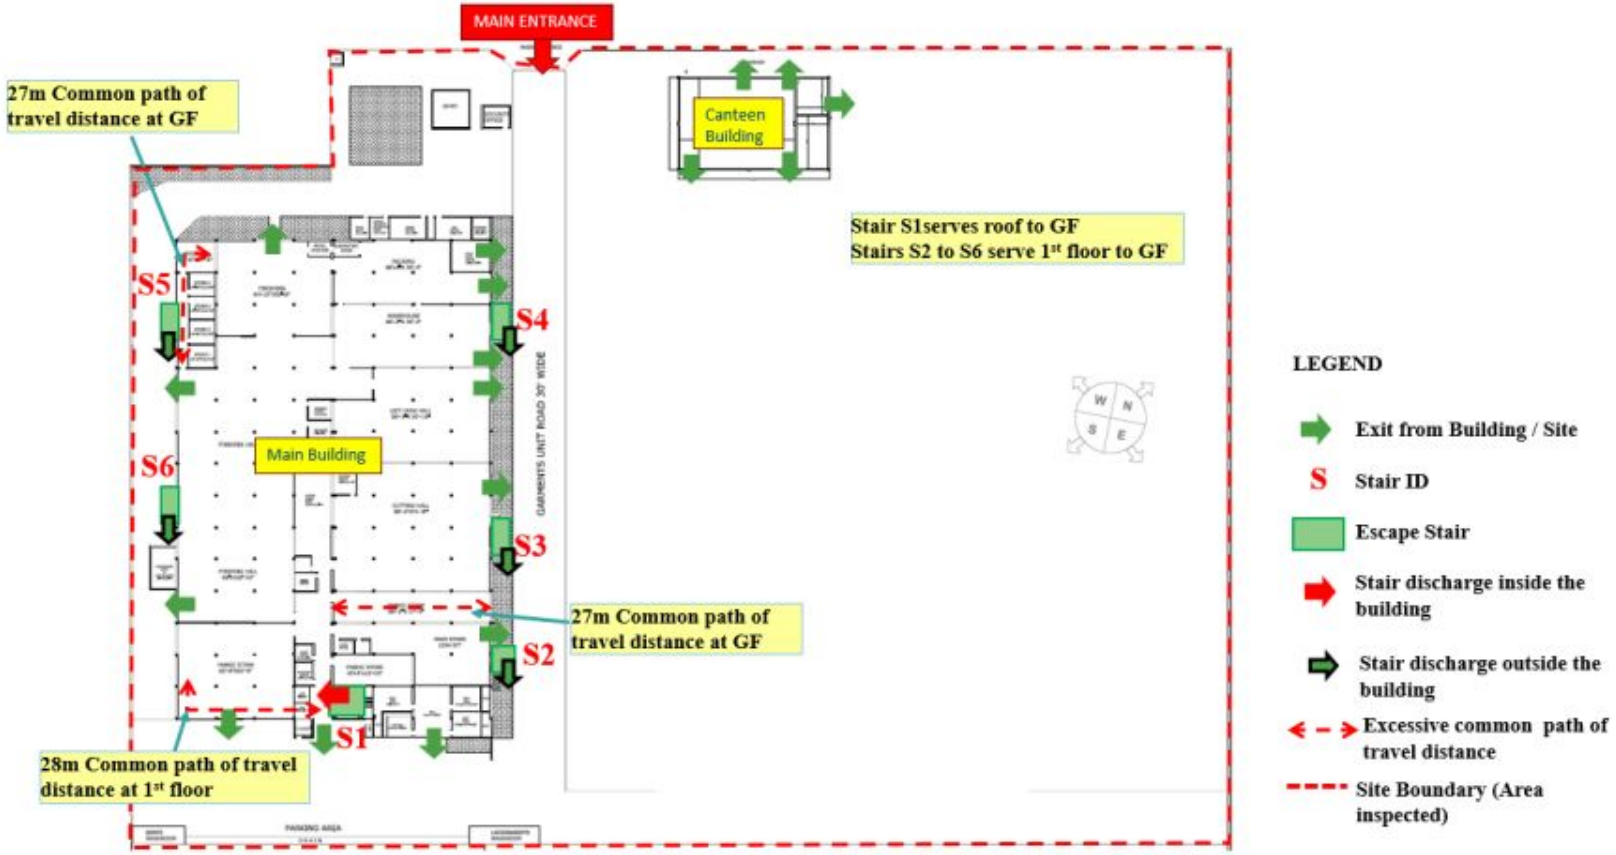
Figure 1.3. Egress layout- Main Building & Canteen Building (Ground floor)

The number of exits and exit capacity is sufficient for all floors & both buildings but common path of travel distance found at Ground & 1st floor of Main Building.
