Issue	**1**
Factory ID	**26207**
Date of Issue	**04-Jun-2026**

Arshad Corporation (Pvt.) Ltd. (Apparel Division)

Structural Safety Inspection Report

Pakistan Accord Initial Safety Inspection Report

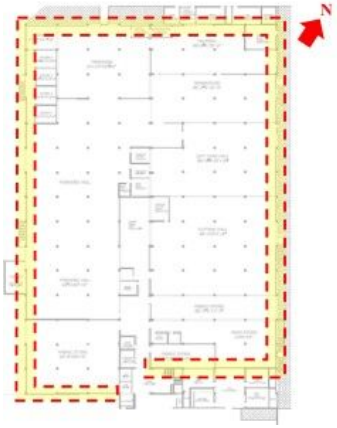
Figure 2.3 - Missing edge protection location at roof of Main Building

This refers to the Main Building.
Edge protection is not provided on the roof level of Main Building. Missing edge protection presents a risk of potential injury resulting from slip, trip or fall from the roof, while accessing and maintaining services on the roof. This is a Health and Safety Concern. F-202604-066153

Figure 2.4 - Missing edge protection at roof of Main Building

Timeline	Remediation Plan
Immediate CAP-0078926	Provide adequate edge protection on the roof, and on any other part of the factory with the same issue.
