Issue	**1**
Factory ID	**25796**
Date of Issue	**30-Jan-2026**

Ebrahim Textile Mills Ltd.

Boiler Safety Inspection Report

Pakistan Accord Initial Safety Inspection Report

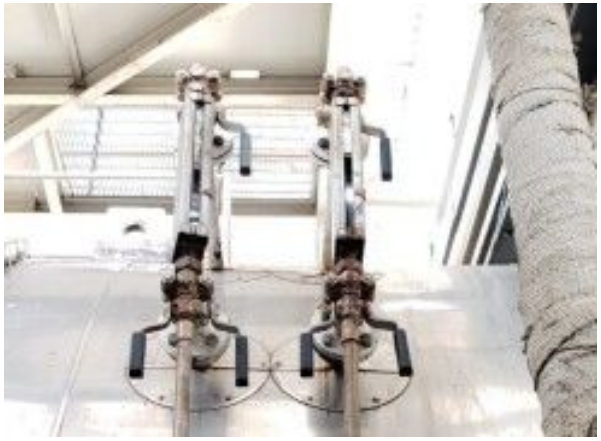
Figure 15 - Water level gauge glass

Finding No	F-202509-022864
Category	Monitoring and Controlling
Subcategory	Labelling and Marking
Boiler Reg. Number	S-3817
Observation	Marking of low water level, and high water level was not found on boiler water level gauge glass.

CAP No	Recommendation	Priority	Timeframe
B1 - CAP-0031112	Low water level, and high water level must be marked and labelled on boiler water level gauge glass.	P2	1 month
