Ebrahim Textile Mills

Latitude: [24.840655], longitude: [67.239885]
Date of inspection: 13-May-2025

Structural Safety Inspection Report

Pakistan Accord Initial Safety Inspection Report

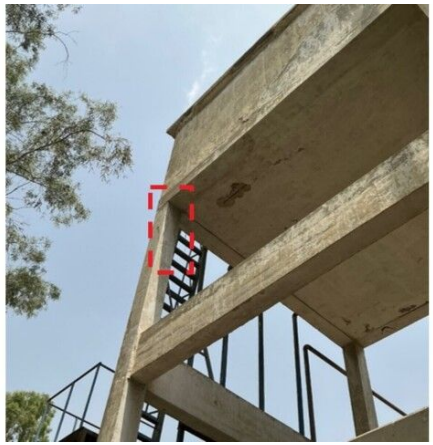
This refers to Building 1 where cracking in multiple columns was observed at multiple locations and levels. The column was found to have cracks penetrating through the concrete, potential cause for damage is due to the water ingress which causes corrosion of reinforcement present in the column resulting expansion in steel bar which is damaging concrete at multiple levels. Although columns are not overstressed, corrosion can compromise the integrity and safety of structure. F-202506-017631

Figure 2.2 - Building 01 - Column crack in OHWT

Timeline	Remediation Plan
Medium Term FIN-0022566	Structural engineer to carry out a detailed assessment of the column to identify the cause of the cracking and the residual load capacity including condition of concrete and rebar. Structural Engineer to investigate whether such cracks exist in any other columns, particularly at Ground floor level. Propose measures to prevent future damage and to repair the existing damage / strengthen the column as required and submit to Pakistan Accord for approval.
Longer Term FIN-0022567	Carry out the remedial works.

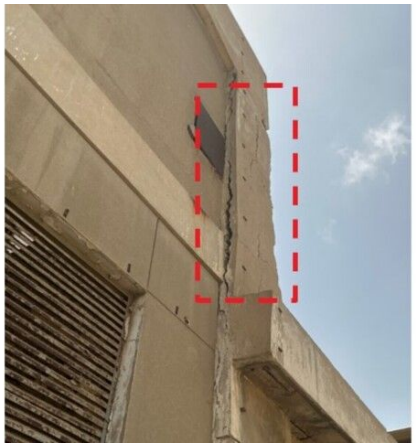
Figure 2.4 - Building 01 - Column crack in warehouse area

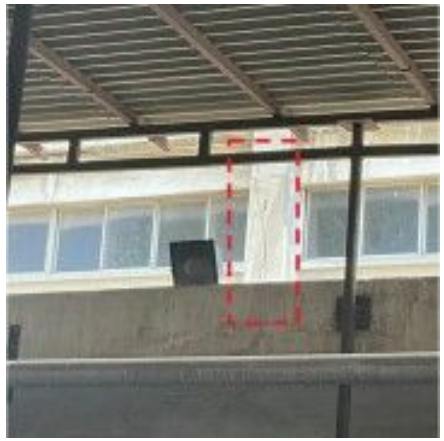
Figure 2.5 - Building 01 - Column crack in warehouse area

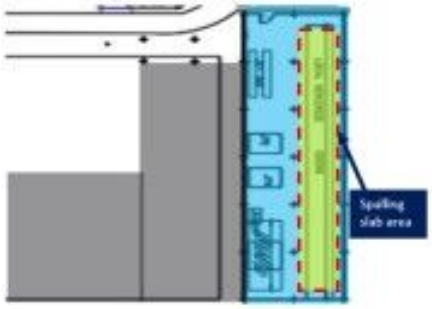
Figure 2.11 - Building B6 (Structure 1)- Location of spalling in roof slab

This refers to the roof floor slab of Building B6 (Structure 1), the concrete of roof slab was spalling. The potential cause of the spalling might be the steam coming out from the mercerize and dryer machines. F-202506-017637

Timeline	Remediation Plan
Medium Term FIN-0022572	Identify the cause of the damage and propose measures to prevent further water damage Inspect damage to the slab and propose repairs to structure Submit report capturing above to Pakistan Accord for approval
Longer Term FIN-0022573	Implement remedial works Continue to monitor for future signs of water ingress/damage

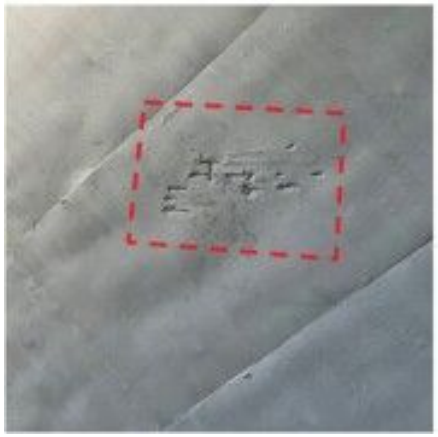
This refers to the roof floor slab of Building B5 (Structure 1 and 3), the concrete of roof slab was spalling. The potential cause of the spalling for structure 5 might be the steam coming out from the mercerize and bleaching machines and for structure 3 is the lack of waterproofing of the shell slab. F-202506-017638

Figure 2.16 - Building 5 (Structure 1)- Spalling in the shell slab of the building

Timeline	Remediation Plan
Medium Term FIN-0022574	Identify the cause of the damage / source of water ingress and propose measures to prevent further water damage Inspect damage to the slab and propose repairs to structure Submit report capturing above to Pakistan Accord for approval
Longer Term FIN-0022575	Implement remedial works Continue to monitor for future signs of water ingress/damage

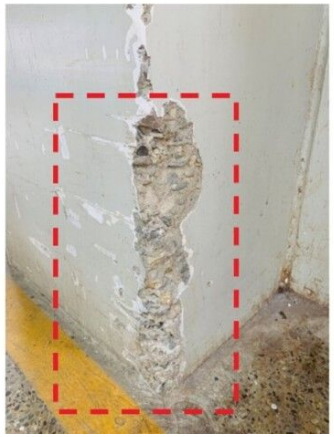
This observation relates to the multiple columns at roof of Building 5 (Structure 4), which was found to be damaged due to impact of trollies at the roof level. F-202506-017639

Figure 2.19 - Building 5 (Structure 4) - Signs of impact damage in column at roof

Timeline	Remediation Plan
Medium Term FIN-0022576	Repair damage to column corners and external faces
Longer Term FIN-0022577	Install protective measures to prevent damage recurring and submit the pictorial evidence to Pakistan Accord. Continue to monitor condition of columns in highly trafficked areas

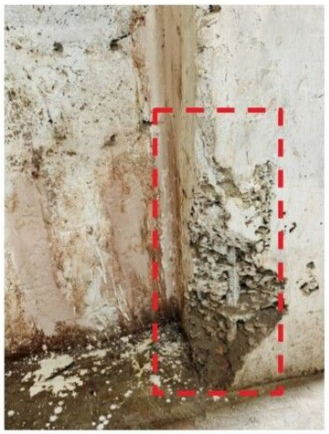
This observation relates to the multiple columns at roof of Building 6 (Structure 1), which was found to be damaged due to impact of trollies at the ground floor level. F-202506-017640

Figure 2.23 - Building 6 (Structure 1) - Signs of impact damage in column at ground floor

Timeline	Remediation Plan
Medium Term FIN-0022578	Repair damage to column corners and external faces
Longer Term FIN-0022579	Install protective measures to prevent damage recurring and submit the pictorial evidence to Pakistan Accord. Continue to monitor condition of columns in highly trafficked areas

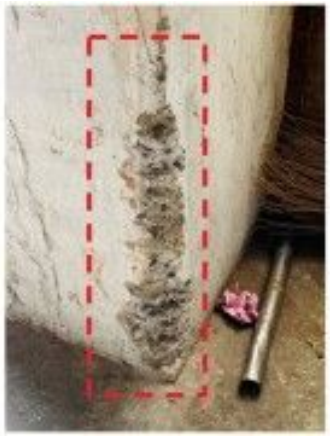
Figure 2.24 - Building 6 (Structure 1) - Signs of impact damage in column at ground floor
