Eclipse Sports (Pvt.) Ltd.

Latitude: [32.477965], longitude: [74.427812]
Date of inspection: 11-Mar-2026

Electrical Safety Inspection Report

Pakistan Accord Initial Safety Inspection Report

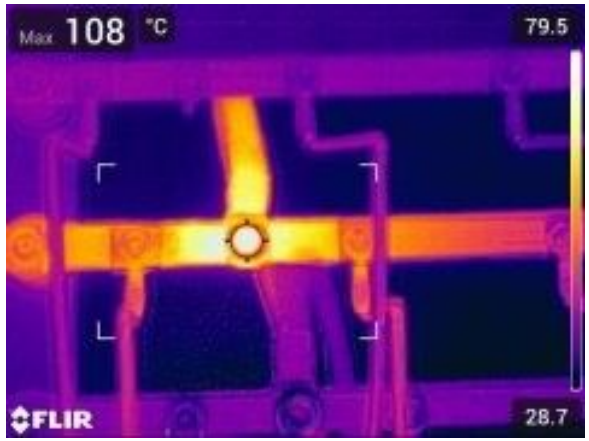
The survey identified numerous hot spots within panels and distribution boards. Hot spots in electrical distribution systems can be caused by several factors, including:

Circuit breakers are typically designed to operate safely within an ambient temperature range of -20°C to 40°C. Commonly used PVC insulated cables typically have a maximum operating temperature of 70°C. Prolonged exposure to temperatures above these can degrade the insulation of the breaker as well as the cable and result in reduced performance.

Figure 2.4 - Hot spot found on the yellow bus bar in PFI (power factor improvement) panel ground floor

Timeline	Remediation Plan
Immediate CAP-0075711	Any circuits identified on site with temperatures exceeding 40°C above the ambient temperature, operating above 90°C or exhibiting visual signs of burning must be immediately isolated and taken out of service. These circuits should remain de-energized until a thorough review has been conducted and appropriate remedial actions have been implemented to resolve the underlying issues.
Medium Term CAP-0075712	During the inspection, several circuits were identified where the temperature was exceeding 20°C above ambient temperature. It is recommended that the factory conducts comprehensive thermographic surveys of all electrical panels to detect similar issues. Identified hot spots should be thoroughly reviewed to determine their underlying causes. Corrective actions must be taken to address and resolve these issues, ensuring safe and reliable operation of the electrical systems.

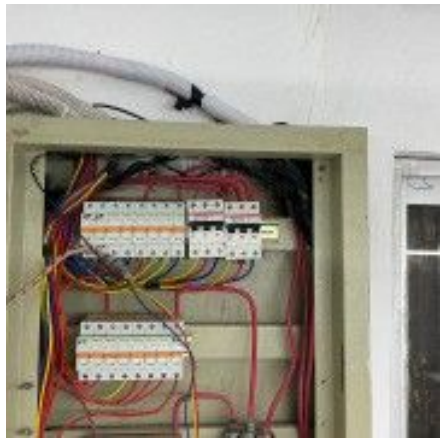
During our inspection, multilooping was observed in a number of electrical panels across the facility. This issue was specifically observed in the distribution board of packing, finishing, stitching, forceps assembling and main electrical panel on third floor.

Multilooping can result in improper distribution of electrical current, leading to voltage drops and potential electrical hazards. To mitigate these risks and ensure the safety and reliability of the electrical system, it is essential to adhere to proper installation practices. This includes using appropriate dedicated circuit breakers for each circuit.F-202603-064040

Figure 2.20 - Multiple connections found in electrical panel of stitching machines on third floor

Timeline	Remediation Plan
Medium Term CAP-0075742	The electrical installation throughout the facility shall be modified to ensure each circuit is protected by a dedicated circuit breaker of a suitable type and rating for each individual circuit in accordance with Section 430 of BS 7671 18th Edition + A2 (2022).

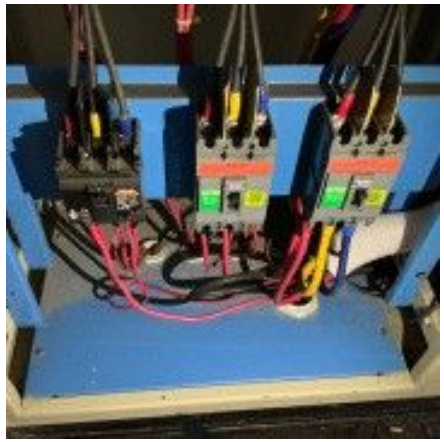
Figure 2.22 - Multiple connections found in the main electrical panel on third floor

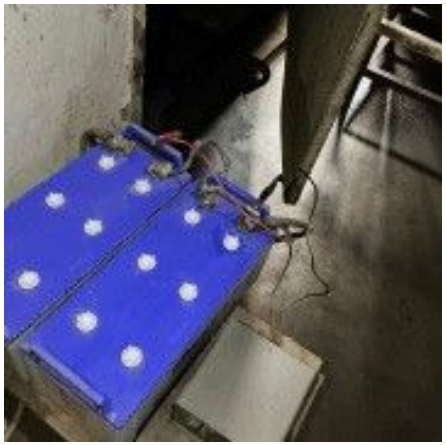
Figure 2.50 - Exposed terminals observed on the generator batteries
