FA Bhatti Industries

Latitude: [32.506017], longitude: [74.553019]
Date of inspection: 16-Mar-2026

Fire Safety Inspection Report

Pakistan Accord Initial Safety Inspection Report

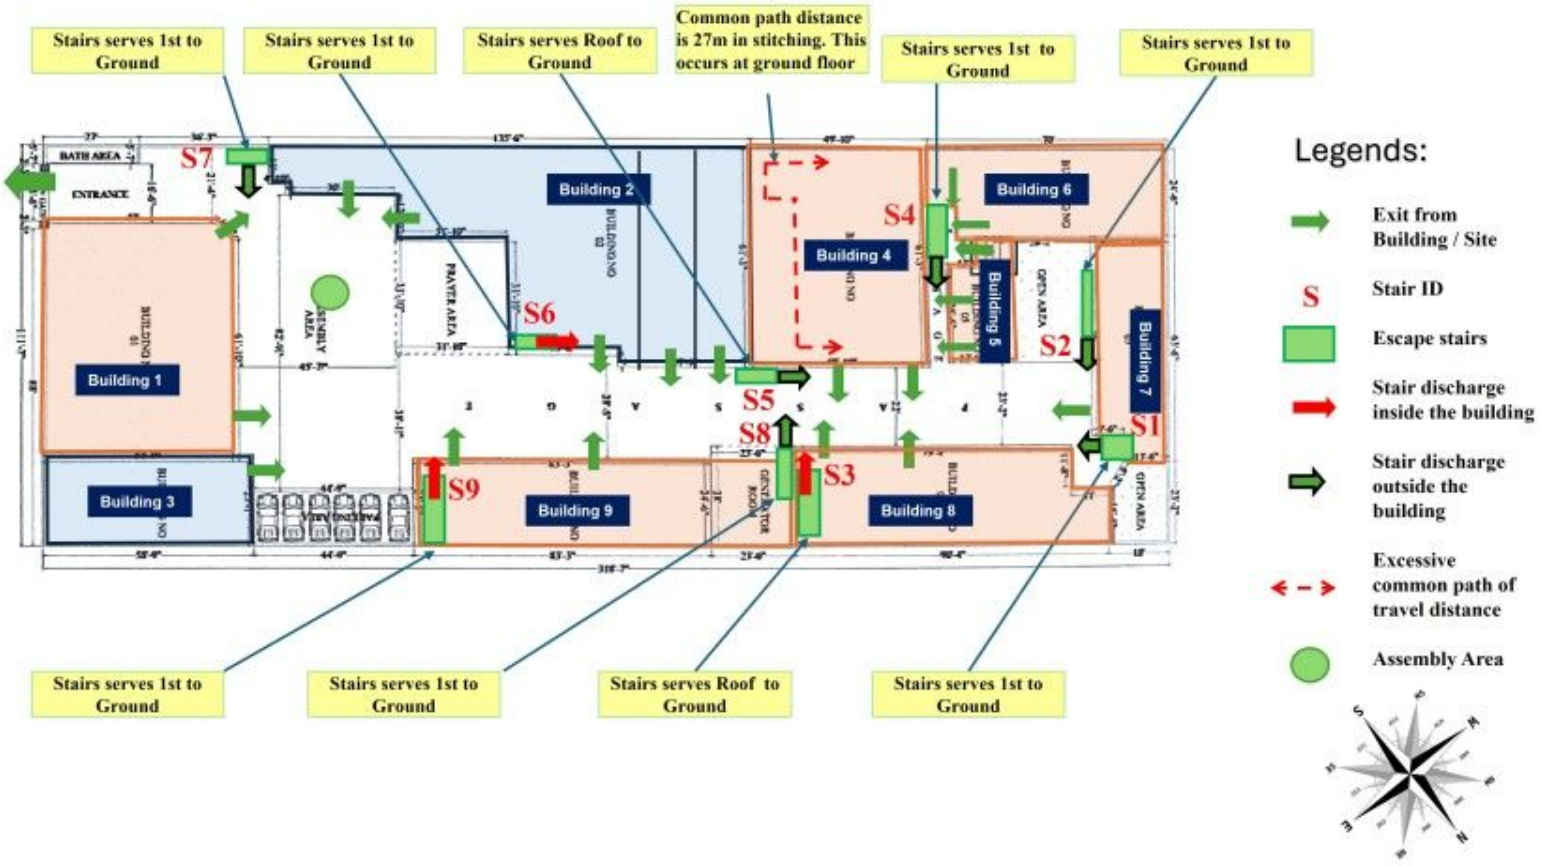
Figure 1.3. Egress Layout of Main Buildings.

The number of exits is insufficient at 1st floor of Building 8. Excessive travel distance issue was found at stitching (ground floor) Building 4.

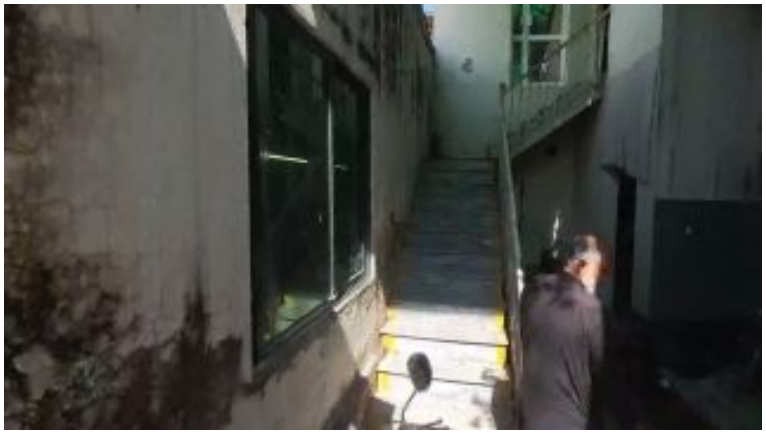
This is not always achieved, examples include (list not exhaustive):
- Unprotected openings into stairs such as unprotected opening into S2 from Building 7, S3 from generator area, S4 from Building 4, 5 & 6 and S5 from Building 4.
- Missing fire rated enclosure and fire doors in stair S6, S8 and S9.
- Fire load under stairs S1 & S4, fire load and obstruction in S3 first floor.

Figure 2.16 - Unprotected opening into S4 from Building 4,5 &6.
