FA Bhatti Industries

Latitude: [32.506017], longitude: [74.553019]
Date of inspection: 16-Mar-2026

Structural Safety Inspection Report

Pakistan Accord Initial Safety Inspection Report

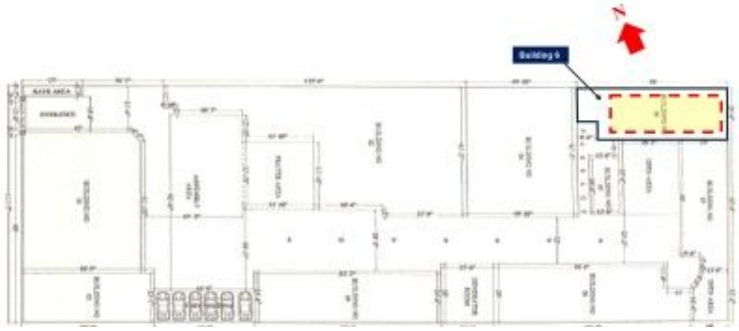
This issue refers to the building 6, where spalling of Concrete was observed at the first-floor slab (Precast Panels).
This is likely due to the moisture ingress and lack of water proofing, which may have caused the corrosion of the reinforcing steel, leading to the spalling of concrete cover.F-202604-064987

Figure 2.1 - Location of concrete spalling at first floor slab of Building 6

Timeline	Remediation Plan
Medium Term CAP-0076920	Identify the cause of the damage and propose measures to prevent further damage.
Medium Term CAP-0076921	Inspect damage to the slab and propose repair to structure.
Medium Term CAP-0078353	Submit report capturing above to Pakistan Accord for approval.
Longer Term CAP-0076922	Implement the required remedial work.
Longer Term CAP-0076923	Continue to Monitor further damage.

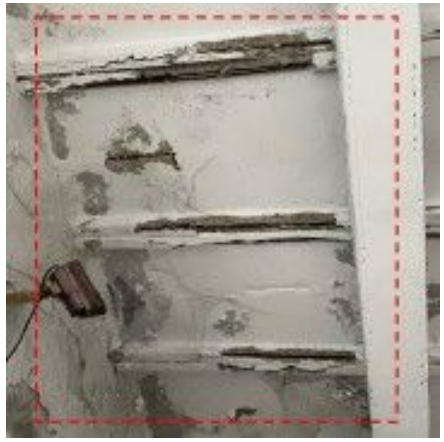
Figure 2.3 - Concrete spalling at first floor slab of Building 6

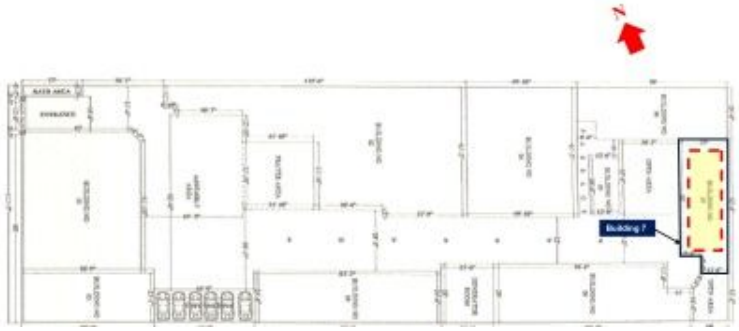
This issue refers to the building 7, where spalling of Concrete was observed at the first-floor slab (Precast Panels).
This is likely due to the moisture ingress and lack of water proofing, which may have caused the corrosion of the reinforcing steel, leading to the spalling of concrete cover.F-202604-064988

Figure 2.4 - Location of Concrete spalling at first floor slab of Building 7

Timeline	Remediation Plan
Medium Term CAP-0076924	Identify the cause of the damage and propose measures to prevent further damage.
Medium Term CAP-0076925	Inspect damage to the slab and propose repairs to structure.
Medium Term CAP-0078354	Submit report capturing above to Pakistan Accord for approval.
Longer Term CAP-0076926	Implement the required remedial work.
Longer Term CAP-0076927	Continue to Monitor further damage.

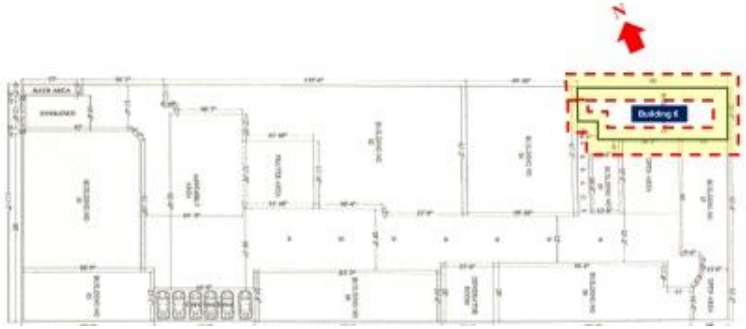
This refers to Building 6.
Edge protection is not provided on the roof level of Building 6. Although the roof was inaccessible, the air-conditioning outdoor unit was found on the roof. Missing edge protection presents a risk of potential injury resulting from slip, trip or fall from the roof while accessing and maintaining services on the roof. This is a Health and Safety Concern.F-202604-064990

Figure 2.9 - Location of Missing edge protection at roof of Building 6

Timeline	Remediation Plan
Immediate CAP-0076929	Provide adequate edge protection and safe access on the roof, and on any other part of the factory with the same issue.

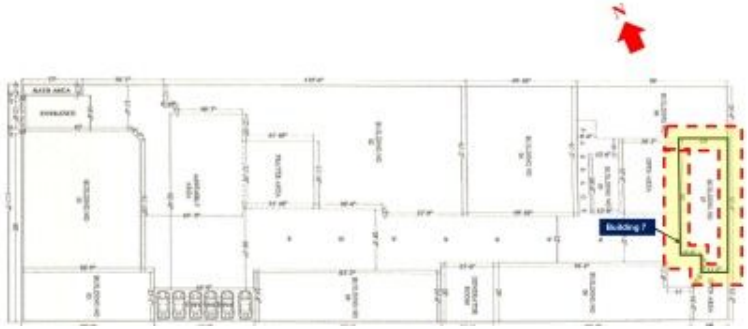
This refers to Building 7.
Edge protection is not provided on the roof level of Building 7. Although, the roof was inaccessible, water tank was witnessed. Missing edge protection presents a risk of potential injury resulting from slip, trip or fall from the roof while accessing and maintaining services on the roof. This is a Health and Safety Concern.F-202604-064991

Figure 2.11 - Location of Missing edge protection at roof of Building 7

Timeline	Remediation Plan
Immediate CAP-0076930	Provide adequate edge protection and safe access on the roof, and on any other part of the factory with the same issue.

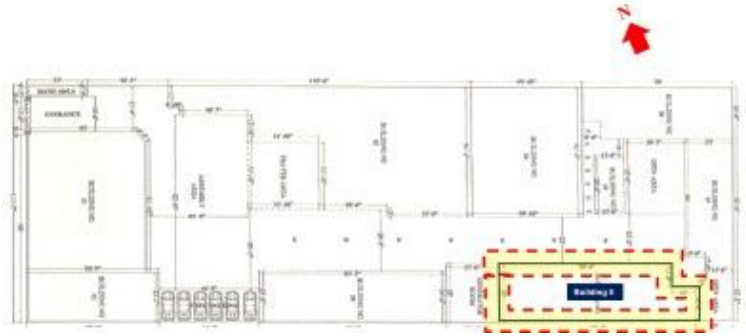
This refers to the Building 8.
Edge protection is not provided on the roof level of Building 8. Furthermore, the internal staircase of Building 8 is also missing an edge protection/safety handrail. Missing edge protection presents a risk of potential injury resulting from slip, trip of fall from the stairs or roof, while accessing and maintaining services on the roof. This is a Health and Safety Concern.F-202604-064992

Figure 2.13 - Location of Missing Edge Protection at roof of Building 8

Timeline	Remediation Plan
Immediate CAP-0076931	Provide adequate edge protection on the roof, and on any other part of the factory with the same issue.
