# Fashion Knits

Latitude: [ 31.441207 ], longitude: [ 73.120085 ]
Date of inspection: 11-Mar-2026

# Fire Safety Inspection Report

# Pakistan Accord Initial Safety Inspection Report

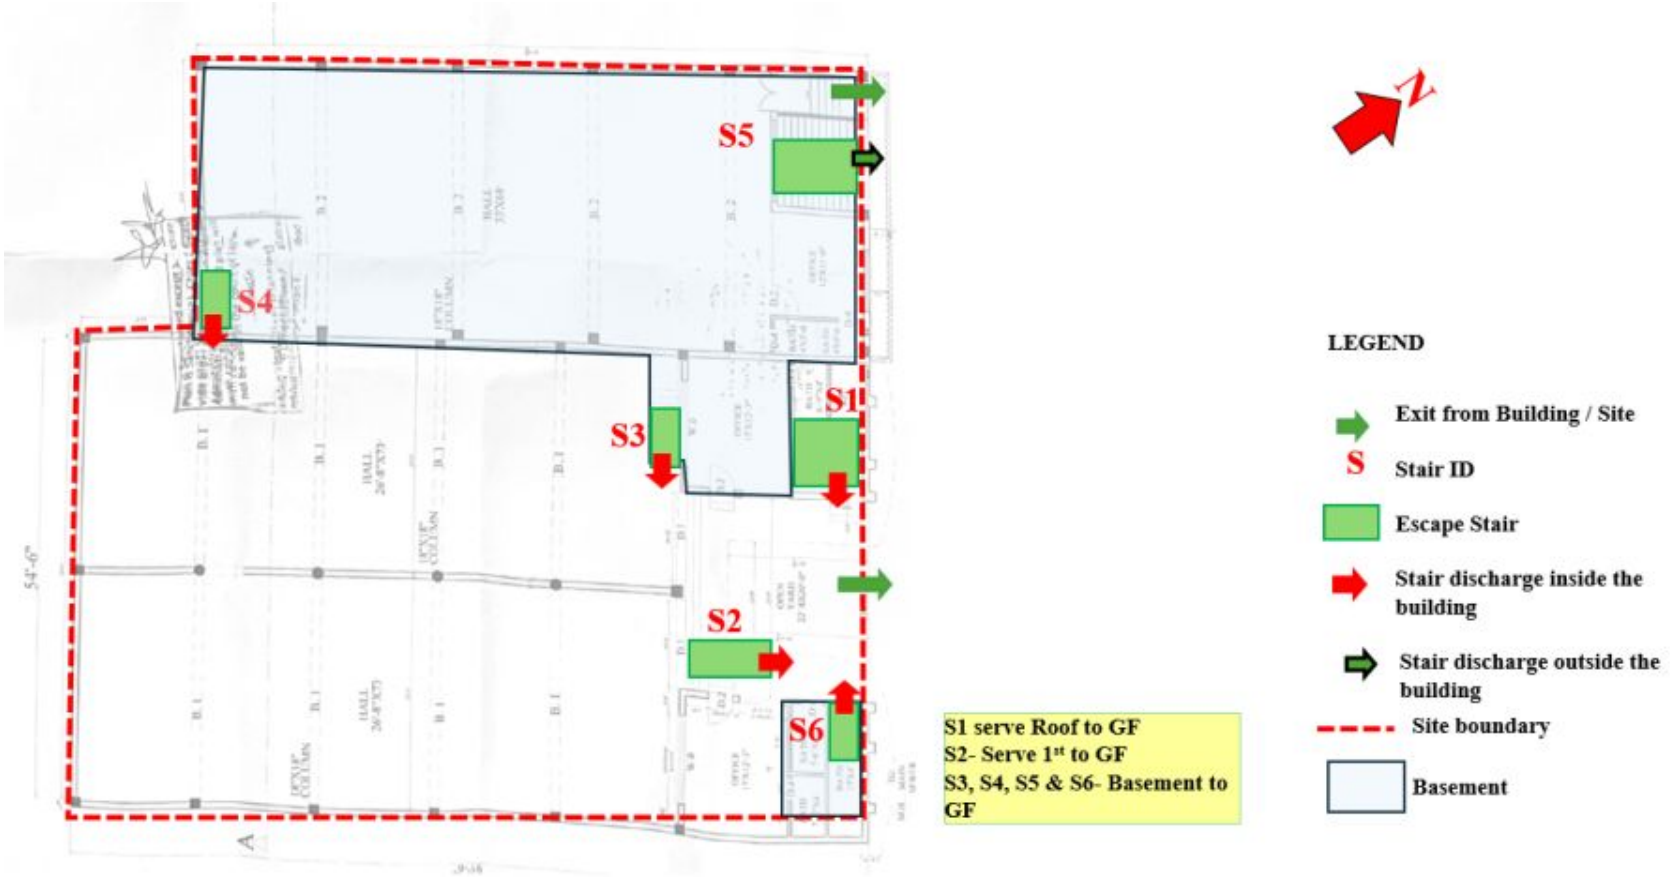
Figure 1.3. Egress layout- Ground floor

The number of exits are not sufficient first floor (since stair S1 & S2 do not meet the remoteness criteria and taken as single exit).
