Issue	**1**
Factory ID	**26329**
Date of Issue	**22-Apr-2026**

Fashion Knits

Structural Safety Inspection Report

Pakistan Accord Initial Safety Inspection Report

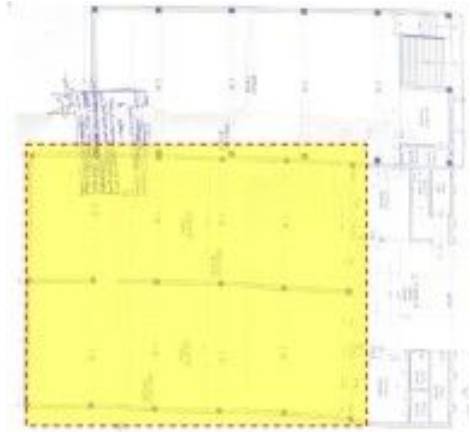
Figure 2.3 - Plan showing location of the area

This refers to the exposed rebars on the roof of main building, where the rebars were corroded because of being exposed to the atmosphere. This corrosion can lead to reduction in the capacity of the rebars overtime. F-202604-064910

Figure 2.1 - Corroded dowel bars at roof of main building

Figure 2.2 - Corroded dowel bars at roof of main building

Timeline	Remediation Plan
Medium Term CAP-0076809	Building Engineer to inspect areas with exposed rebars and protect it from the weathering effects, also propose the remedial solution to further reduce the effect of corrosion and present to Pakistan Accord for review.
Longer Term CAP-0076810	Implement the remedial works.
