Fashion & Styles

Pakistan ACCORD for Health and Safety in the Garment and Textile Industry

Electrical Safety Inspection Report

Pakistan Accord Initial Safety Inspection Report

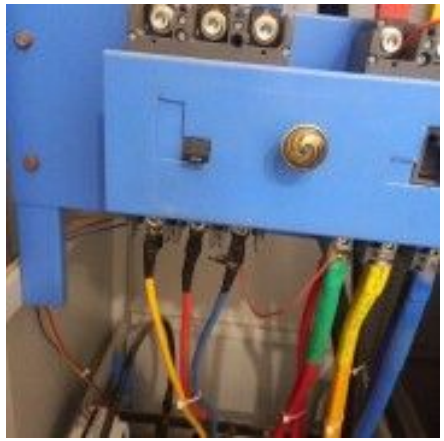
It was observed that multiple circuit breakers had ratings that were not appropriate for the connected cable sizes. Issues observed are as follows:

i. 250A circuit breaker on 25sq.mm cable observed in main LT panel at ground floor of building 1.
ii. 100A circuit breaker on 4sq.mm cable observed in main distribution board at first floor of building 1.

Specifically, some circuit breakers had higher ratings than the cables could safely handle, which poses a significant risk of overheating and potential fire hazards. Conversely, other circuit breakers had lower ratings than necessary, resulting in frequent and unnecessary tripping. To ensure both safety and operational efficiency, corrective action is required to align the circuit breaker ratings with the cable capacities. This adjustment will mitigate the risks associated with overheating and improve the reliability of the electrical system. F-202603-063920

Figure 2.1 - 250A circuit breaker on 25sq.mm cable observed in main LT panel at ground floor of building 1

Timeline	Remediation Plan
Medium Term CAP-0074809	Evaluate the breaker ratings and cable sizes for all circuits in the facility according to Section 433.1.1 and Appendix 4 of BS 7671 18th Edition + A2 (2022). Ensure that the breaker rating does not exceed the cable's current-carrying capacity. If the breaker has adjustable settings, they must be configured to allow current within the cable's ampacity after applying derating factors.

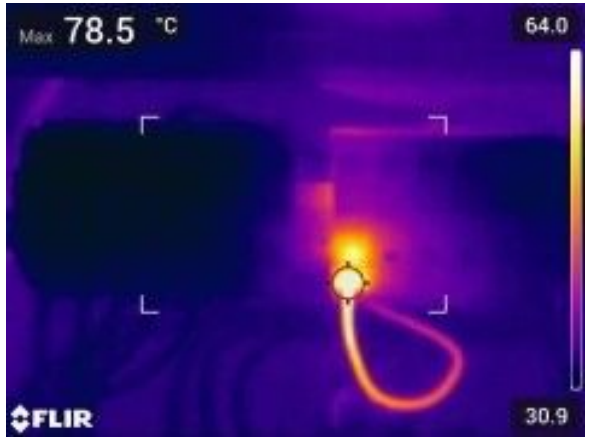
The survey identified numerous hot spots within panels and distribution boards. Hot spots in electrical distribution systems can be caused by several factors, including:

i. Hotspot of 78 °C was observed in main distribution board at second floor of building 1.
ii. Hotspot of 54 °C observed in main distribution board at first floor of building 1.
iii. Hotspot of 53 °C was observed in lighting distribution board at ground floor of building 1.

Figure 2.3 - Hotspot observed in main distribution board at second floor of building 1

Timeline	Remediation Plan
Immediate CAP-0074880	Any circuits identified on site with temperatures exceeding 40°C above the ambient temperature, operating above 90°C or exhibiting visual signs of burning must be immediately isolated and taken out of service. These circuits should remain de-energized until a thorough review has been conducted and appropriate remedial actions have been implemented to resolve the underlying issues.
Medium Term CAP-0074881	During the inspection, several circuits were identified where the temperature was exceeding 20°C above ambient temperature, as illustrated in the example images below. It is recommended that the factory conducts comprehensive thermographic surveys of all electrical panels to detect similar issues. Identified hot spots should be thoroughly reviewed to determine their underlying causes. Corrective actions must be taken to address and resolve these issues, ensuring safe and reliable operation of the electrical systems.

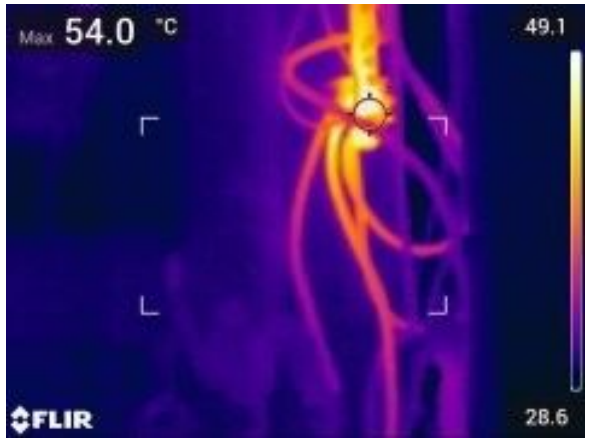
Figure 2.4 - Hotspot observed in main distribution board at second floor of building 1

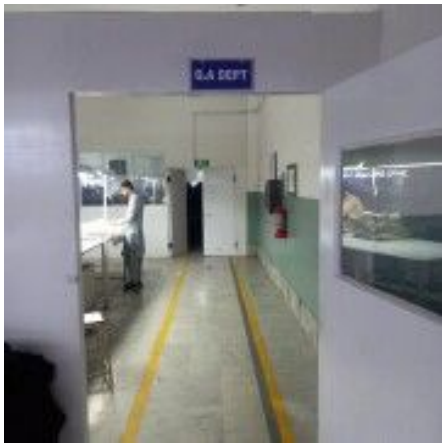
i. Emergeny light and exit signage layout was missing for the factory.
ii. Several areas lack sufficient emergency lighting and exit signage coverage.
iii. External emergency lighting was not provided, preventing people from reaching a place of safety outside the facility during nighttime evacuations.

Adequate and functional emergency lighting throughout the facility is crucial for providing necessary illumination during power failures or other emergencies, ensuring the safe evacuation of workers.F-202603-063923

Figure 2.30 - No exit signage observed at ground floor of building 1

Longer Term CAP-0074877	Establish a regular maintenance and testing schedule to check the functionality of emergency lighting systems routinely. This should include periodic tests, inspections, and prompt maintenance actions to address any issues. Maintain detailed records of all inspections, tests, repairs, and maintenance activities. Train facility maintenance staff on the procedures for inspecting and maintaining emergency lighting systems to ensure ongoing reliability and compliance with safety standards.

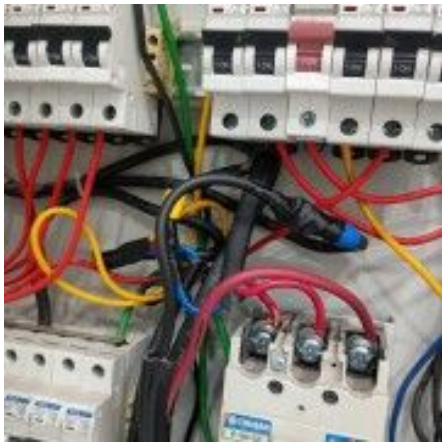
i. Cables terminations within panels and switchgears were made without cable lugs, resulting in breaking strands and loose connections. This presents a significant fire risk due to the potential for electrical arcing and overheating, which can ignite nearby materials and cause a fire. Furthermore, loose connections can cause voltage drops and equipment malfunctions, posing a life safety hazard. This issue was observed in both building 1 & 2.
ii. PVC tape joints were found in several locations - including within distribution boards - where cables were either damaged or two cables were being joined together. This method of jointing is unreliable and can deteriorate over time, increasing the risk of electrical shorts and fires. The adhesive on PVC tape can degrade, leading to exposed conductors that can spark and ignite surrounding materials, presenting both fire and life safety risks. This issue was observed in both building 1 & 2.

For any future electrical work, the termination of stranded cables must be done with cable lugs and PVC tape joints shall not be utilised. Proper termination ensures secure and reliable connections, reducing the risk of electrical failures and enhancing overall safety. F-202603-063916

Figure 2.42 - Taped joints observed in main distribution board of office area at ground floor of building 2

Timeline	Remediation Plan
Medium Term CAP-0074796	i. install cable lugs on all improperly terminated cables within panels and switchgears to secure connections and prevent breaking strands and loose connections in accordance with Regulation 526.1 of BS7671 18th Edition + A2 (2022)
Medium Term CAP-0074797	ii. Replace all PVC tape joints with proper terminal blocks or connectors to ensure secure and stable connections in accordance with Regulation 526.1 of BS7671 18th Edition + A2 (2022). Replace all damaged cabling with new wiring.

Medium Term CAP-0074798	iii. Replace the directly inserted power wires with proper power plugs to ensure safe and secure connections.
Longer Term CAP-0074799	i. Implement a standard operating procedure (SOP) requiring the use of cable lugs for all future cable terminations. Regularly train and audit personnel to ensure compliance with this procedure, thus maintaining safe and reliable electrical connections.
Longer Term CAP-0074800	ii. Establish a policy prohibiting the use of PVC tape for electrical jointing. Regularly inspect and maintain electrical installations to ensure compliance, and provide continuous training for staff on proper jointing techniques.
Longer Term CAP-0074801	iii. Develop and enforce a facility-wide electrical safety protocol that mandates the use of power plugs for all equipment. Conduct regular safety audits and provide training sessions to staff to reinforce the importance of using proper power plugs and adherence to electrical safety standards.
