Fashion & Styles

Latitude: [31.502287], longitude: [73.10175]
Date of inspection: 12-Mar-2026

Fire Safety Inspection Report

Pakistan Accord Initial Safety Inspection Report

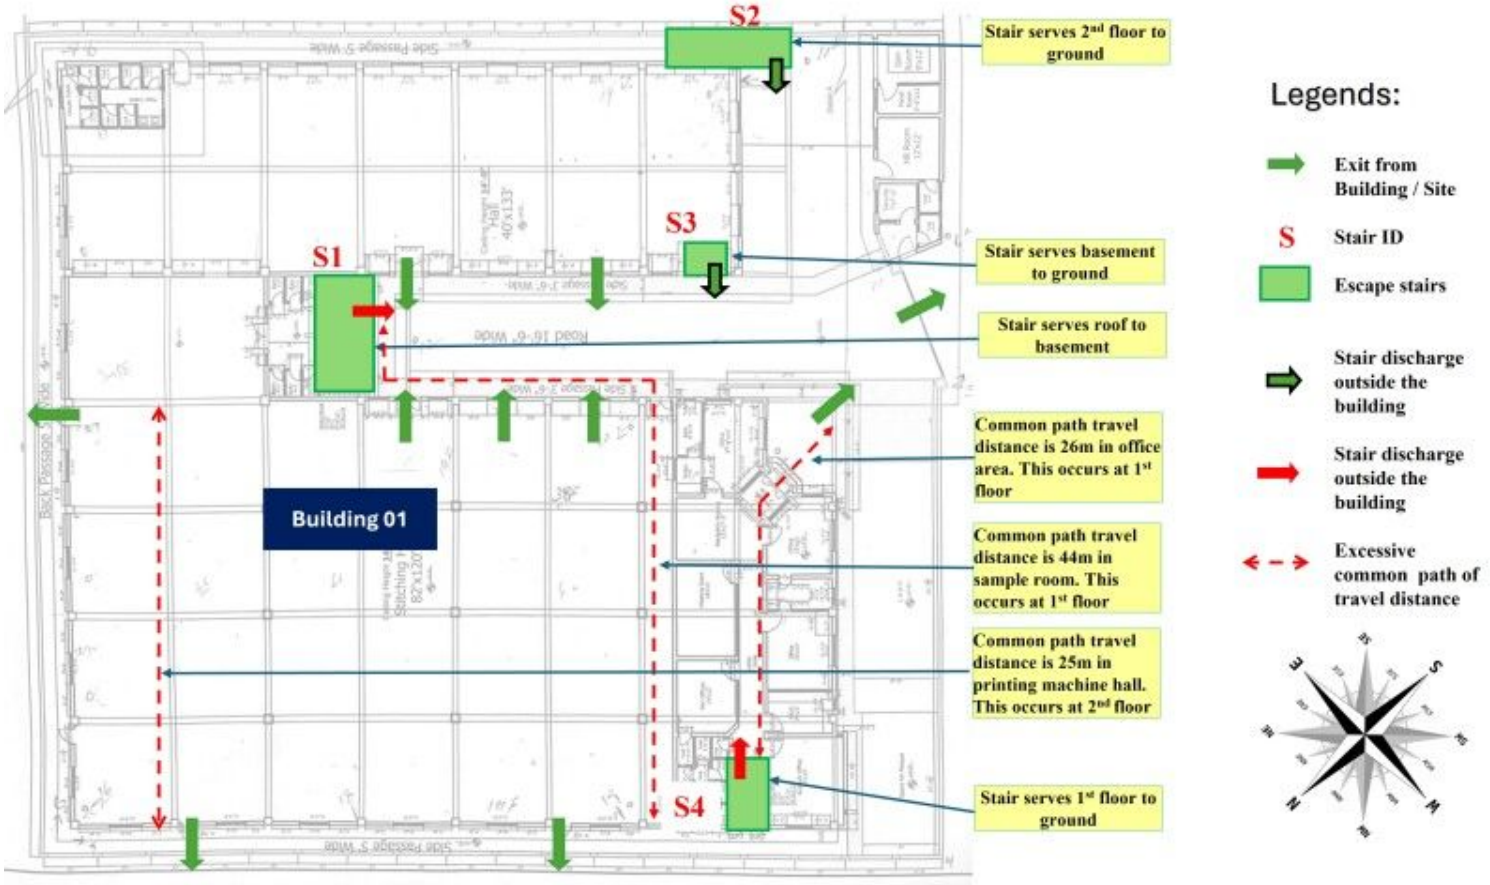
Figure 1.4. Egress Layout of Building 1.

The number of exits is insufficient at offices(1st floor) Building 1. Excessive common path of 25m, 26m and 44m were found at printing machine hall (2nd floor), office area and sample room (1st floor) of Building 1.

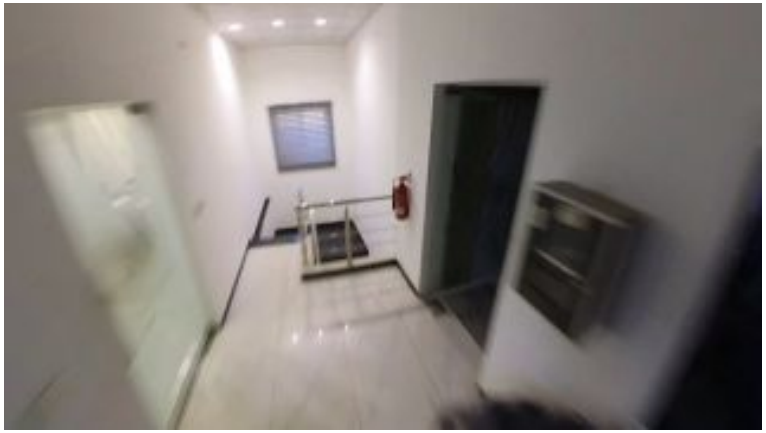
The following deficiencies have been observed on site, including (list not exhaustive):
- Missing exit signs at entry into stair S4 from 1st floor.
- Missing exit signs in production areas at printing hall (2nd floor) Building 1.
- Missing exit signs in office area (ground floor) at Building 1.
- Exit signs are not clear / misleading such as misleading emergency exit sign at cutting area (2nd floor) as it leads towards the closed door installed at balcony.
-Electrically powered exit signs are not a tested and listed system.

Figure 2.17 - Missing exit signs at entry into stair S4 from 1st floor of Building 1.

Timeline	Remediation Plan
Immediate CAP-0076316	Remove misleading directional escape signs.
Medium Term CAP-0076317	Rectify and/or provide exit signage so access to exits is marked by approved, readily visible signs from all areas of the floor and clearly visible at exits, to comply with Pakistan Accord Standard and BCP 10.15.1, 10.15.2 and 10.15.3
Longer Term CAP-0076318	Ensure that all exit signage is checked periodically and in good working condition.
