Fashion & Styles

Pakistan ACCORD for Health and Safety in the Garment and Textile Industry

Chak 117/JB, (Dhanola) Millat Industrial Estate Road
37600 Faisalabad
Punjab Pakistan

Structural Safety Inspection Report

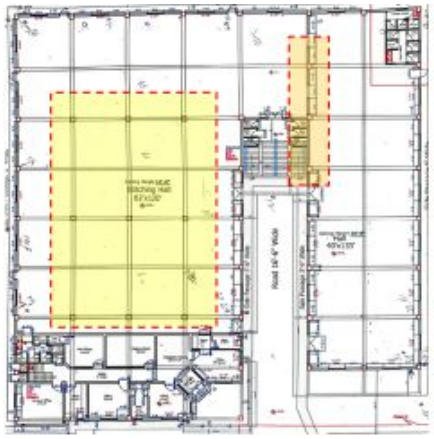
The internal columns of the building 01 are observed to be highly stressed in following areas:

- In area 1 at basement level due to the greater number of storeys(B+G+2), unavailability of concrete data and relatively large grid spacing (12.19x5.89m) in proportion to their section sizes (0.46x0.46m).
- In area 2 at ground level due to the greater number of storeys(G+2), unavailability of concrete data and relatively large grid spacing (11.64x5.94m) in proportion to their section sizes (0.51x0.51m).F-202603-064105

Figure 2.1 - Identified location of highly overstressed internal column at basement level of building 01 (area1)

Timeline	Remediation Plan
Immediate CAP-0075133	Verify the thickness and type of floor finishes at all super structural levels. Submit pictorial evidence to Pakistan Accord.
Immediate CAP-0075134	Verify insitu reinforcement by removing cover and confirming no. and diameter of bars and submit results to Pakistan Accord.
Immediate CAP-0075135	Verify in-situ concrete strength for the identified columns either by 100mm dia. cores from at least 4 columns or existing cylinder strength data and submit results to Pakistan Accord.
Immediate CAP-0075136	Factory Engineer to review design, loads and columns stresses in area identified and submit to Pakistan Accord for review.
Immediate CAP-0075138	(1) Appoint a qualified and competent Structural Engineer to carry out DEA on the full building, in accordance with the DEA scope and minimum requirements set out in the Initial Inspection report.
Medium Term CAP-0075139	(2) Submit accurate As-built Drawings showing structure, loading, elements, dimensions, levels, foundations and framing on Plan, Section and Elevation drawings and a report on Engineering tests carried out to justify material strengths and reinforcement content in all key elements studied, to Pakistan Accord for review

Medium Term CAP-0075140	(3) Submit structural engineering assessment with supporting calculations based on the as-built drawing and material strengths along with safe load plans reviewed previously using a model-based design that justifies the safety and serviceability of the building against loading as set out in Building Code of Pakistan.
Medium Term CAP-0075141	(4) Submit proposals for any retrofitting works that may be needed to demonstrate the adequacy of the structure to Pakistan Accord for review.
Longer Term CAP-0075142	(5) Carry out all retrofitting works if needed as proposed and previously reviewed by Pakistan Accord.
Longer Term CAP-0075143	(6) Factory to advise Pakistan Accord when all retrofitting works are complete and make provision for a verification inspection attended by the factory Structural Engineer. Once Pakistan Accord has verified retrofitting works in accordance with previously reviewed proposals, then this item will be complete.

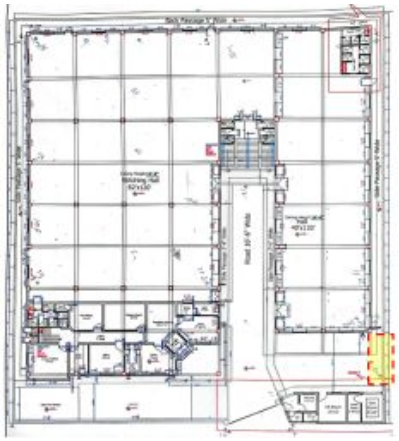
Cracking was observed in the boundary wall located between Building 01 and Gate Office 1. The potential cause can be due to additional imposed load by the steel stair resting directly on wall. F-202603-064125

Figure 2.2 - Identified location of craking in boundary wall at ground floor.

Timeline	Remediation Plan
Medium Term CAP-0075228	Building Engineer to inspect the wall and confirm the source of the cracking.
Medium Term CAP-0075229	Propose the remedial work and submit to Pakistan Accord for review.
Longer Term CAP-0075230	Implement the required remedial works.

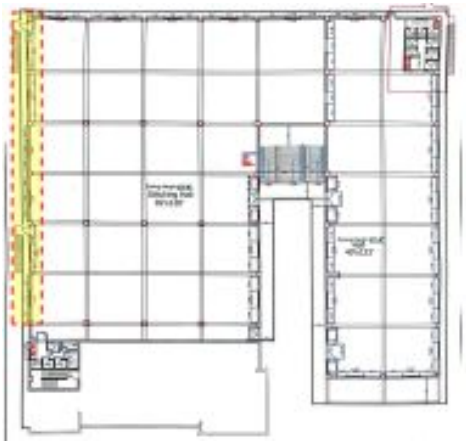
It concerns with lack of edge protection on the roof of building 01 in all three areas (area 1, area2 and area 3), and at the projection at second and first floor in area 2 of building 01, which present a risk of potential injury resulting from slip, trip or fall from roof during the access and maintenance of services – Health & Safety concern. F-202603-064109

Figure 2.11 - Identified location of lack of edge protection at projection on second and first floor of building 01 (area 2)

Timeline	Remediation Plan
Immediate CAP-0075157	Provide adequate edge protection at the identified locations, and on any other part of the factory with the same issue.
