First American Corporation (Pvt.) Ltd.

19 Km Main Daska Road, Ghuinke
51310 Sialkot
Punjab Pakistan

Structural Safety Inspection Report

Pakistan Accord Initial Safety Inspection Report

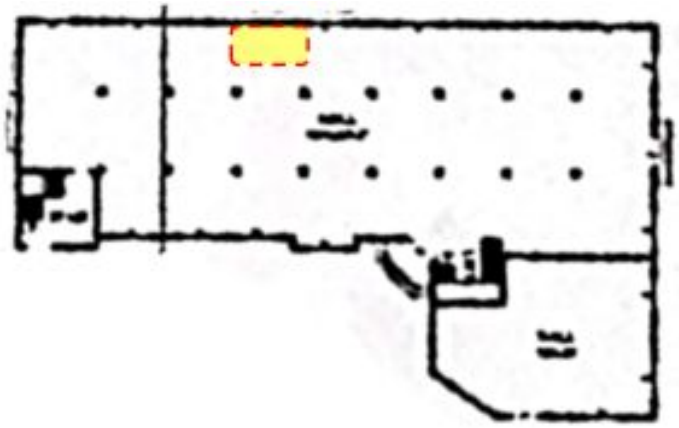
Figure 2.1 - Location of OHWT at the Third Floor of Garment Building

This issue refers to the third floor of the Garment Building, where the Overhead Water Tank (OHWT) is located. Cracks have been observed in the RC retaining walls of the tank and the supporting beams and columns. The reinforcement is severely corroded and exposed due to concrete spalling at several locations. This condition may reduce the structural capacity of the tank and its supporting elements. The deterioration may also be associated with moisture ingress from the tank, which can accelerate corrosion in the supporting structural components beneath the floor. F-202603-064366

Figure 2.3 - Cracking and Exposed Corroded Reinforcement in the OHWT Walls

Figure 2.2 - Damaged RC Column and Beam Supporting OHWT

Figure 2.4 - Cracking in the Wall of OHWT

Timeline	Remediation Plan
Medium Term CAP-0075842	Identify the cause of the damage / source of water ingress and propose measures to prevent further water damage .
Medium Term CAP-0075843	Inspect damage to the RC walls, beams and columns and propose repairs to structure.
Medium Term CAP-0075844	Submit report capturing above to Pakistan Accord for review.
Longer Term CAP-0075845	Implement the required remedial works.
Longer Term CAP-0075846	Continue to monitor for future signs of water ingress/damage.

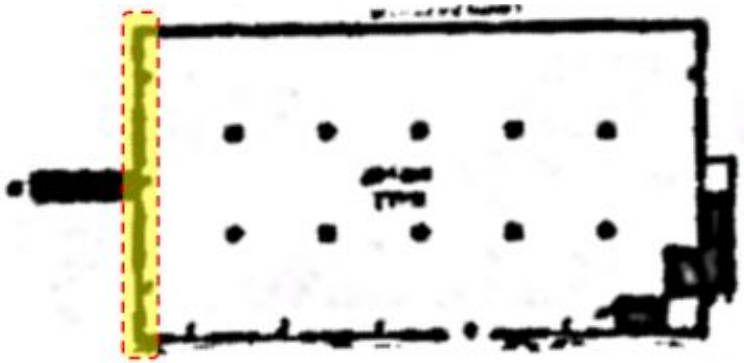
Figure 2.5 - Location of Missing Bracing at the Second Floor of Belt Stitching and Packing Department Building

This issue refers to the Second Floor of the Belt Stitching and Packing Department Building. The vertical cross bracing appears to be missing due to the presence of a door opening, which may compromise the lateral load resistance and overall structural stability of the steel shed. As the structural design documentation for the shed is not available, the adequacy of the existing lateral stability system cannot be verified. F-202603-064367

Timeline	Remediation Plan
Medium Term CAP-0075849	Building structural engineer to review the as-built design for code compliance (vertical and lateral loads) and confirm if it is adequate.
Medium Term CAP-0075850	Propose strengthening works as required and submit to Pakistan Accord for review.
Longer Term CAP-0075851	Implement strengthening works as required.

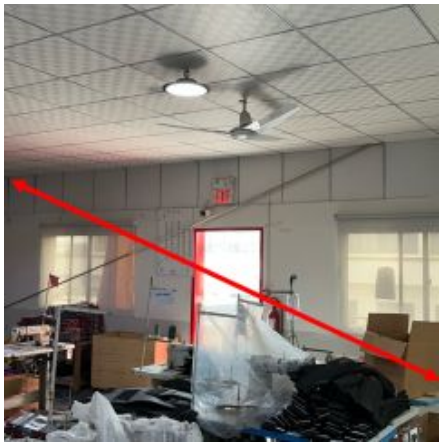
Figure 2.6 - Missing Bracing at the Second Floor of Belt Stitching and Packing Department Building

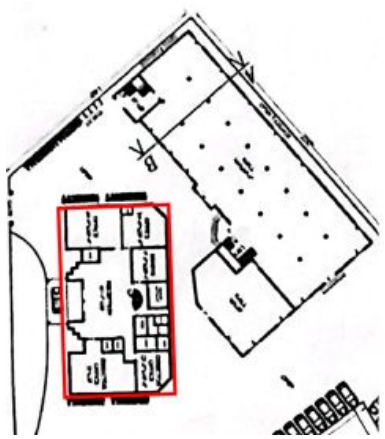
It concerns with inadequate edge protection at the roof of the Admin Block which present a risk of potential injury resulting from slip, trip or fall from roof during the access and maintenance of services – Health & Safety concern. F-202603-064369

Figure 2.15 - Red Line Indicated Missing Edge Protection Boundary at the Roof of Admin Block

Figure 2.16 - Missing Edge Protection at the Roof of Admin Block

Timeline	Remediation Plan
Immediate CAP-0075878	Provide adequate edge protection on the roof, and on any other part of the factory with the same issue.

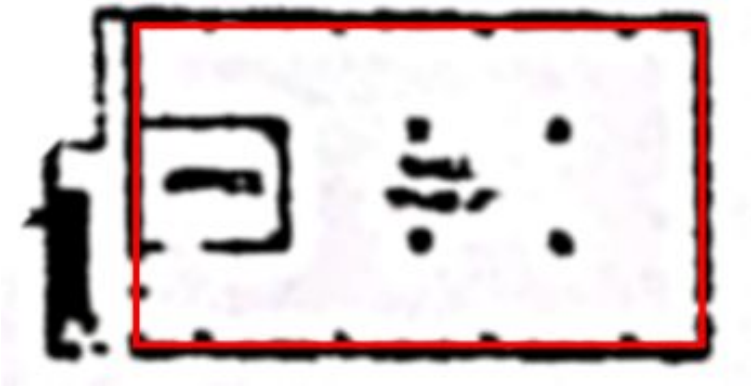
It concerns with inadequate edge protection at the roof of the Heat Transfer / Bag Production Building which present a risk of potential injury resulting from slip, trip or fall from roof during the access and maintenance of services – Health & Safety concern. F-202603-064375

Figure 2.17 - Red Line Indicated Missing Edge Protection Boundary at the Roof of Heat Transfer and Bag Production Building

Figure 2.18 - Missing Edge Protection at the Roof of Heat Transfer and Bag Production Building

Timeline	Remediation Plan
Immediate CAP-0075879	Provide adequate edge protection on the roof, and on any other part of the factory with the same issue.

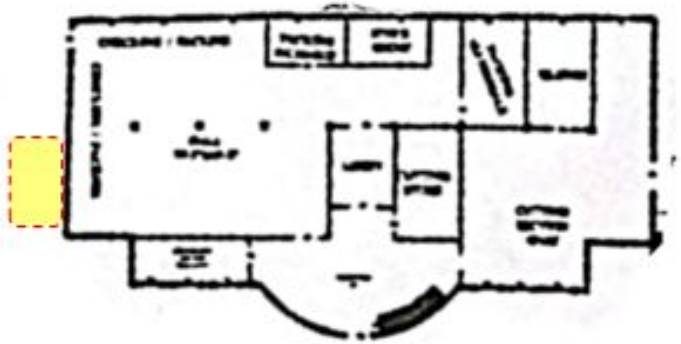
Figure 2.27 - Location of Steel Staircase in the Hummel Building

This issue refers to the steel stairs in the Hummel Building. The stairs have undersized structural elements and lack proper bracing, making them highly vulnerable. F-202603-064373

Figure 2.28 - Structural Stability and Strength Issue in the Steel Staircase of Hummel Building

Timeline	Remediation Plan
Medium Term CAP-0075891	Building structural engineer to review the as-built design for code compliance (vertical and lateral loads) and confirm if it is adequate.
Medium Term CAP-0075892	Propose strengthening works as required and submit to Pakistan Accord for review.
Longer Term CAP-0075893	Implement strengthening works as required.
