Interloop Ltd. (HD05) co-located w/Interloop Ltd. Apparel Park

Latitude: [31.452469], longitude: [73.281943]
Date of inspection: 06-Apr-2026

Structural Safety Inspection Report

Pakistan Accord Initial Safety Inspection Report

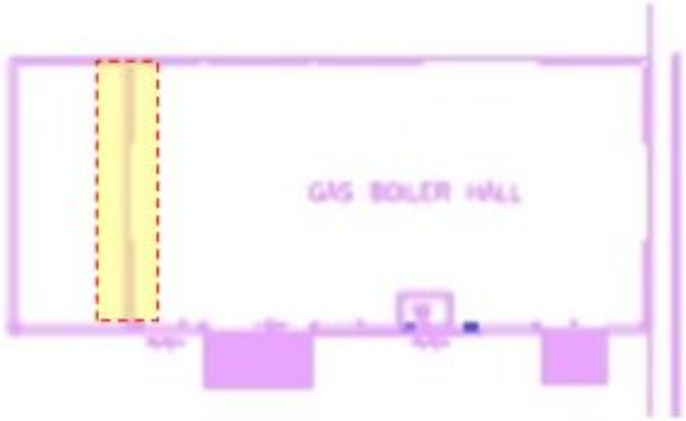
This issue refers to the gas boiler area.
The vertical cross bracing were missing at the wall of gas boiler area at ground floor, which compromises its lateral load resistance and overall structural stability.F-202604-066066

Figure 2.1 - Gas boiler area - Identified location of missing cross bracing at wall at ground level

Figure 2.2 - Gas boiler area - Location of missing cross bracing at wall at ground level

Timeline	Remediation Plan
Longer Term CAP-0079865	Implement the remediation as required.
Medium Term CAP-0078647	Building engineer to review the design of structure and propose any strengthening measures as required.

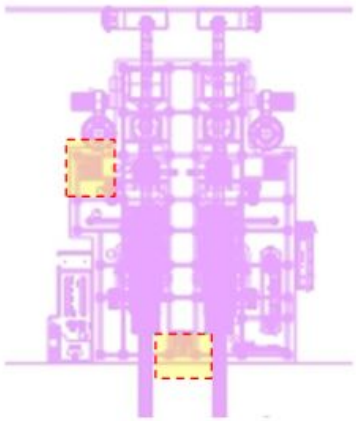
This issue refers to the biomass boiler area.
The vertical cross bracing were missing at the stair of biomass boiler area , which compromises its lateral load resistance and overall structural stability.F-202604-066069

Figure 2.3 - Biomass boiler area - Identified location of missing cross bracing at stairs

Figure 2.4 - Biomass boiler area - Location of missing cross bracing at stairs

Timeline	Remediation Plan
Medium Term CAP-0078650	Building engineer to review the design of structure and propose any strengthening measures as required.
Longer Term CAP-0079866	Implement the remediation as required.

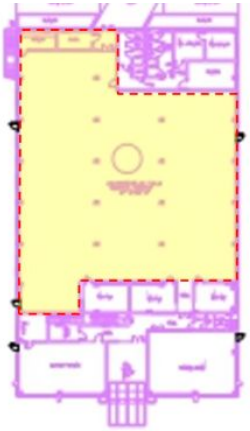
This refers to the exposed rebars on the roof level of office block where the rebars were corroded because of being exposed to the atmosphere. This corrosion can lead to reduction in the capacity of the rebars over time F-202604-066046

Figure 2.7 - Office block - Identified location of corrosion of dowel reinforcemetn at roof level

Figure 2.8 - Office block - Location of corrosion of dowel reinforcemetn at roof level

Timeline	Remediation Plan
Medium Term CAP-0078643	Propose the remedial measure to protect the dowel reinforcement from future atmospheric corrosion and submit to Pakistan Accord for review.
Longer Term CAP-0078644	Implement the required remedial work.
