K.M Ashraf & Sons

Latitude: [32.478145], longitude: [74.538269]
Date of inspection: 05-May-2026

Structural Safety Inspection Report

Pakistan Accord Initial Safety Inspection Report

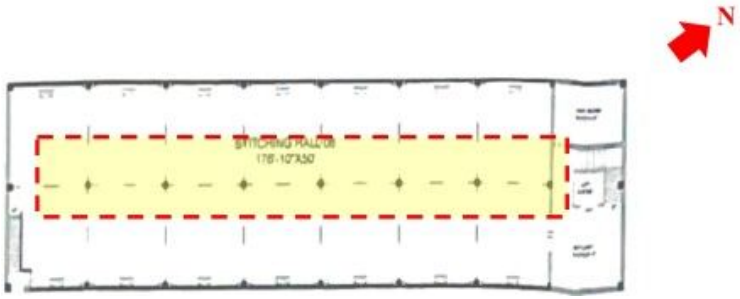
The internal columns of the Building 4 at basement level were observed to be highly stressed, which may be attributed to the relatively larger structural grid size (7.65 m x 7.65 m), more number of stories exceeding the load carrying capacity of the column and unavailability of in-situ design data i.e., concrete compressive strength and steel tensile strength. F-202605-067511

Figure 2.2 - Highly stressed Internal columns at Basement level of Building 4

Timeline	Remediation Plan
Immediate CAP-0081295	Verify in-situ reinforcement by removing cover and confirming no. and diameter of bars and submit results to Pakistan Accord.
Immediate CAP-0081296	Verify in-situ concrete strength for the identified columns either by 100mm dia. cores from at least 4 columns or existing cylinder strength data and submit results to Pakistan Accord.
Immediate CAP-0081297	(1) Appoint qualified and competent Structural Engineer to carry out the DEA on the full building, in accordance with the DEA scope and minimum requirements set out in the initial inspection report.
Medium Term CAP-0081299	Factory Engineer to review design, loads and columns stresses in area identified.
Medium Term CAP-0081298	(2) Submit accurate As-built Drawings showing structure, loading, elements, dimensions, levels, foundations and framing on Plan, Section and Elevation drawings and a report on Engineering tests carried out to justify material strengths and reinforcement content in all key elements studied, to Pakistan Accord for review.

Medium Term CAP-0081300	(3) Submit structural engineering assessment with supporting calculations based on the as-built drawing and material strengths reviewed previously using a model-based design that justifies the safety and serviceability of the building against loading as set out in Building Code of Pakistan.
Longer Term CAP-0081301	(4) Submit proposals for any retrofitting works that may be needed to demonstrate the adequacy of the structure to Pakistan Accord for review.
Longer Term CAP-0081303	(5) Carry out all retrofitting works if needed as proposed and previously reviewed by Pakistan Accord.

Longer Term CAP-0081304	(6) Factory to advise Pakistan Accord when all retrofitting works are complete and make provision for a verification inspection attended by the factory Structural Engineer. Once Pakistan Accord has verified retrofitting works in accordance with previously reviewed proposals, then this item will be complete.
Longer Term CAP-0081302	Continue to implement load plan.

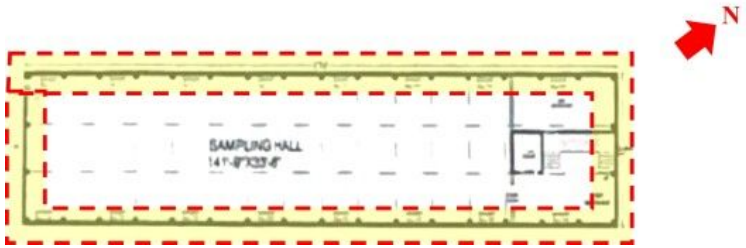
This refers to the Building 3, where edge protection is not provided on the roof level. Missing edge protection presents a risk of potential injury resulting from slip, trip or fall from the roof, while accessing and maintaining services on the roof. This is a Health and Safety Concern. F-202605-067514

Figure 2.7 - Missing Edge Protection Location at Roof of Building 3

Timeline	Remediation Plan
Immediate CAP-0081291	Provide safe access and adequate edge protection on the roof, and on any other part of the factory with the same issue.

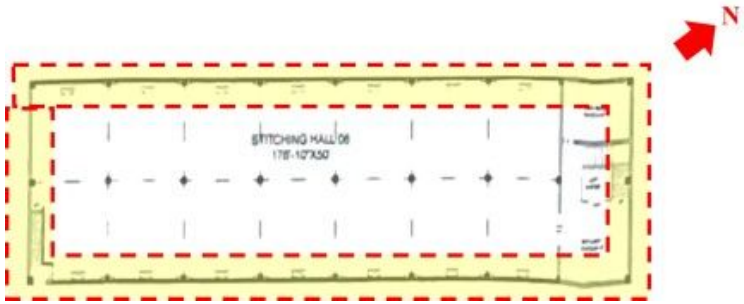
This refers to the Building 4, where edge protection is not provided on the roof level. Missing edge protection presents a risk of potential injury resulting from slip, trip or fall from the roof, while accessing and maintaining services on the roof. This is a Health and Safety Concern. F-202605-067515

Figure 2.9 - Missing Edge Protection Location at Roof of Building 4

Timeline	Remediation Plan
Immediate CAP-0081292	Provide safe access and adequate edge protection on the roof, and on any other part of the factory with the same issue.
