Issue	**1**
Factory ID	**920037**
Date of Issue	**10-Jun-2026**

M/S Stylers International Ltd. - Unit 2 (Raiwind)

Electrical Safety Inspection Report

Pakistan Accord Initial Safety Inspection Report

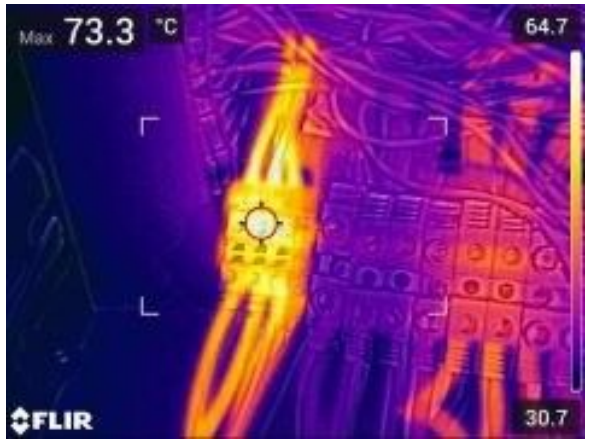
The categories of identified hot spots have been evaluated as per the ANSI NETA MTS 2019 standard, Table 100.18. Hot spots were observed, particularly at the following locations:
i. 85.8°C and 82.1°C at the busbar connection points, and 71.9°C on the base plate in the solar distribution board located on the rooftop of the main building.
ii. 73.7°C at the cable connector in the ETP distribution board.
iii. 61.1°C at the terminal block cable connection in the boiler distribution board.

Circuit breakers are typically designed to operate safely within an ambient temperature range of -20°C to 40°C. Commonly used PVC-insulated cables typically have a maximum operating temperature of 70°C. Prolonged exposure to temperatures above these can degrade the insulation of the breaker as well as the cable and result in reduced performance.

Figure 2.9 - Hot spot found on the cable connector in the ETP distribution board

Timeline	Remediation Plan
Immediate CAP-0076462	Any circuits identified on site with temperatures exceeding 40°C above the ambient temperature, operating above 90°C or exhibiting visual signs of burning must be immediately isolated and taken out of service. These circuits should remain de-energized until a thorough review has been conducted and appropriate remedial actions have been implemented to resolve the underlying issues.
Medium Term CAP-0076463	During the inspection, several circuits were identified where the temperature was exceeding 20°C above ambient temperature, as illustrated in the example images below. It is recommended that the factory conducts comprehensive thermographic surveys of all electrical panels to detect similar issues. Identified hot spots should be thoroughly reviewed to determine their underlying causes. Corrective actions must be taken to address and resolve these issues, ensuring safe and reliable operation of the electrical systems.

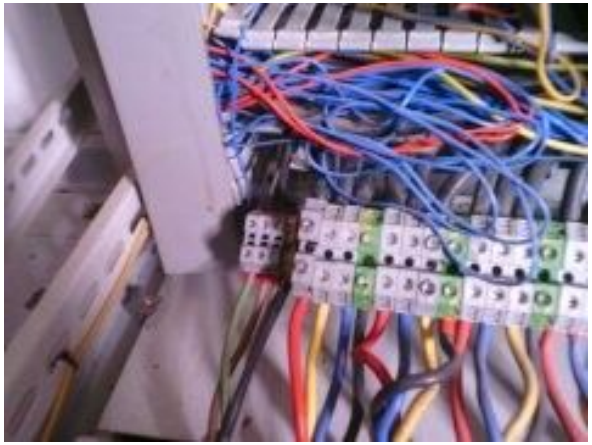
Figure 2.10 - Hot spot found on the cable connector in the ETP distribution board

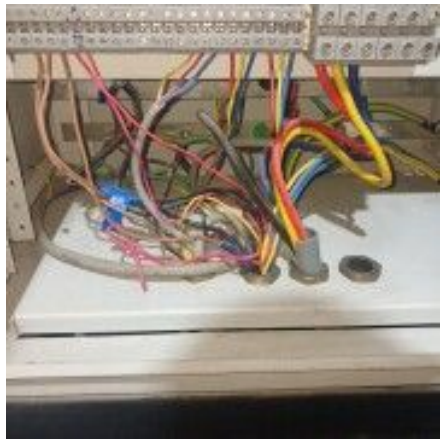
Figure 2.62 - Exposed connections and PVC tape joints in the compressor distribution board
