M/S Stylers International Ltd. - Unit 2 (Raiwind)

Structural Safety Inspection Report

Observations & Actions

Pakistan Accord Initial Safety Inspection Report

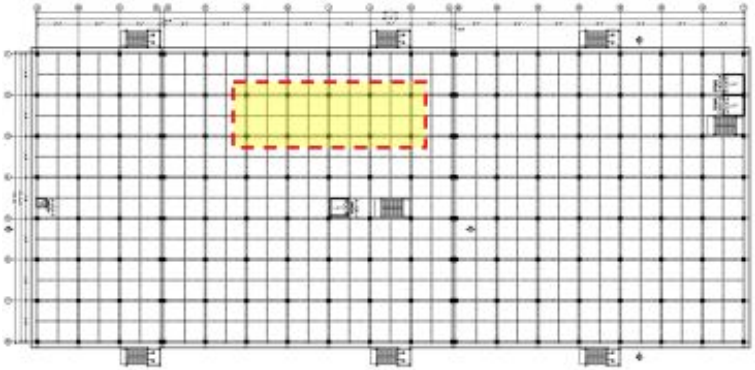
Figure 2.2 - Location of Impact Damage on Columns at Ground Floor of the Mill Building

This issue refers to the ground floor washing area of the mill building.
Impact damage was observed on multiple columns within the washing area, likely due to the trolley movement. The damage is limited to minor surface abrasion of the concrete, with no significant depth or exposure of reinforcement noted. At present, the issue is of low structural severity; however, continued impact may lead to progressive deterioration.F-202604-064932

Figure 2.1 - Impact Damage on Columns at Ground Floor of the Mill Building

Timeline	Remediation Plan
Medium Term CAP-0076858	Repair damage to column corners and external faces.
Medium Term CAP-0076859	Install protective measures to prevent damage recurring, particularly in areas subjected to trolley and machinery movement within the factory.
Longer Term CAP-0076860	Continue to monitor condition of columns in highly trafficked areas.
