Issue	**1**
Factory ID	**26347**
Date of Issue	**22-Apr-2026**

Select Enterprise

Fire Safety Inspection Report

Pakistan Accord Initial Safety Inspection Report

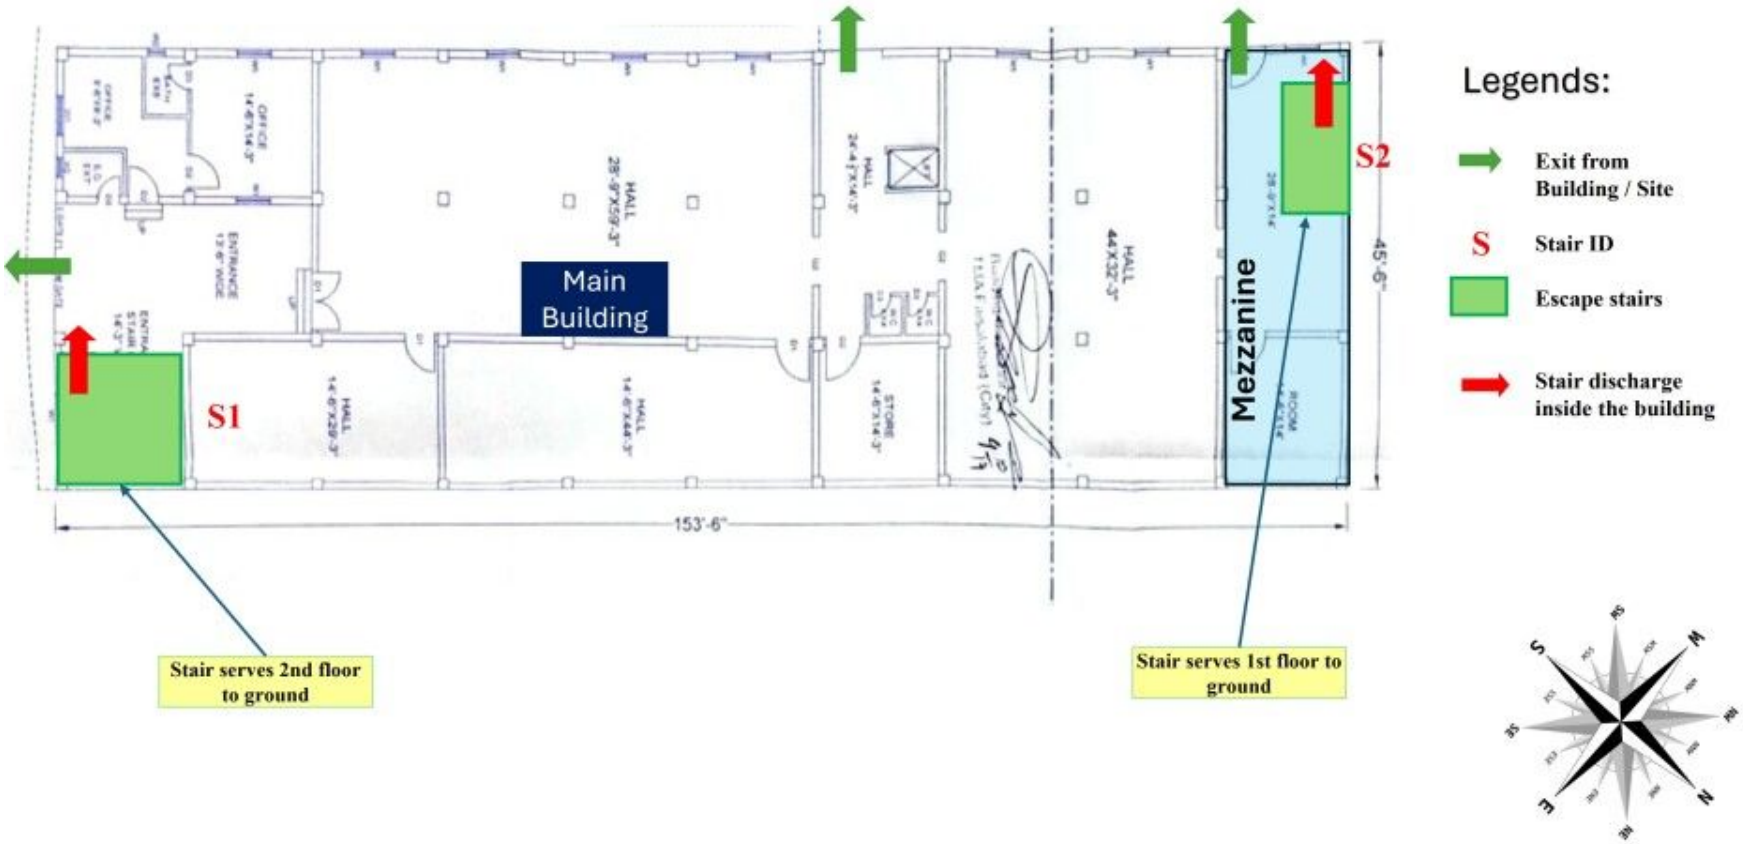
Figure 1.4. Egress Layout of Main Building

The number of exits is sufficient at Main Building. No excessive common path was observed in the Main Building.
