Smart Apparel (Pvt.) Ltd.

Pakistan ACCORD for Health and Safety in the Garment and Textile Industry

Structural Safety Inspection Report

Pakistan Accord Initial Safety Inspection Report

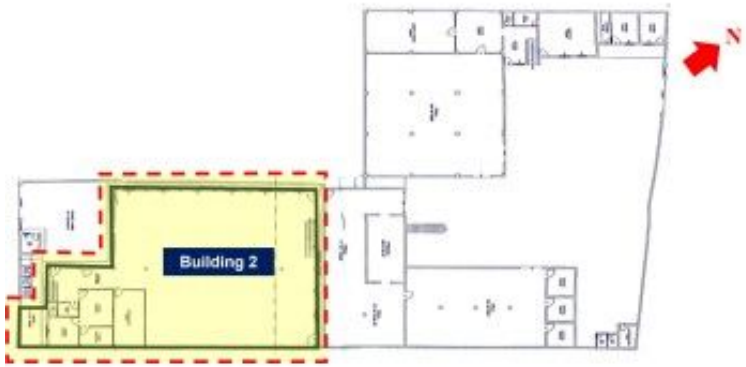
The dowel reinforcement of the columns at the first floor level of Building 2 has been significantly affected by atmospheric corrosion. This condition may compromise the structural integrity over time.F-202604-065693

Figure 2.3 - Corrosion of Column Dowel Reinforcement at First Floor Level of Building 2

Timeline	Remediation Plan
Medium Term CAP-0078071	Propose the remedial measure to protect the dowel reinforcement from future atmospheric corrosion and submit to Pakistan Accord for review.
Longer Term CAP-0078072	Implement the required remedial work.
