TAJ Industries

Latitude: [24.910152], longitude: [67.012005]
Date of inspection: 14-Apr-2026

Fire Safety Inspection Report

Pakistan Accord Initial Safety Inspection Report

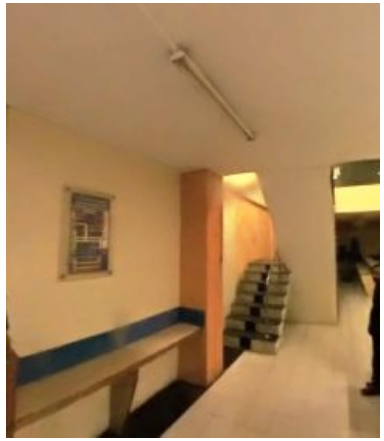
Figure 2.6 - Insufficient headroom along escape route mezzanine floor record room.

Timeline	Remediation Plan
Immediate CAP-0077835	Remove trip hazards on escape routes and keep them clear for escape. Provide warning signs where headroom height is less than 2.05 m on escape routes. Install Smart Padding at locations with headroom clearance below 2.05 m.
Medium Term CAP-0077836	For stairs discharging within the building, prepare drawings showing the proposed fire separating construction to stair discharge corridor leading outside the building. These shall be submitted to the Accord for review and approval prior to the rectification works. The drawings should cover: - Layout showing the location of fire rated walls/doors to protect stair discharge corridors - Details of proposed fire resisting walls and fire door assemblies (e.g. fire door listing, fire rating period, self-closers, door opening direction, details of the door opening mechanism and locks) Propose modifications to ensure 2.05m headroom height is achieved along the escape routes or propose alternative egress routes that comply. Submit the proposal to Pakistan Accord for review.

Longer Term CAP-0077837	Ensure stair discharge routes / corridors are adequately fire separated from the rest of the building or any fire hazards using 2 hours fire separating construction with 90-minute fire doors. The design shall follow the reviewed proposal and comply with Pakistan Accord Standard. Some of the key requirements include: - All doors into stair discharge corridors need to be fire resisting doors (except stair discharge doors to external air). Penetration through the doors is not permitted. All fire doors require self-closers. Doors into stair discharge routes should be kept closed (but not locked) at all times. - All penetrations through walls into stair discharge corridors need to be fire stopped. Unprotected openings (e.g. holes or window/ louver openings) are not permitted. Implement measures to ensure adequate clear head height is achieved along all escape routes.
