TAJ Industries

Structural Safety Inspection Report

Pakistan Accord Initial Safety Inspection Report

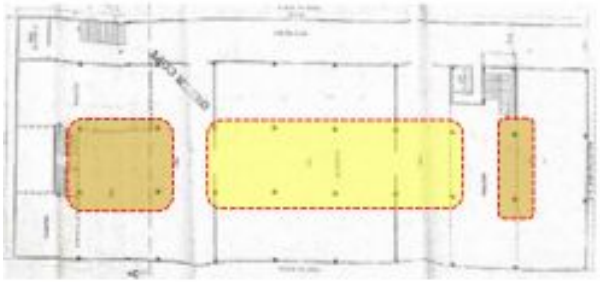
Figure 2.1 - Location of stressed columns (yellow) and highly stressed columns (amber)

Based on the initial assessment and considering the observed loading conditions, the internal RC columns at ground floor level of the main building appear to be highly stressed, likely attributed to the relatively large structural grid (7.64 m × 5.9 m) and unavailibility of concrete strength data. F-202604-065622

Timeline	Remediation Plan
Immediate CAP-0077868	Verify insitu reinforcement by removing cover and confirming no. and diameter of bars and submit results to Pakistan Accord.
Immediate CAP-0077869	Verify in-situ concrete strength for the identified columns either by 100mm dia. cores from at least 4 columns or existing cylinder strength data and submit results to Pakistan Accord.
Immediate CAP-0077870	Verify strength of reinforcement through laboratory tensile strength testing.
Immediate CAP-0077871	(1) Appoint qualified and competent Structural Engineer to carry out DEA on the full building , in accordance with the DEA scope and minimum requirements set out in the Initial Inspection report.
Medium Term CAP-0077872	Factory Engineer to review design, loads and columns stresses in area identified and submit to Pakistan Accord for review.
Medium Term CAP-0077873	(2) Submit accurate As-built Drawings showing structure, loading, elements, dimensions, levels, foundations and framing on Plan, Section and Elevation drawings and a report on Engineering tests carried out to justify material strengths and reinforcement content in all key elements studied, to Pakistan Accord for review

Medium Term CAP-0077874	(3) Submit structural engineering assessment with supporting calculations based on the as-built drawing and material strengths along with safe load plans reviewed previously using a model-based design that justifies the safety and serviceability of the building against loading as set out in Building Code of Pakistan

Medium Term CAP-0077875	(4) Submit proposals for any retrofitting works that may be needed to demonstrate the adequacy of the structure to Pakistan Accord for review
Longer Term CAP-0077876	(5) Carry out all retrofitting works if needed as proposed and previously reviewed by Pakistan Accord
Longer Term CAP-0077877	(6) Factory to advise Pakistan Accord when all retrofitting works are complete and make provision for a verification inspection attended by the factory Structural Engineer. Once Pakistan Accord has verified retrofitting works in accordance with previously reviewed proposals, then this item will be complete.
Longer Term CAP-0077878	Continue to implement load plan

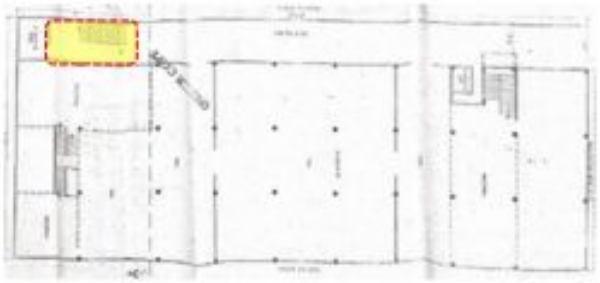
Figure 2.2 - Location of steel emergency staircase

This observation relates to the steel emergency staircase of the main building. At each level, the stair flight members are found to be bearing on undersized landing members. Additionally, a portion of these members remains unwelded/unconnected, resulting in inadequate load transfer and increased structural vulnerability. F-202604-065627

Timeline	Remediation Plan
Medium Term CAP-0077861	Building structural engineer to review the as-built design for code compliance and confirm if the connection details is adequate and submit the report with remedial measures to Pakistan Accord for review.
Longer Term CAP-0080629	Implement the required remedial works

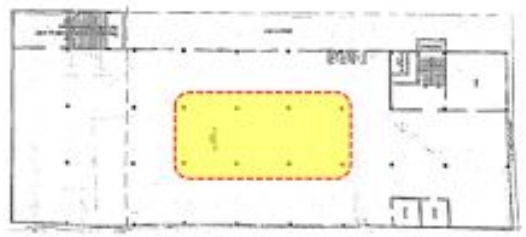
Figure 2.6 - Location of exposed column rebars at roof

This observation relates to the roof level of the main building, where column reinforcement bars are exposed, posing a high risk of corrosion due to direct exposure to environmental conditions. F-202604-065631

Timeline	Remediation Plan
Medium Term CAP-0077895	Building Engineer to inspect areas with protect the exposed rebars from the weather and to propose the remedial solution to further stop reduce the effect of corrosion.
Longer Term CAP-0077896	Implement the remedial works.
