Usman & Sons

Pakistan ACCORD for Health and Safety in the Garment and Textile Industry

Structural Safety Inspection Report

Pakistan Accord Initial Safety Inspection Report

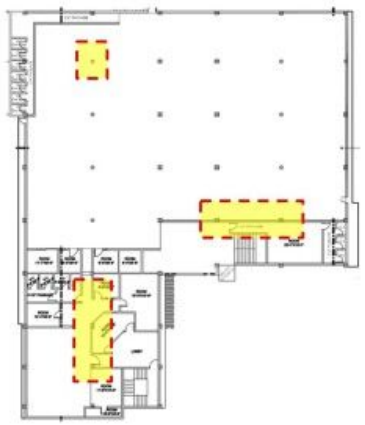
A few interior columns of the main building at the ground floor level appear to be overstressed based on the observed loading conditions. The likely cause of the overstressing is the additional load imposed by the overhead water tank and the additional mezzanine floor.

Column analysis and design calculations were available for a limited number of columns; however, supporting analysis and design documentation for the overhead water tank and the mezzanine floor were not available.F-202605-067251

Figure 2.1 - Plan showing approximate location of overstressed columns

Timeline	Remediation Plan
Medium Term CAP-0083314	Verify strength of reinforcement through laboratory tensile strength testing.
Medium Term CAP-0083315	Factory Engineer to review design, loads and columns stresses in area identified above.
Longer Term CAP-0083316	Produce and actively manage a loading plan for all floor plates within the factory giving consideration to floor capacity and column capacity.

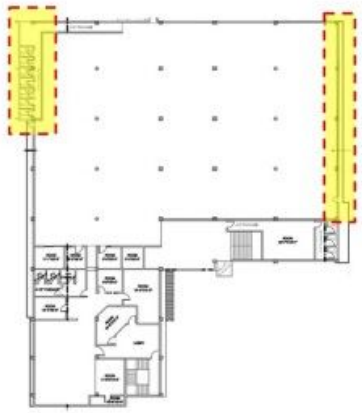
This concern relates to the main building, where slab spalling has been observed at the 1st and 2nd floors, particularly in the toilet areas and slab projections. The likely cause of the spalling is inadequate drainage and water leakage, which may have resulted in deterioration of the slab concrete. F-202605-067303

Figure 2.5 - Approximate location of damaged areas of main building

Timeline	Remediation Plan
Medium Term CAP-0080962	Identify the cause of the damage / source of water ingress and propose measures to prevent further water damage
Medium Term CAP-0080963	Inspect damage to the slab and propose repairs to structure Submit report capturing above to Pakistan Accord for approval
Longer Term CAP-0080966	Implement remedial works
Longer Term CAP-0080967	Continue to monitor for future signs of water ingress/damage

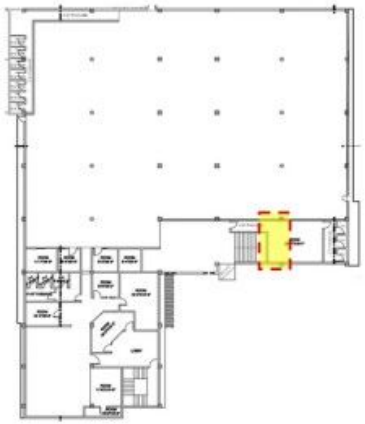
It concerns with inadequate edge protection which present a risk of potential injury resulting from slip, trip or fall from 3rd floor at missing staircase railing during the access and maintenance of services – Health & Safety concern F-202605-067304

Figure 2.10 - Plan showing location of missing edge protection in main building

Timeline	Remediation Plan
Immediate CAP-0080968	Provide adequate edge protection at staircase on 3rd floor, and on any other part of the factory with the same issue.
