Brown burned filament??

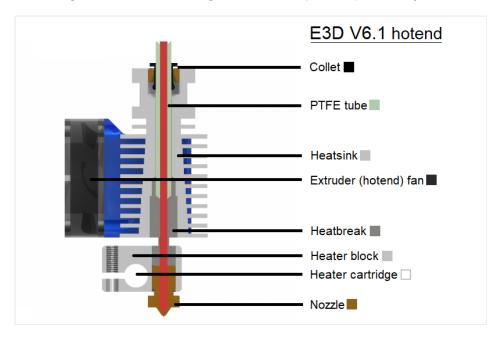
Here's a good cross-section figure someone posted previously.

If melted filament is coming out where the heat break goes into the top of the heater block that would indicate a leak.

When the nozzle and heat break are tightened against each other they form the seal that keeps the melted filament from leaking out.

If tightening doesn't help you may have a nozzle or heat break that isn't perfectly flat where the 2 meet or some debris between them.
